102-07272-MLL/JR
June 9, 2016

Subject: **Palo Verde Nuclear Generating Station (PVNGS) Unit 1
Docket No. STN 50-528 / License No. NPF 41
Licensee Event Report 2016-001-00**

4. TITLE
Leakage from Reactor Coolant Pump 2B Discharge Pipe Instrument Nozzle

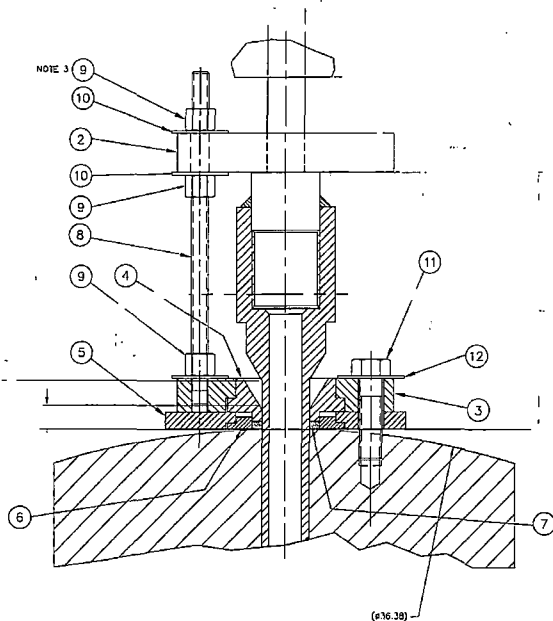
Figure 1 – Mechanical Nozzle Seal Assembly

The cause of the event was determined to be primary water stress corrosion cracking of the Alloy 600 instrument nozzle in the region of the seal weld.

An investigation was initiated to evaluate the condition and to establish necessary corrective actions. Scheduled refueling outage activities were continued and Unit 1 transitioned from Mode 6 to a Defueled condition on April 18, 2016, when all fuel was removed from the reactor vessel. The RCS piping was drained as necessary to allow repairs to the nozzle. To characterize the problem, engineering personnel conducted additional inspections of the nozzle and piping penetration. This included visual (VT) and dye-penetrant exams as well as eddy-current testing. The VT exam of the nozzle interior and seal weld revealed an axial crack in the nozzle in the region of the seal weld. The eddy-current testing results aligned with the VT exam. Repairs to the nozzle were performed per application of Code Case N-733 (no exceptions) with the utilization of a Mechanical Nozzle Seal Assembly (MNSA). Figure 1 illustrates the MNSA.

Repairs to the nozzle were performed per application of Code Case N-733 (no exceptions) with the utilization of a MNSA. A final repair of the nozzle will be evaluated and addressed in the Corrective Action Program.
