**UNITED STATES
NUCLEAR REGULATORY COMMISSION**
REGION IV
1600 E. LAMAR BLVD.
ARLINGTON, TX 76011-4511

**SUBJECT: ARKANSAS NUCLEAR ONE – NRC INSPECTION REPORT 05000368/2016011
AND PRELIMINARY WHITE FINDING**

.1 Unit 2 Emergency Diesel Generator A Bearing Failure

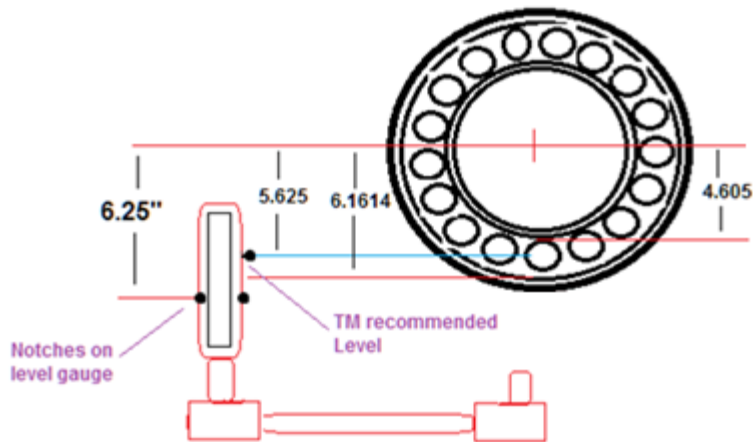
During a causal investigation for the lack of lubrication, the licensee identified that the oil level scribe mark on the sight glass was below the minimum level necessary to provide proper oil lubrication to the bearing. The licensee concluded that on November 11, 2014, while performing Work Order 356569, maintenance personnel had removed and inadvertently inverted the sight glass, which caused the scribe mark to be below the bottom of the bearing rollers (see diagram below). With the sight glass inverted, the scribe mark was 3/8-inch lower than if it was in the correct orientation. Post-failure measurements identified that the scribe mark was 5/8-inch below the correct position. The licensee concluded that adequate oil was initially provided following the sight glass reinstallation. Evidence to support this included multiple successful surveillance tests with no increase in vibrations, including a 24-hour surveillance on January 12, 2015, and having an oil sample from the bearing on June 22, 2016, with no indications of abnormal wear.

On June 22, 2016, maintenance personnel changed the oil in the inboard generator bearing after taking an oil sample in accordance with Work Order 52656389. Maintenance personnel documented leaving the oil level within the procedural limits relative to the scribe mark. Vibrations and system performance were normal during the post-maintenance runs and surveillance tests on June 26, 2016. The licensee determined that the inboard generator bearing had not been leaking oil between the oil change on June 22, 2016, and the September 16, 2016, surveillance failure.

The licensee concluded that the oil in the inboard generator bearing heated up slowly during the 24-hour surveillance. After 14 hours, enough oil had vaporized within the bearing casing that the liquid oil level became inadequate to lubricate the bearing, resulting in bearing failure. Therefore, the inspectors concluded that the emergency diesel generator could have failed approximately 14 hours after the start of a postulated event between June 26, 2016, and September 16, 2016.

The inspectors concluded that multiple causes led to the lack of oil lubrication. The licensee failed to incorporate vendor manual instructions to properly set and verify the correct oil sight glass scribe mark into Work Order 356569 for maintenance performed in

The licensee documented the issue in Condition Report CR-ANO-2-2016-03307. The licensee replaced the damaged parts, machined the shaft and installed a sleeve, and raised the sight glass scribe mark to the correct level for adequate lubrication to the bearing. This violation is being treated as an apparent violation pending a final significance determination. AV 05000368/2016011-01 "Failure to Ensure Adequate Lubrication for Emergency Diesel Generator Bearing."
