Re: St. Lucie Unit 1  
Docket No. 50-335  
Renewed Facility Operating Licenses DPR-67  
Inservice Inspection Plan  
Fourth Ten-Year Interval Unit 1 Relief Request No. 14, Revision 0

***Proposed Alternative***  
***in Accordance with 10 CFR 50.55a(z)(2)***  
***--Hardship without a compensating increase in quality and safety--***

**ST LUCIE 1B2 RCP HEAT EXCHANGER FLAW**

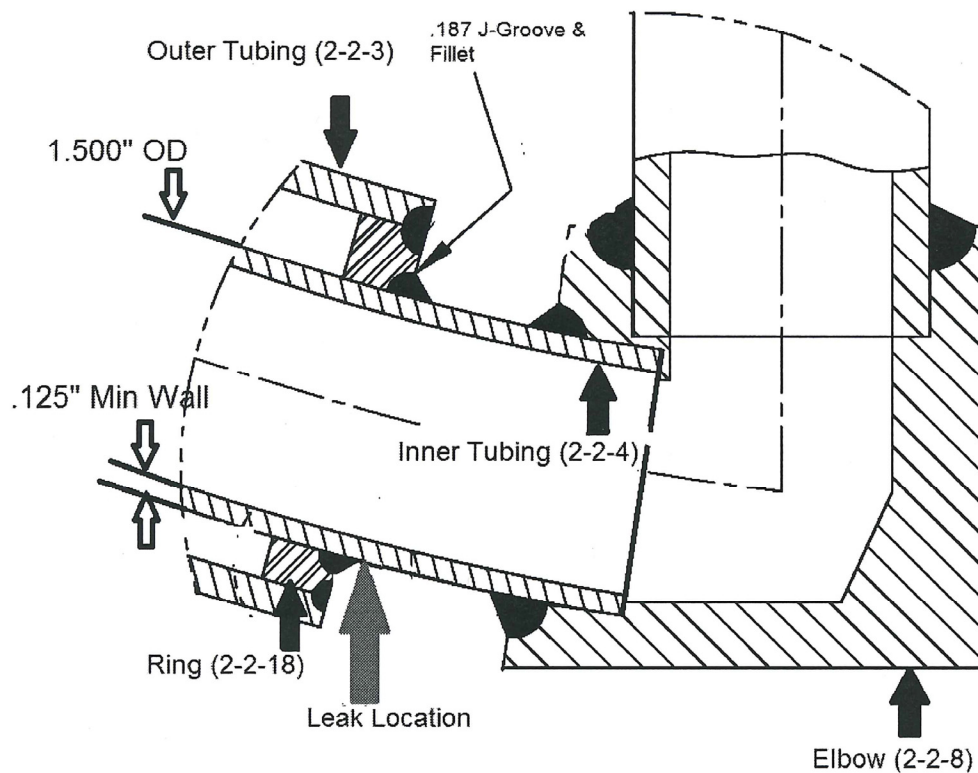
**FIGURE 1**

The seal heat exchanger is a tube in tube type. The inner tube material is 1.5 inch outside diameter (OD) ASME Class 1, SA-213 Type 316 tubing. The minimum wall thickness is 0.125 inches. The location of the flaw is where the inner reactor coolant pressure boundary tube (2-2-4 in Figure 1 below) exits the outer tube of the heat exchanger (Item 2-2-3 in Figure 1 below) before returning to the pump cover.

On January 31, 2017, St. Lucie Unit 1 was shut down to investigate leakage in the 1B2 RCP shroud. The investigation revealed that the 1B2 RCP seal cooler heat exchanger tubing was leaking. The leak is located in the tube material near the toe of the fillet weld that joins the seal cooler tube (Figure 1, Item 2-2-4) and the heat exchanger ring (Figure 1 Item 2-2-18). Based on the location and apparent orientation of the leak/defect the likely cause is OD initiated fatigue. The flaw orientation and size will be further characterized as part of the initial surface visual and dye penetrant examinations prior to defect excavation to assure defect removal and will validate the initial cause. The cause and extent of condition will be determined by the station's corrective action program.

The geometry of the RCP seal cooling line and heat exchanger assembly as shown in Figure 1, does not allow for in-situ radiographic examination. Specifically, the design of the assembly in this location does not use full penetration welds, has various diameters/thicknesses and has multiple access obstructions which does not allow for a radiographic examination of the repair weld in the tube material.

FPL proposes to fully remove the flaw and perform a weld repair to restore the tube wall in accordance with the applicable ASME Code. An alternative is requested to the ASME Code nondestructive examination requirements as described below.

As an alternative to performing radiographic examination of the repair weld to the seal cooler tube material (NB-2539), FPL proposes that progressive dye penetrant examinations be performed.

The defect will be completely removed by mechanical means. The repair area will be excavated and prepared suitable for welding. The prepared excavation will be cleaned as complete as possible. As the repair is an open root weld, the back side of the joint (tube ID) will be purged to eliminate moisture and provide a backing gas for the root pass. The root pass will be dye penetrant examined to assure weld quality. Subsequent weld layers, until the minimum tube wall is restored, will also be dye penetrant examined to assure the weld quality. As an added level of assurance, additional weld metal overlay layer(s) will be applied to the repair area and incorporated into the existing fillet weld to provide a smooth transition between the fillet weld and the tube. This transition will resemble a 2:1 fillet weld configuration as much as physical access to the repair region permits. The final weld repair area will receive a dye penetrant examination to assure the quality of the completed repair. Since the flaw will be completely removed, and the Code compliant repair restores the full thickness of the tube, the original design requirements will be met and the repair will be a life time repair. The progressive dye penetrant examinations are expected to provide a comparable level of quality as the partial penetration and fillet welds used in the RCP seal cooler tube connection welds which are not volumetrically examined.
