ST. LUCIE UNIT 1  
EXTRACTION STEAM PIPING  
INSPECTION PROGRAM GUIDELINES  
JANUARY 28, 1987  
REVISION 1

ST. LUCIE UNIT 1  
INSPECTION PROGRAM RESULTS  
SUMMARY  
APRIL 28, 1987

ST. LUCIE UNIT 2  
PIPING INSPECTIONS FOR  
EROSION/CORROSION  
AUGUST 12, 1987

ST. LUCIE UNIT 1 TURBINE  
CROSS UNDER PIPE INSPECTION  
1983 REFUELING OUTAGE

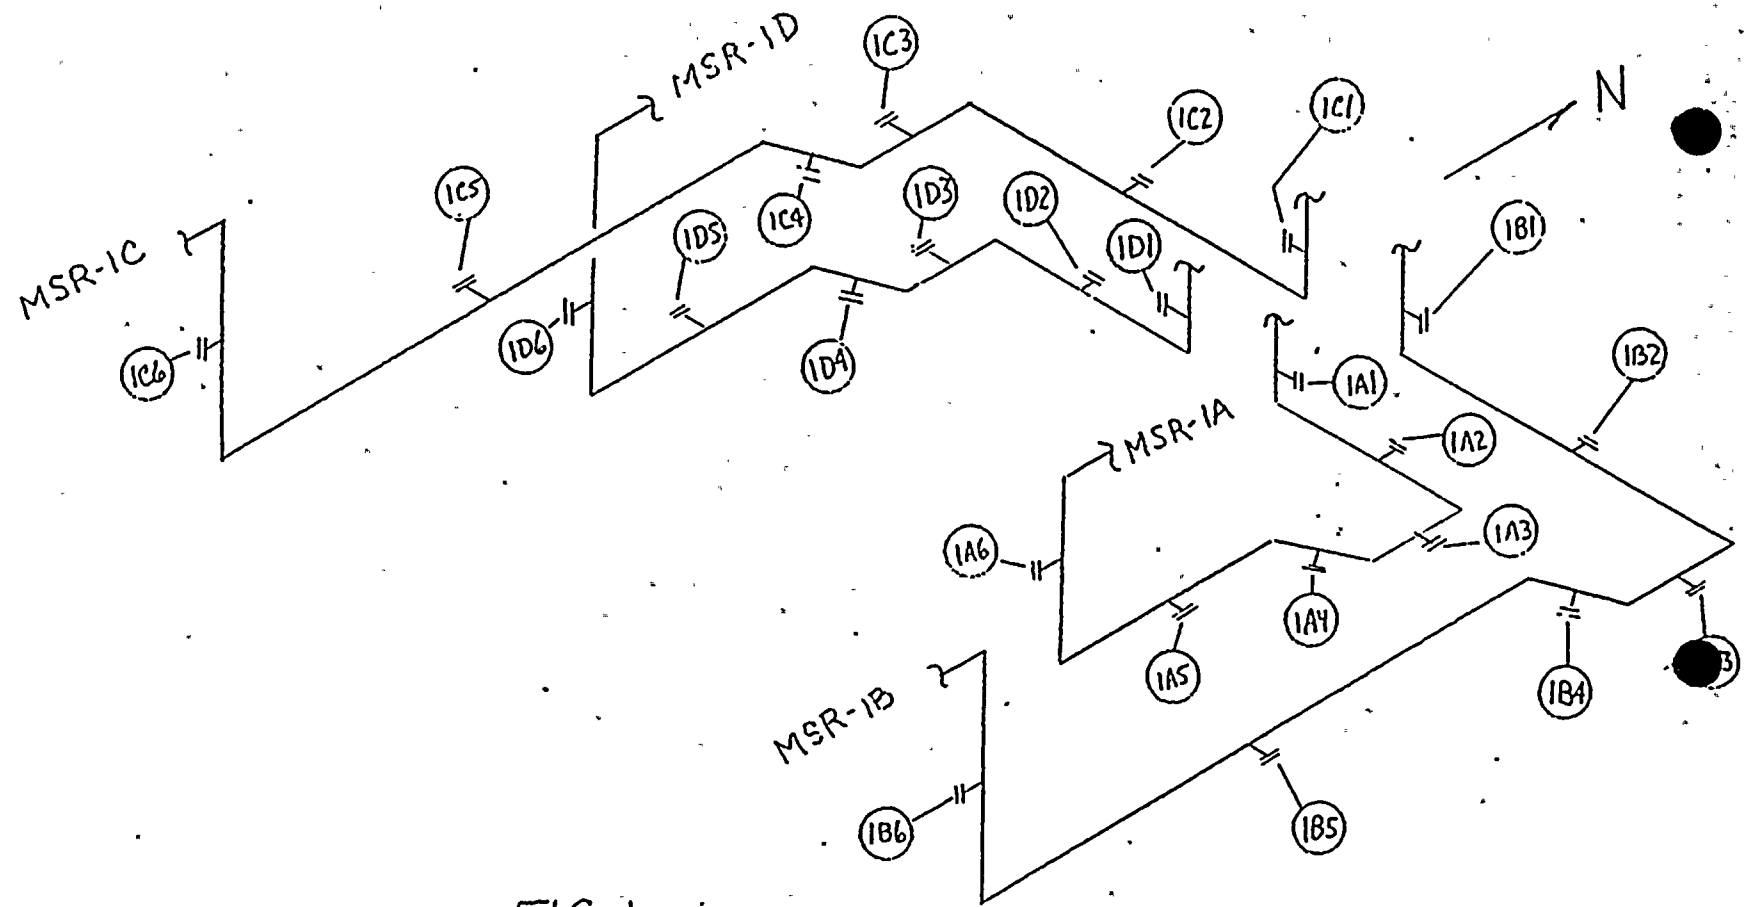
FIG. 1

The turbine cross under piping consists of four (4) 36 inch lines connecting the HP turbine exhaust to the four (4) moisture separator reheaters. The pipes are equipped with turning vanes at each bend to prevent pipe wall erosion. Each pipe section has six (6) manways located between the turning vanes to allow for access (see the attached Fig. 1 for piping layout).

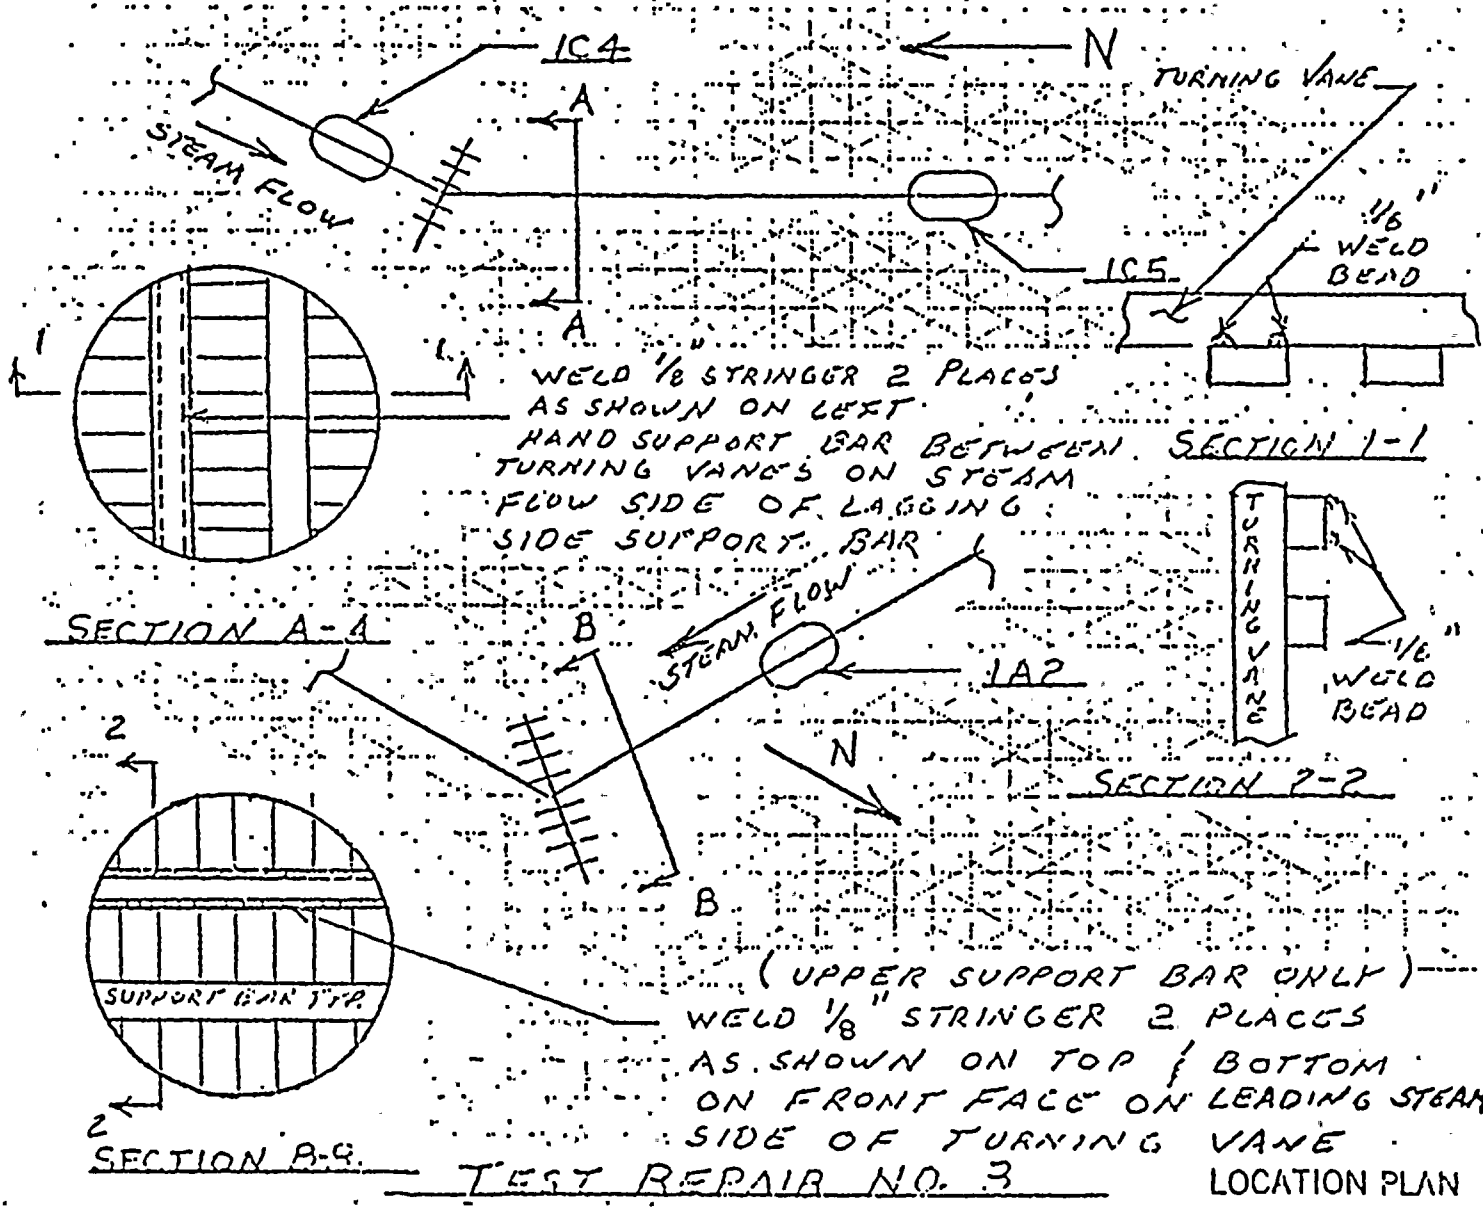
TEST REPAIR NO. 3 LOCATION PLAN

The third repair consisted of welding a bead of metal on the upstream, outer face of both a leading and trailing edge support. One leading edge support located between manways 1A2 and 1A3 plus one trailing edge support located between manways 1C4 and 1C5 received the weld bead repair. The other supports were left alone for the sake of comparison (see Fig. 2 for details). The time required to repair one (1) support in this manner was 20 manhours.

WELD 1/8" STRINGER 2 PLACES AS SHOWN ON LEFT. HAND SUPPORT BAR BETWEEN TURNING VANES ON STEAM FLOW SIDE OF LAGGING. SIDE SUPPORT BAR

(UPPER SUPPORT BAR ONLY) WELD 1/8" STRINGER 2 PLACES AS SHOWN ON TOP { BOTTOM ON FRONT FACE ON LEADING STEAM SIDE OF TURNING VANE
