UNITED STATES NUCLEAR REGULATORY COMMISSION

# **Temporary Overhead Crane Failure at Arkansas Nuclear One**

Workshop on Sharing Operating Experience  
from Rigging, Lifting and Load Handling  
Events

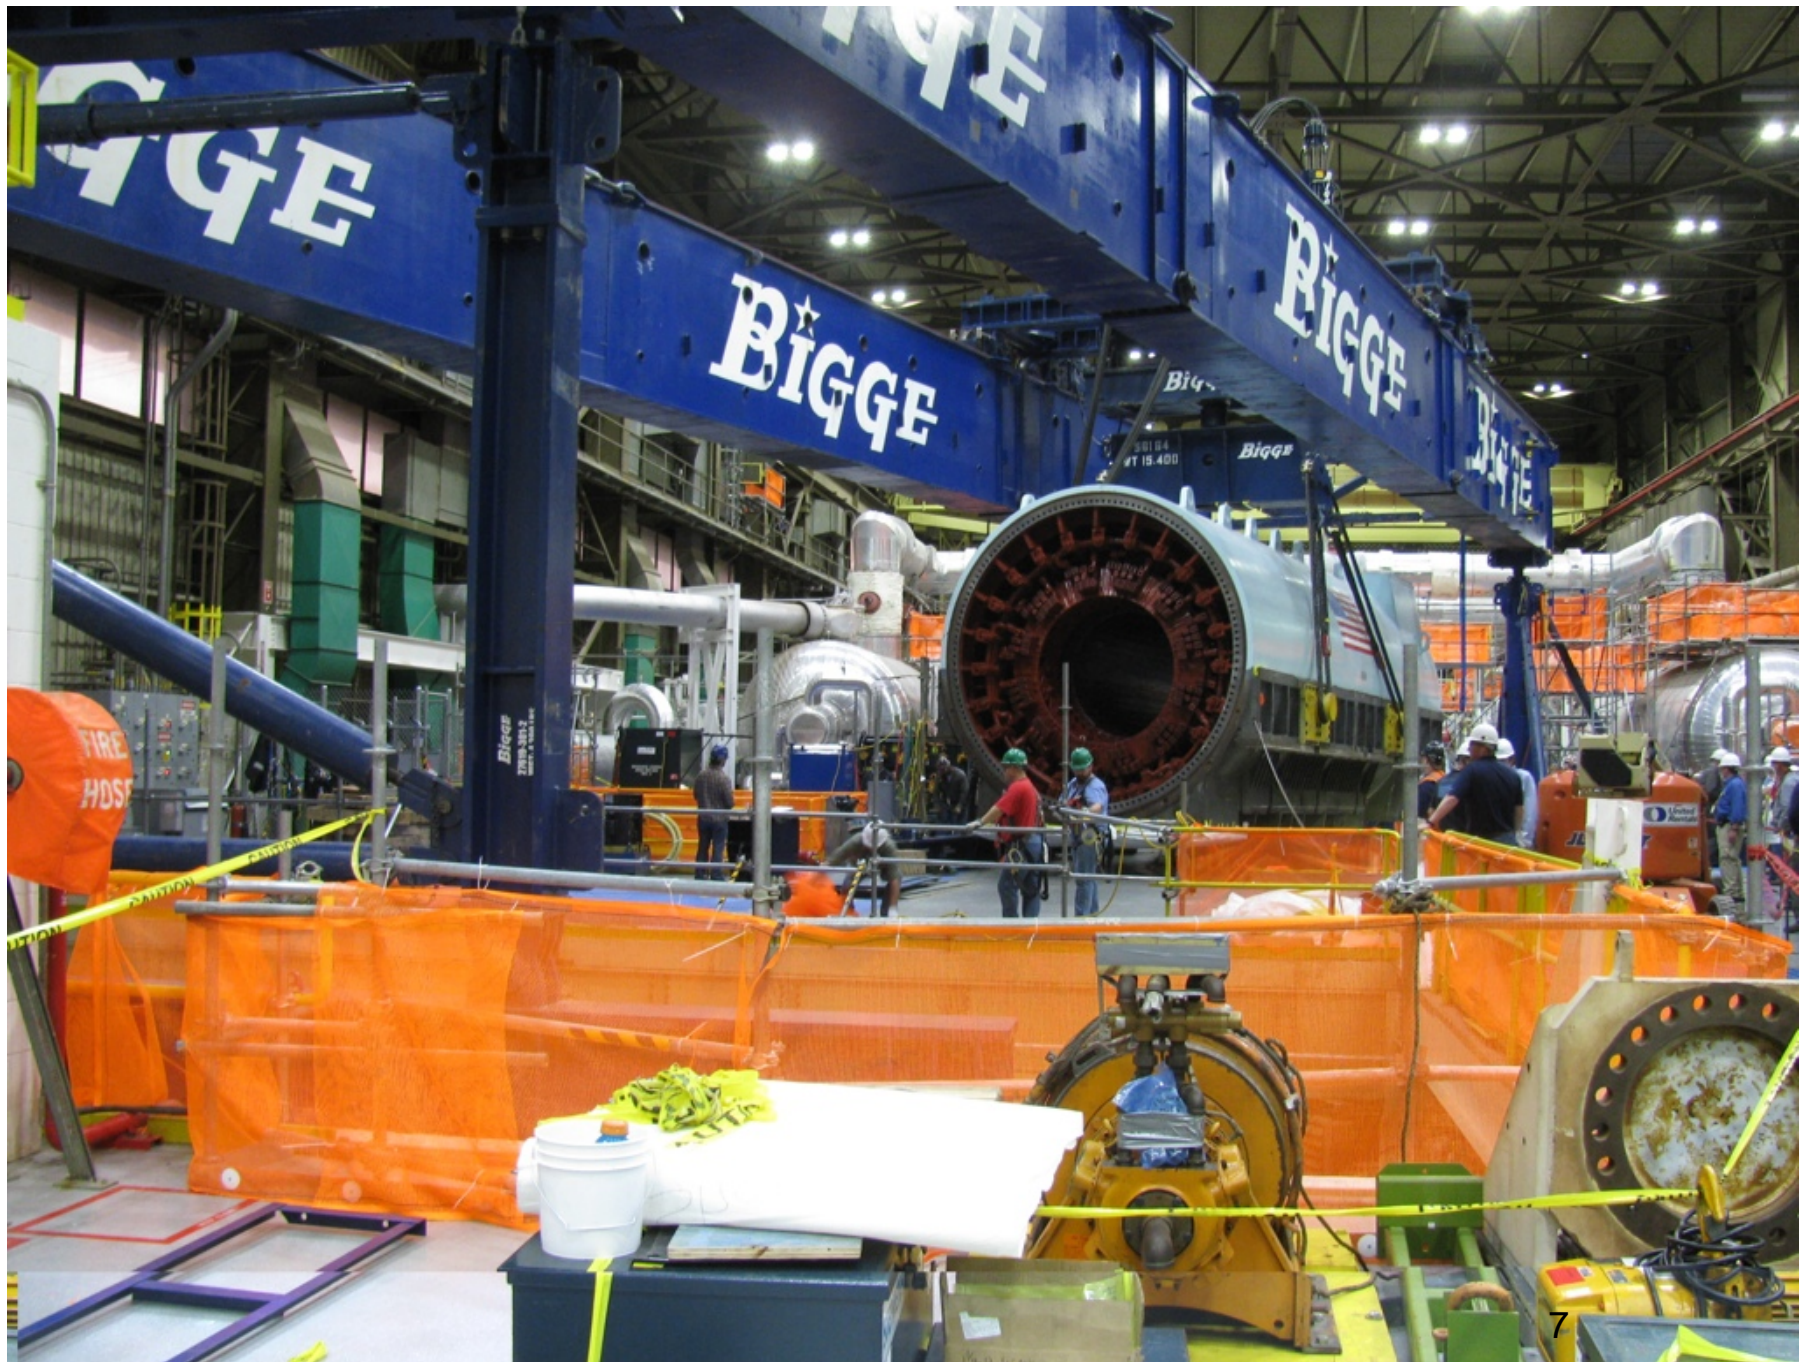
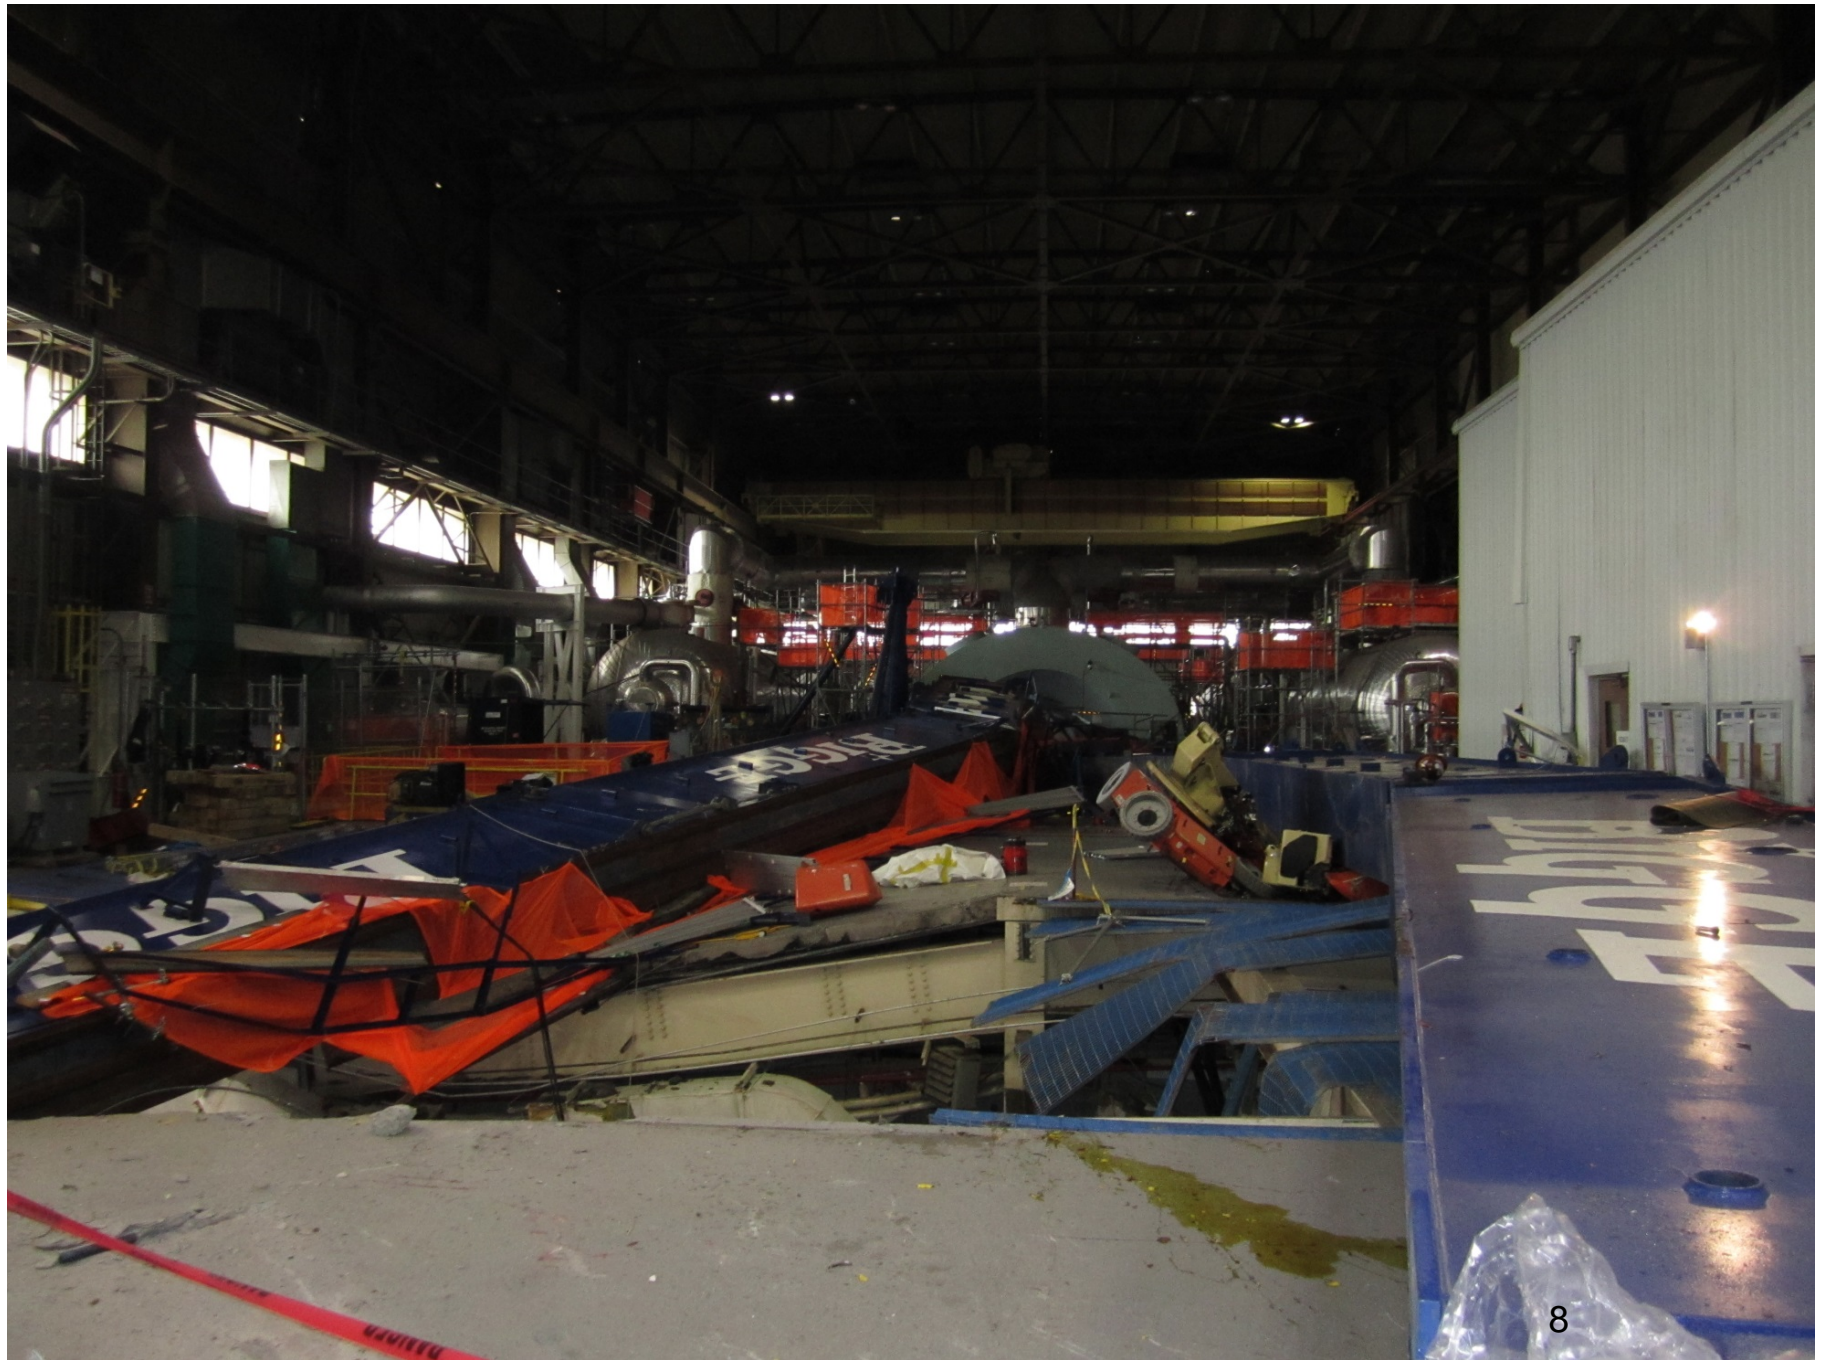
0750: Crane fails, immediate loss of offsite power to Unit 1 (switchgear damaged), Unit 2 reactor coolant pump trip (vibration-induced) and reactor trip, fire piping ruptured

0923: Breaker failure from water leakage causes Unit 2 partial loss of offsite power and loss of instrument air to both units

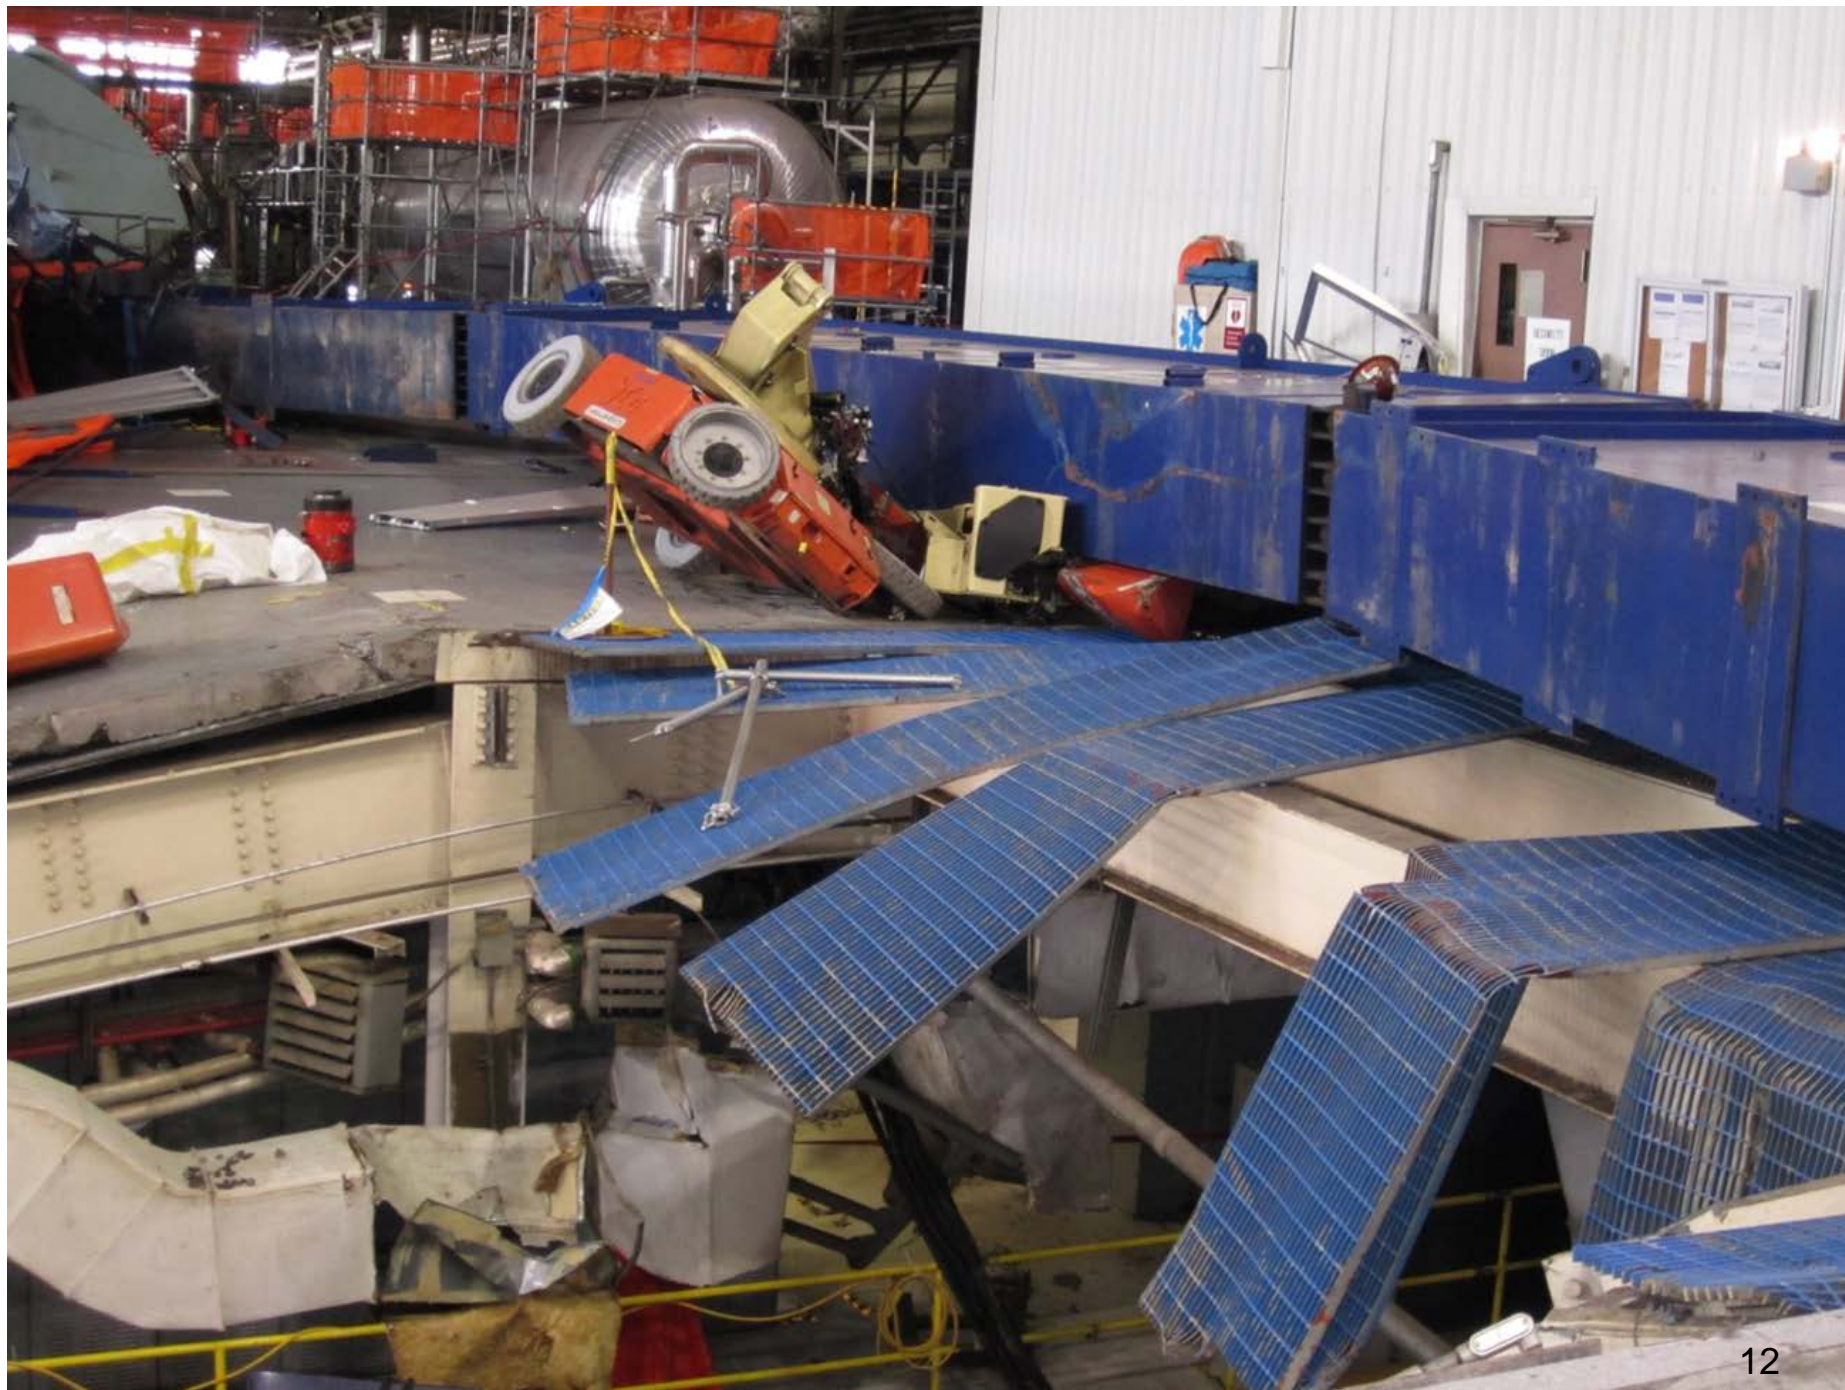
- **Personnel Safety for Suspended Loads**
  - Be aware the area of impact could be more than beneath the suspended load from falling hoist/crane members or other damaged equipment
  - Installed/available cameras can be used to limit observers in the area

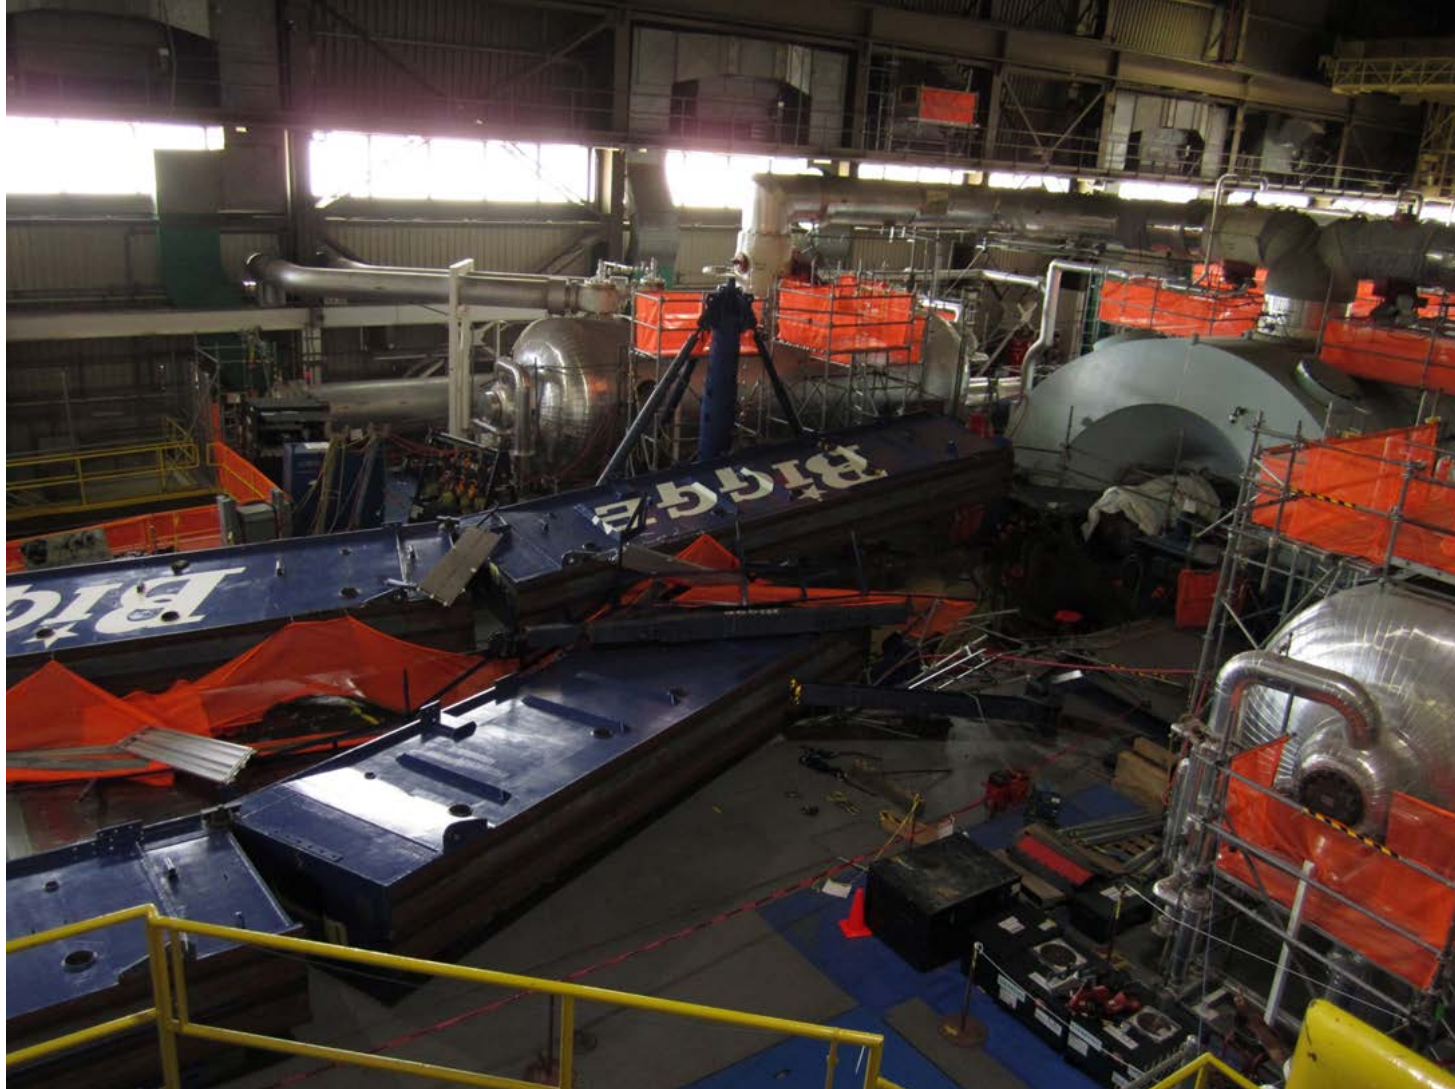
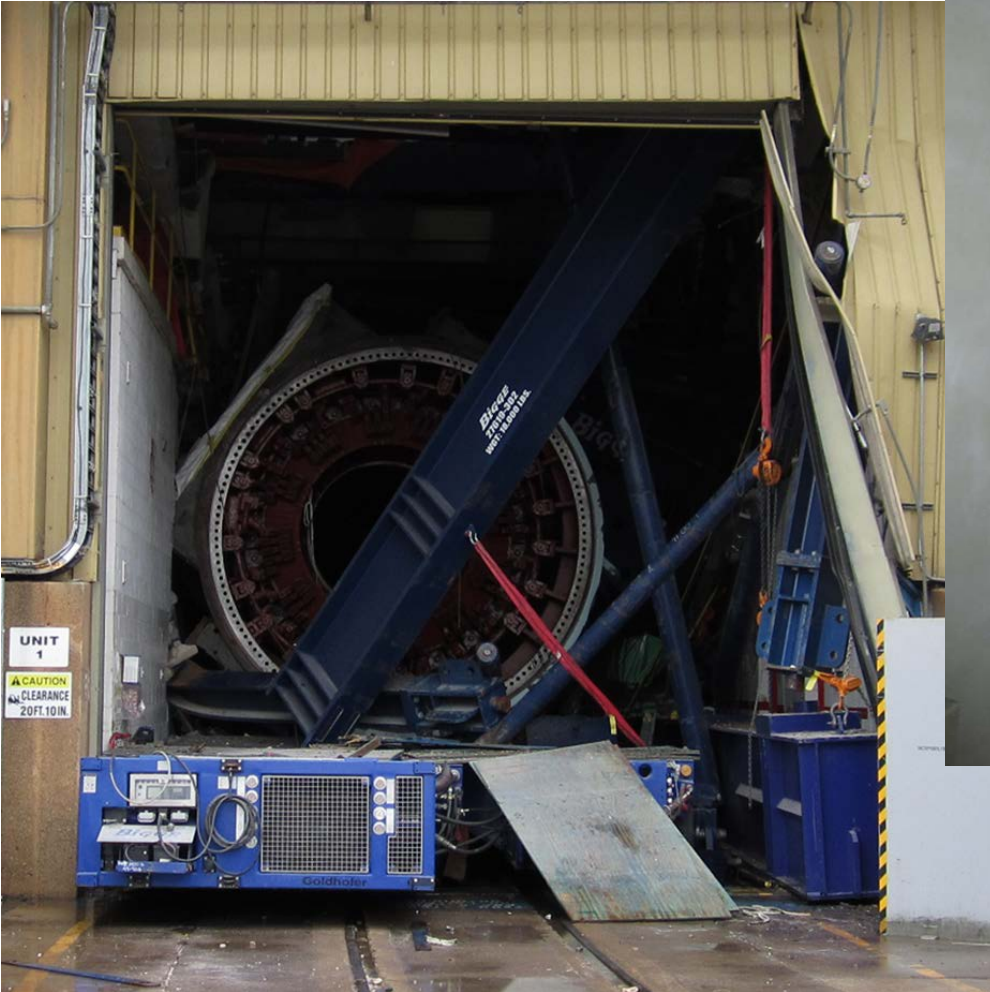
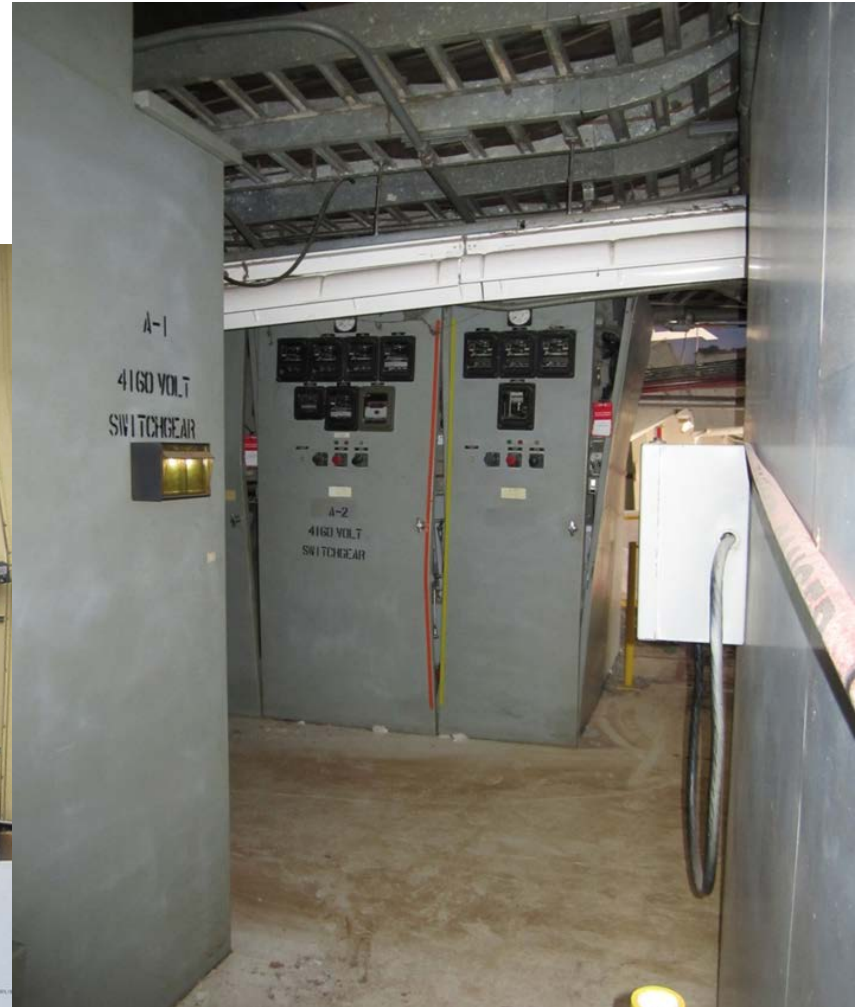
- Collateral Damage Possible from Chain Reaction Events
  - Water from ruptured piping
  - Power failures
- Expect Complications to Response and Recovery
  - Blocked access routes
  - Personnel injuries/fatalities
