REGULATORY INFORMATION DISTRIBUTION SYSTEM (RIDS)

SWAGELOK COMPANY 29500 Solon Road, Solon, Ohio 44139-3492 U.S.A.

Subject: Defects Potentially Reportable Under 10CFR21

We are writing to inform you about a possible machining defect in certain one inch stainless steel Swagelok front ferrules, part number SS-1613-1.

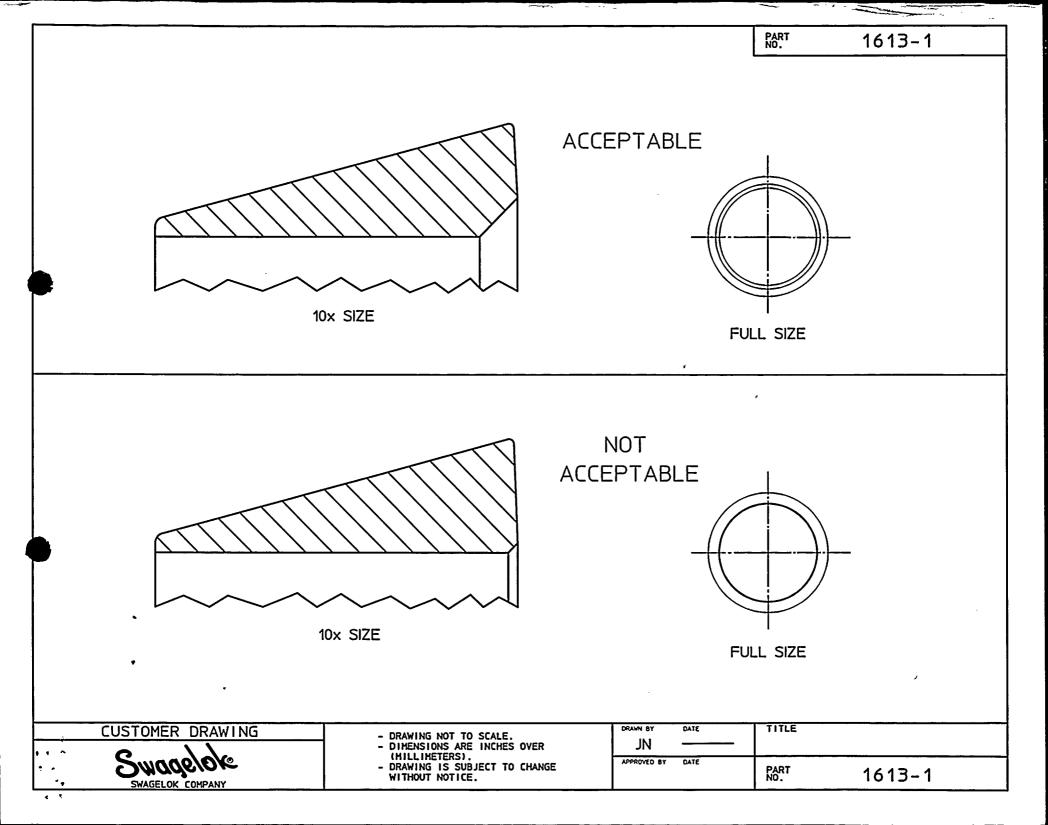
The possible defect is that the 45 degree chamfer on the trailing edge of the ferrule may not be correct. A drawing is enclosed that shows this dimension, along with a drawing that illustrates the front ferrules' position in the Swagelok tube fitting. When these ferrules were machined, an improper set-up allowed a few pieces to be manufactured with an inappropriate dimension. Our inspection of the lots involved shows that about 0.019 per cent of the ferrules manufactured in these lots were affected.

Laboratory testing of these parts with this incorrect dimension had the tubing slip out of the fitting at three times working pressure of the tubing.

Our corrective action includes doubling our sample size on these parts and implementing a long term project to 100 per cent inspect using automation.
