LICENSEE EVENT REPORT (LER)

FACILITY NAME (1) Browns Ferry Nuclear Plant (BFN) Unit 2	DOCKET NUMBER (2) 05000260	PAGE (3) 1 OF 8
---	--------------------------------------	---------------------------

TITLE (4) An invalid local leak rate test on the drywell head seals resulted in a condition prohibited by Technical Specifications

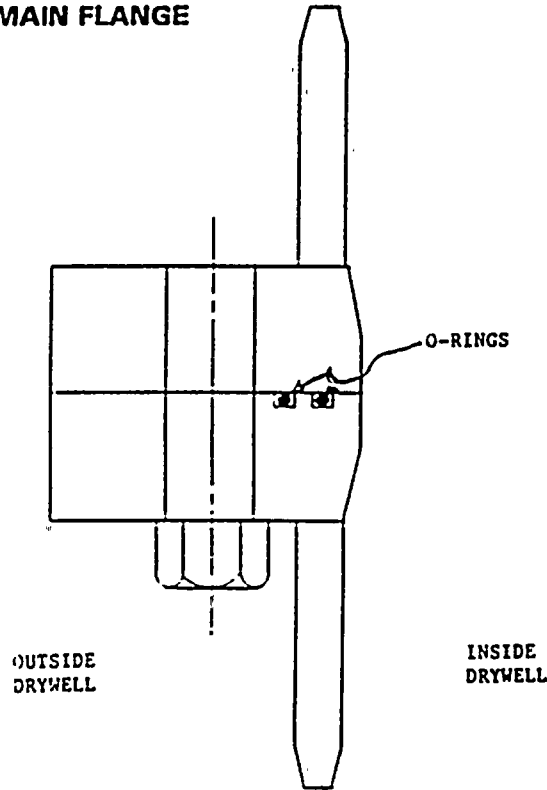
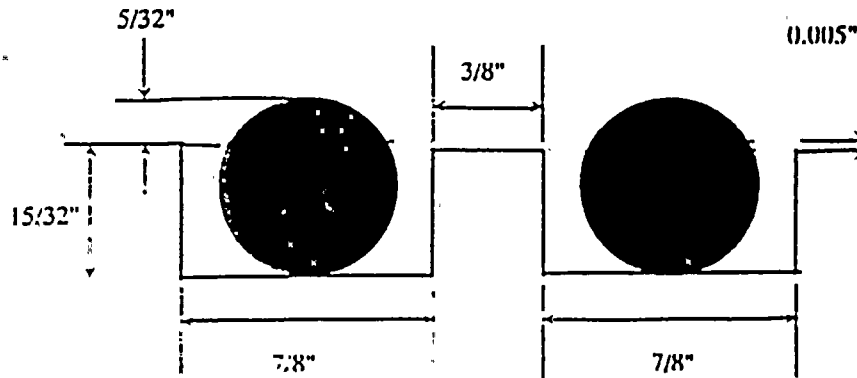
DRYWELL HEAD FLANGE O-RING CONFIGURATION

On October 2, 1994, TVA was removing the BFN Unit 2 drywell head during a scheduled refueling outage. While removing the drywell head, personnel observed an excessive amount of sealing material (i.e., RTV-102) on the lower flange. The sealant had been used to facilitate installation of the drywell head O-rings during the cycle 6 refueling outage. Additionally, approximately three inches of the inner O-ring protruded from its groove (the drywell head flange O-ring configuration is shown on page 7).

indicated that it was adhering tightly to the flange surface. The LLRT volume between the inner and outer O-rings was completely filled. Approximately three inches of the inner O-ring flange groove was empty because the O-ring had been dislodged and was crushed between the flange surfaces with a small portion extending from between the flange surfaces into the drywell interior.

Examination of the outer O-ring indicated that it was seated in its associated groove and compressed along the entire circumference of the drywell head flange. Only one O-ring is required to provide the seal between the upper and lower flange surfaces for the drywell head. Therefore, the drywell head was effectively sealed.

Before reinstalling the drywell head during the Unit 2 Cycle 7 refueling outage, documentation will be provided as to limiting the amount of RTV allowed for the drywell head installation to ensure that it does not interfere with the LLRT. A Problem Evaluation Report (PER) has been initiated and an II is in progress.

The Unit 2 replacement of the drywell head O-rings for the Unit 2, Cycle 7 restart will be performed using an approved procedure that addresses the use of RTV. Any further substantial corrective actions that result from the II will be provided in the supplemental report.

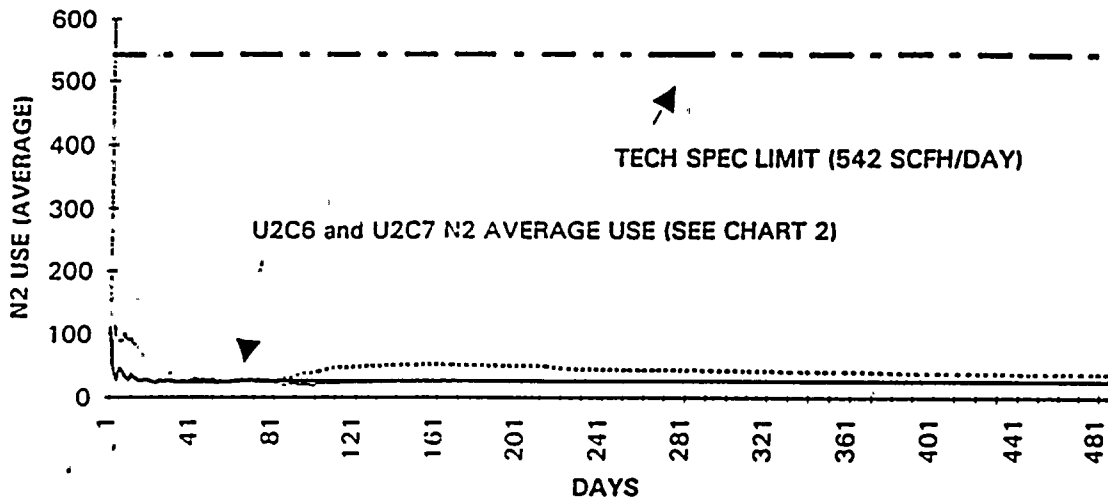
U2C6 - U2C7 N2 USE COMPARISON - CHART 1

No abnormal nitrogen makeup [LK] requirements for drywell inerting were observed during operating cycle 7 (See chart 1 on page 8). The average amount of nitrogen consumed for the first 81 days was less than the amount that was used during operating cycle 6 when the drywell head was sealed without RTV [see chart 2 on page 8). However, the average amount of nitrogen consumed did increase over the remainder of the operating cycle 7. This increase was due to a drywell air compressor problem. If the drywell air compressor problem had not occurred, TVA believes that the nitrogen consumption would have continued to follow the trend of the first 81 days (i.e., less than cycle 6 nitrogen consumption). During the last two operating cycles, the amount of nitrogen consumed was significantly below the Technical Specifications limit.
