LICENSEE EVENT REPORT (LER)

FACILITY NAME (1) Browns Ferry Nuclear Plant (BFN) Unit 2	DOCKET NUMBER (2) 05000260	PAGE (3) 1 OF 10
---	--------------------------------------	----------------------------

TITLE (4) An invalid local leak rate test on the drywell head seals resulted in a condition prohibited by Technical Specifications

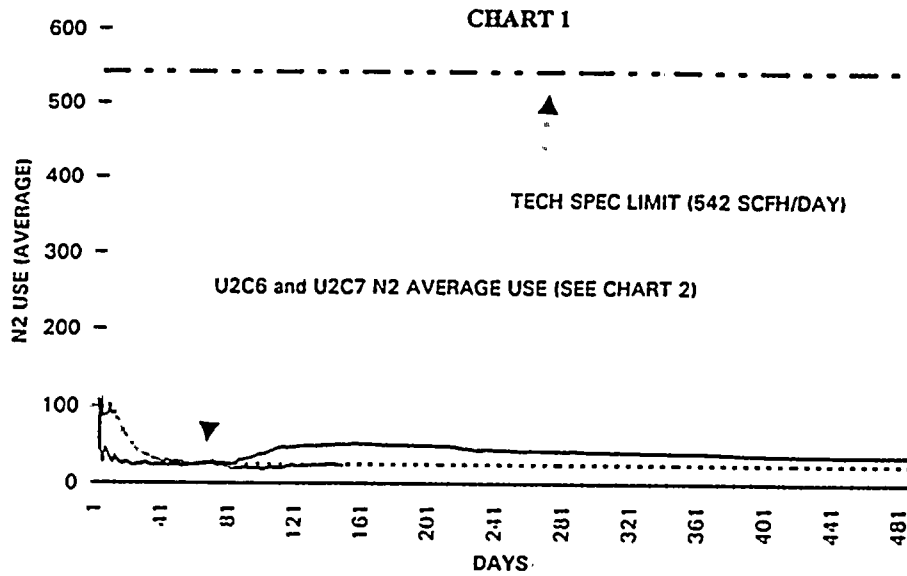
U2C6 - U2C7 N2 USE COMPARISON

No abnormal nitrogen makeup [LK] requirements for drywell inerting were observed during operating Cycle 7 (See Chart 1 on page 9). The average amount of nitrogen consumed for the first 81 days was less than the amount that was used during operating Cycle 6 when the drywell head was sealed without RTV [see Chart 2 on page 9]. However, the average amount of nitrogen consumed did increase over the remainder of the operating Cycle 7. This increase was due to a drywell air compressor problem. If the drywell air compressor problem had not occurred, TVA believes that the nitrogen consumption would have continued to follow the trend of the first 81 days (i.e., less than Cycle 6 nitrogen consumption). During the last two operating cycles, the amount of nitrogen consumed was significantly below the Technical Specifications limit.

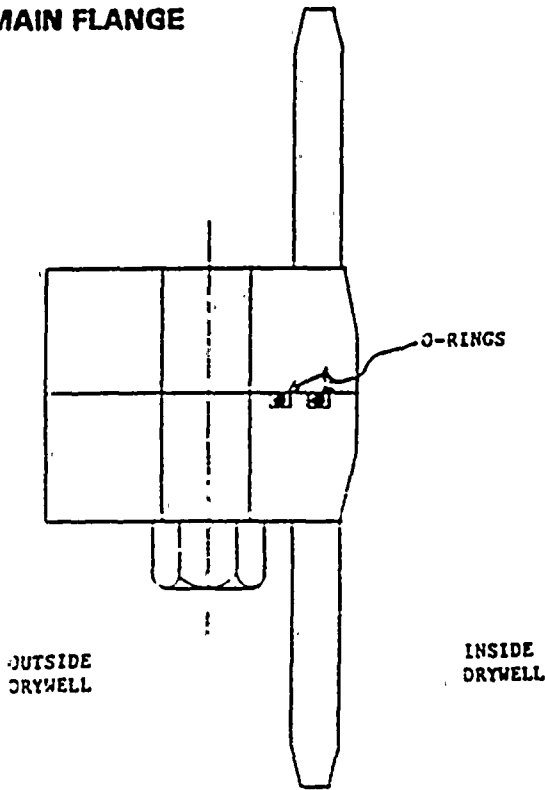
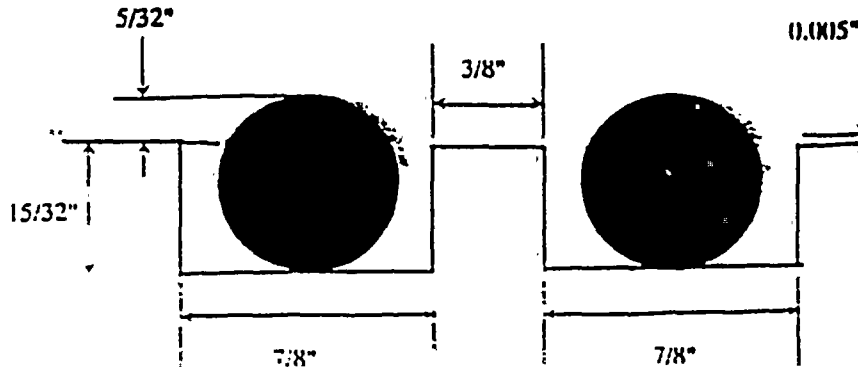
DRYWELL HEAD FLANGE O-RING CONFIGURATION

On October 2, 1994, TVA was removing the BFN Unit 2 drywell head during a scheduled refueling outage. While removing the drywell head, personnel observed an excessive amount of sealing material (i.e., Room Temperature Vulcanizing (RTV)-102) on the lower flange. The sealant had been used to facilitate installation of the drywell head O-rings during the Cycle 6 refueling outage. Additionally, approximately three inches of the inner O-ring protruded from its groove (the drywell head flange O-ring configuration is shown on page 10).

Based on the observations of the O-rings [SEAL] when the drywell head [NH] was removed this outage, it was concluded that an invalid LLRT had been performed before the restart of Unit 2 on May 25, 1993. Specifically, the RTV was in the area between the O-rings, and the inner O-ring seal was broken. Thus, the excessive amount of RTV obstructed the LLRT test volume. Further details of this event are provided below.

As stated previously, an excessive amount of RTV was observed on the lower flange of the drywell head. The RTV was found to be uniformly distributed around the lower flange surface from near the inner radius of the flange across the O-rings outward past the O-ring grooves. Examination of the RTV on the lower flange of the drywell head indicated that it was adhering tightly to the flange surface. The LLRT volume between the inner and outer O-rings was completely filled. Approximately three inches of the inner O-ring flange groove was empty because the O-ring had been dislodged and was crushed between the flange surfaces with a small portion extending from between the flange surfaces into the drywell interior.

Examination of the outer O-ring indicated that it was seated in its associated groove and compressed along the entire circumference of the drywell head flange. Only one O-ring is required to provide the seal between the upper and lower flange surfaces for the drywell head. Therefore, the drywell head was effectively sealed.

The Unit 2 replacement of the drywell head O-rings for the Unit 2, Cycle 7 restart was performed using an approved procedure that addressed the use of RTV. Prior to reinstalling the head during the Unit 2 Cycle 7 refueling outage, a DCN was issued which controlled the amount of RTV so that it would not interfere with the LLRT. Additionally, this evolution was performed using an approved procedure that addressed the use of RTV. Additional management oversight was provided on the refuel floor during the Unit 2 Cycle 7 refueling outage to ensure adequate control of refueling evolutions.
