LICENSEE EVENT REPORT (LER)

FACILITY NAME (1)
Browns Ferry Nuclear Plant (BFN) Unit 2

TITLE (4) Diesel Generator Turbocharger Failure That Resulted In Noncompliance With Technical Specification Limiting Condition For Operation

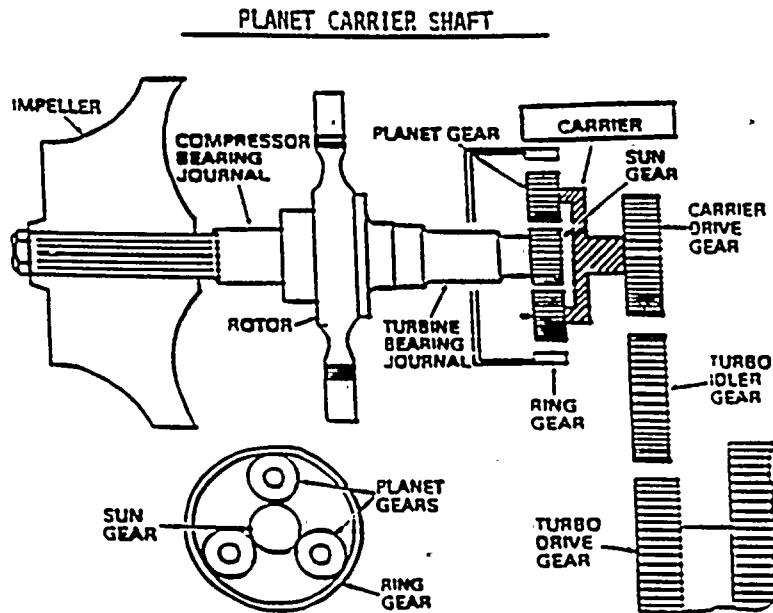
TURBOCHARGER PLANET GEAR TRAIN

This event resulted from a failure of the turbocharger planetary gears and sun gear (see attached figure). TVA believes that the most probable cause of the turbocharger failure was failure of a tooth on the sun gear due to bending fatigue. This tooth failure caused subsequent failures of the remaining sun gear teeth and the planetary gear teeth.

TVA performed a metallurgical evaluation of the failed turbocharger components. TVA's evaluation identified evidence of fatigue on the sun gear and the planetary gears. TVA also identified signs of overheating, including discoloration and oxide-filled cracks, in these gears. The bearings appeared to have sustained no damage. The most probable cause of the gear failures was fatigue; however, due to the extensive thermal and mechanical damage to the sun gear and planetary gears, TVA cannot conclusively determine the root cause of the failure.

During the event, as the engine was unloaded and the amount of available exhaust gases decreased, the turbocharger decelerated to a point where it should have been driven from the planetary gear train. The decrease in the exhaust gas resulted in a removal of the driving force to the turbocharger. Because the gear train had failed, combustion air was lost. At this point, the engine shutdown.

The turbocharger on the EDG was replaced. After completing post maintenance testing, the EDG was returned to standby readiness.

TVA plans to remove the EDG 1A turbocharger before or during its next biennial inspection, currently scheduled for June 1996, and inspect it for any degradation which could potentially cause the turbocharger to fail.
