LICENSEE EVENT REPORT (LER)

FACILITY NAME (1)
Browns Ferry Nuclear Plant (BFN) Unit 2

TITLE (4) Diesel Generator Turbocharger Failure That Resulted In Noncompliance With Technical Specification Limiting Condition For Operation

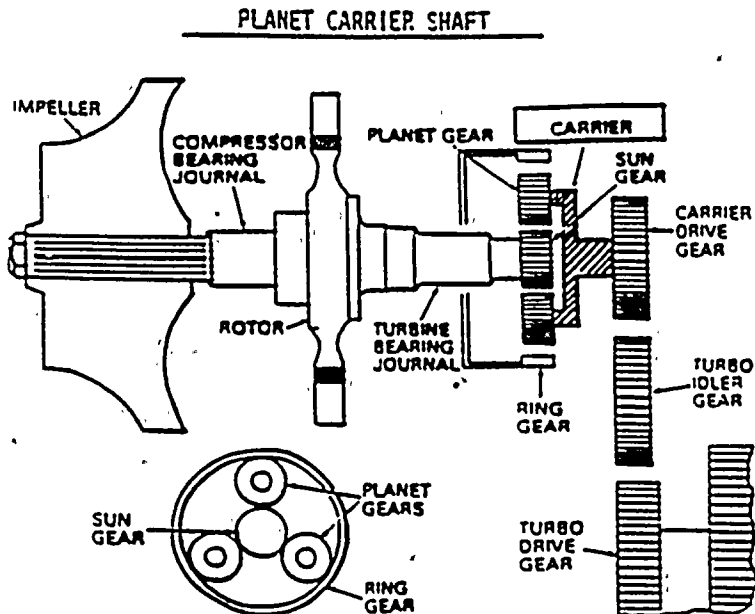
TURBOCHARGER PLANET GEAR TRAIN

This event resulted from a failure of the turbocharger planetary gears and sun gear (see attached figure). The root cause of the failure has been determined to be a manufacturing defect.

TVA performed a metallurgical evaluation of the failed turbocharger components. TVA's evaluation identified evidence of fatigue on the sun gear and the planetary gears. TVA also identified signs of overheating, including discoloration and oxide-filled cracks, in these gears. The bearings appeared to have sustained no damage. This analysis found the most probable cause of the gear failures was fatigue; however, due to the extensive thermal and mechanical damage to the sun gear and planetary gears, TVA could not conclusively determine the root cause of the failure.

It was determined during the evaluation that the failure of the components from EDG C was due to quench cracking that occurred during the manufacturer's heat treatment process. The quench cracking was followed by an area of fatigue cracks that propagated across the tooth section of the gears until final catastrophic failure. Therefore, TVA has concluded that the root cause of the failure of EDG C was a manufacturing defect.

The turbocharger on the EDG was replaced. After completing post maintenance testing, the EDG was returned to standby readiness.

TVA has recently instituted vibration monitoring program for the EDG turbochargers. The program provides valuable information which is being used to identify any abnormal operating characteristics of the turbochargers.
