LICENSEE EVENT REPORT (LER)

Browns Ferry Nuclear Plant (BFN) Unit 3

05000296

When a valve was malfunctioning, an LCO was not entered. The root cause for this event was that Operations crew lacked a questioning attitude and mindset. This LCO oversight is prohibited by technical specifications.

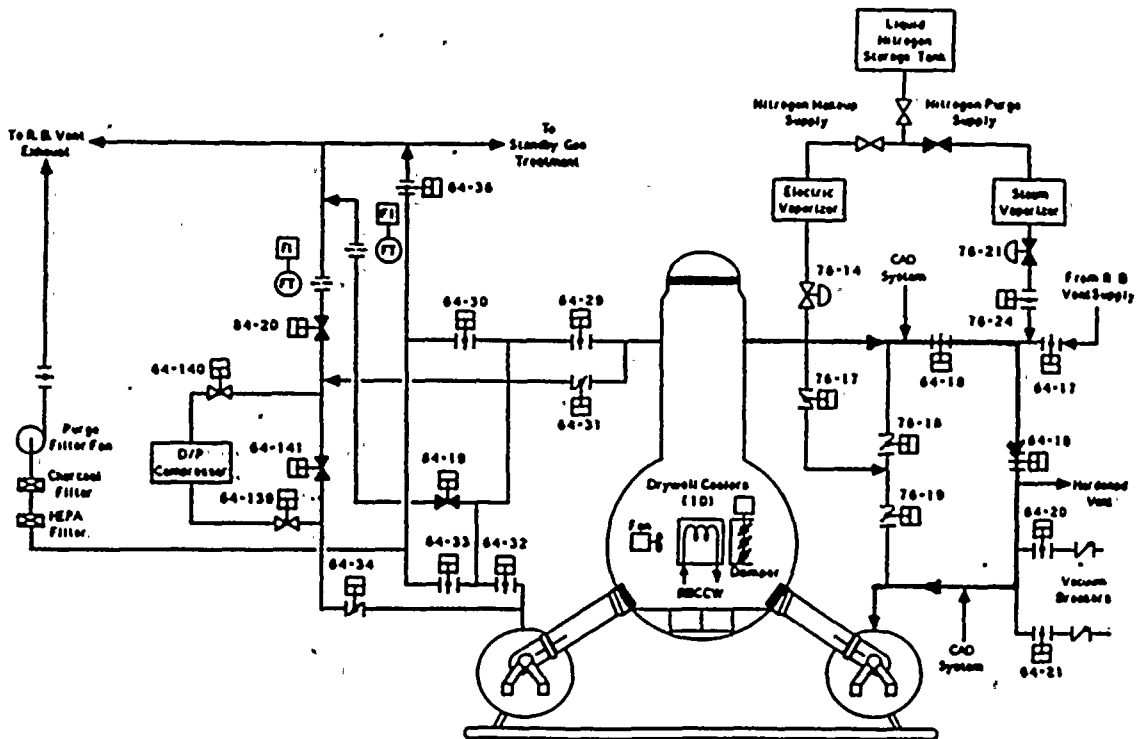
FIGURE 1

On August 24, 1997, at 1945 hours, Central Daylight Time, one of Unit 3 primary containment isolation flow control valve (PCIFCV) (3-FCV-64-34) [FCV] [VA] on the suppression pool ventilation line (See Figure 1) to the reactor building ventilation exhaust/standby gas treatment system failed to close even though a relay (3-86-64-34) in its circuit was replaced five (5) days earlier (See simplified control logic on Figure 2). The relay replacement did not resolve a problem with the malfunctioning PCIFCV. Consequently, during the performance of the surveillance instruction (SI) for testing the containment atmosphere dilution system valve operability, the PCIFCV failed to close within the time frame specified in the SI acceptance criteria. At that time, a Senior Reactor Operator (SRO) (Utility, licensed) made a cognitive error by failing to recognize the true nature of the event in that the plant did not enter a Limiting Condition for Operation (LCO) as required by the plant's technical specifications (TS)s.

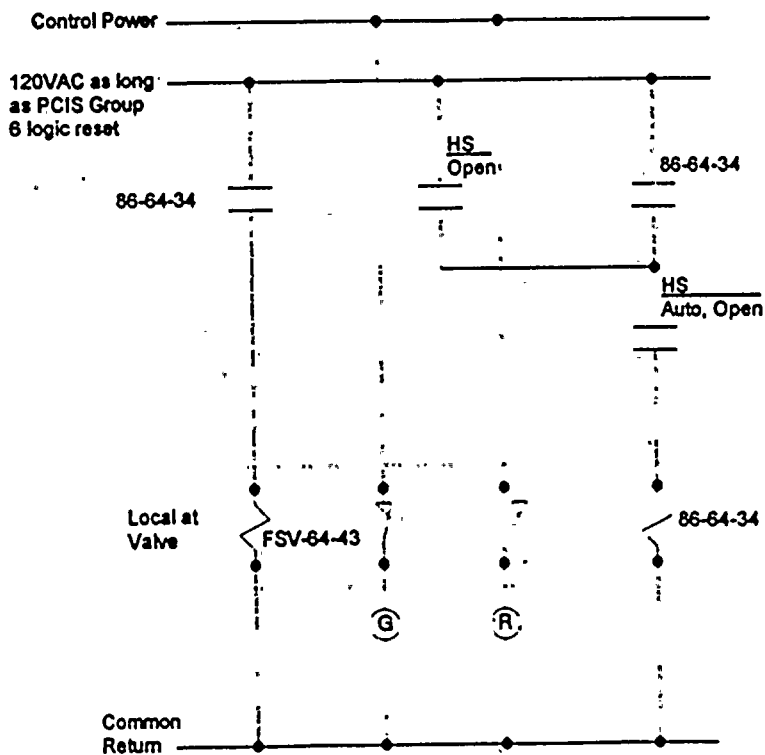
FIGURE 2

3-FCV-64-34 Simplified Control Logic
