LICENSEE EVENT REPORT (LER)

Browns Ferry Unit 3

Engineered Safety Features Actuation As a Result of a Switch Failure

| EVENT DATE (5) | | | LER NUMBER (6) | | | REPORT DATE (7) | | | OTHER FACILITIES INVOLVED (8) | |
|---|---|---|---|---|---|---|---|---|---|---|
| 03 | 10 | 1998 | 1998 | 002 | 00 | 04 | 09 | 98 | FACILITY NAME | DOCKET NUMBER |

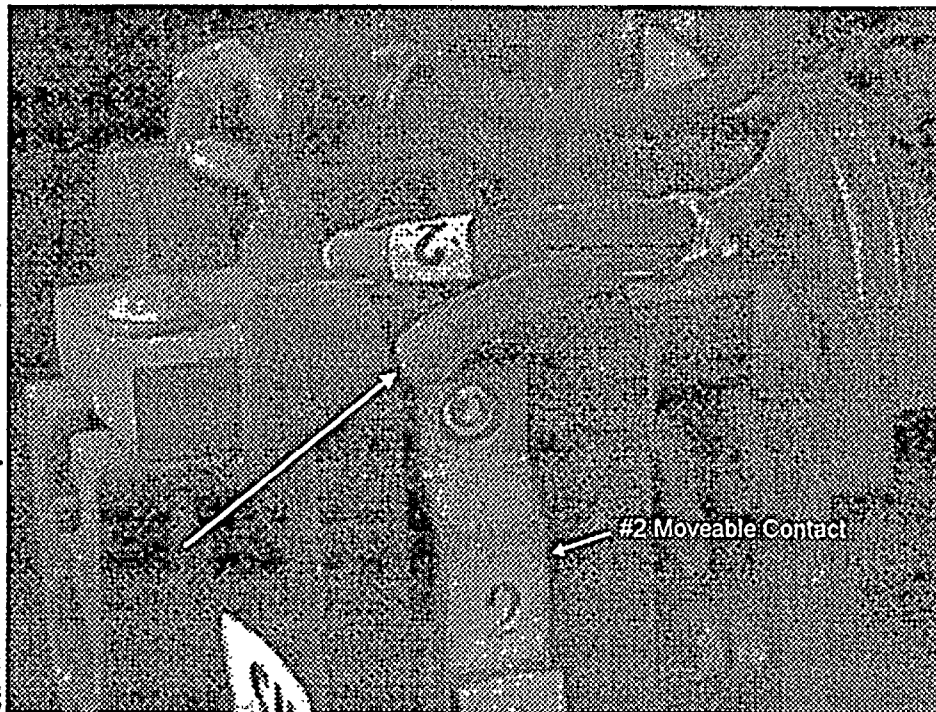
Figure 1
Wire Interference With Alternate Feeder Breaker Position Switch Moveable Contact

The immediate cause of this event was the failure of the 480V Shutdown Board 3B alternate feeder breaker position switch to close. A mispositioned wire interfered with the proper operation of the switch close contacts.

The most probable root cause of the wire being mispositioned, was improper wire routing and/or improper removal or installation of the switch cover which caused the wire to interfere with the contacts.

Inspection of switch revealed a wire which was landed on the #2C switch terminal was in close proximity to the #2 moveable contact. The moveable contact was observed to move the wire out of the way when the switch was operated with the cover removed. However, with the cover installed sufficient interference was present to prevent contact closure. No maintenance or modification history was discovered relevant to condition of the switch. It was concluded that the most probable root cause of the event was improper wire routing and/or removal or replacement of the switch cover which caused the wire to interfere with the contacts. The absence of maintenance or modification history prevented the evaluation of human performance issues.

Figure 1 shows the wire impact point with moveable contact #2.

The wiring interference with the 480V Shutdown Board 3B alternate feeder breaker position switch was corrected and proper operation of the switch was verified.

The maintenance instruction(s) applicable to GE type SB-1 switches will be revised to ensure appropriate wire routing guidance is incorporated.¹
