November 1, 2018

SUBJECT: COLEMAN A. YOUNG INTERNATIONAL AIRPORT — RESULTS OF THE U.S. NUCLEAR REGULATORY COMMISSION'S INITIAL SITE VISIT AND REQUEST FOR CONFIRMATION OF VOLUNTARY CONTROLS; EXERCISE OF ENFORCEMENT DISCRETION

**OAK RIDGE ASSOCIATED UNIVERSITIES:  
SITE STATUS REPORT FOR COLEMAN A. YOUNG INTERNATIONAL AIRPORT  
(FORMERLY DETROIT CITY AIRPORT) AT  
11499 CONNER STREET IN DETROIT, MICHIGAN**

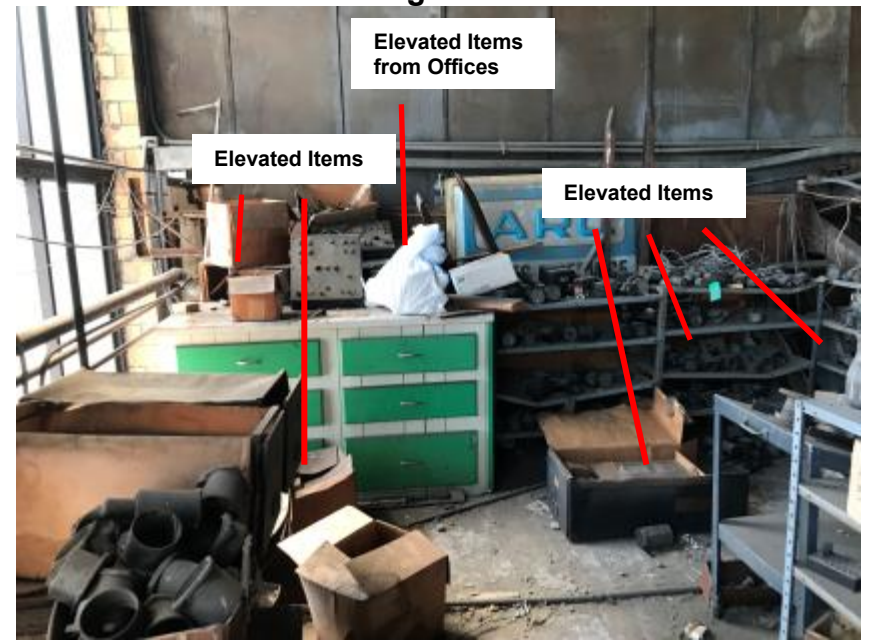
**A-12. Elevated Items Placed on Roof of Offices within Hangar 13**

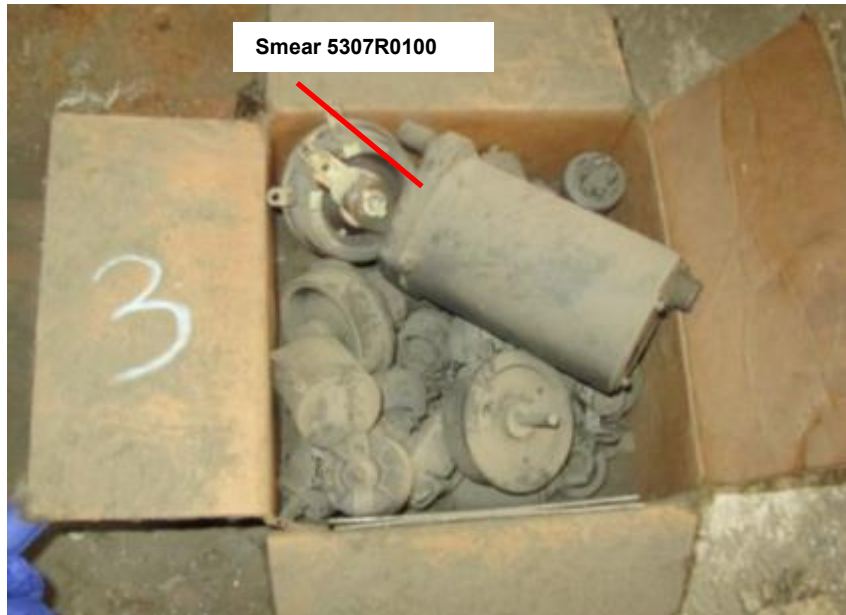
A-13. Elevated Items on Roof of Offices within Hangar 13

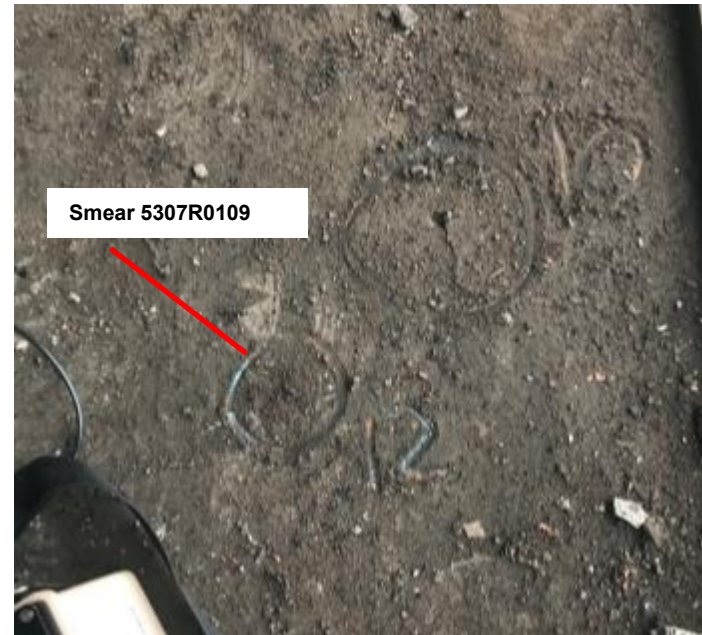
A-14. Elevated Areas on Roof of Offices within Hangar 13

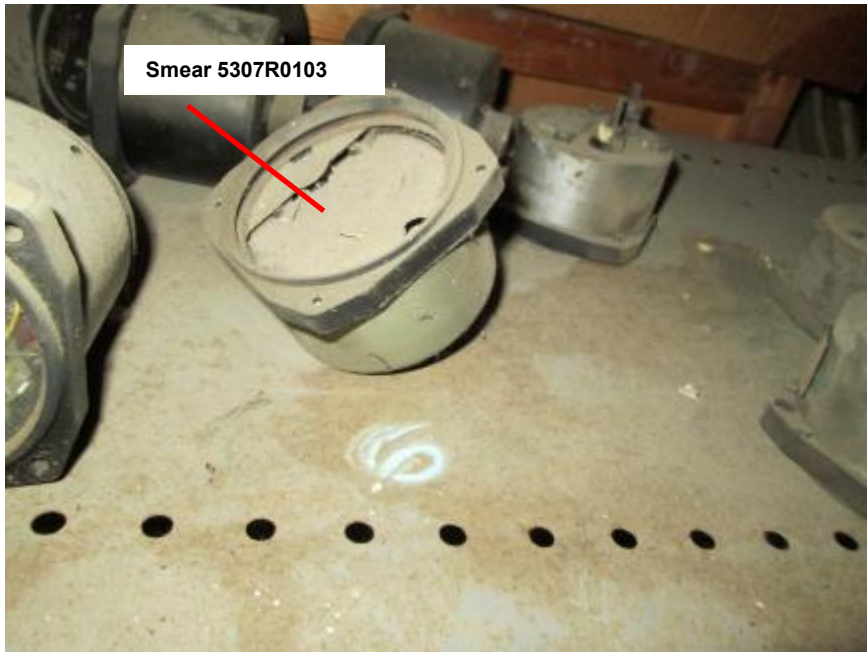
A-15. Elevated Item on Roof of Offices

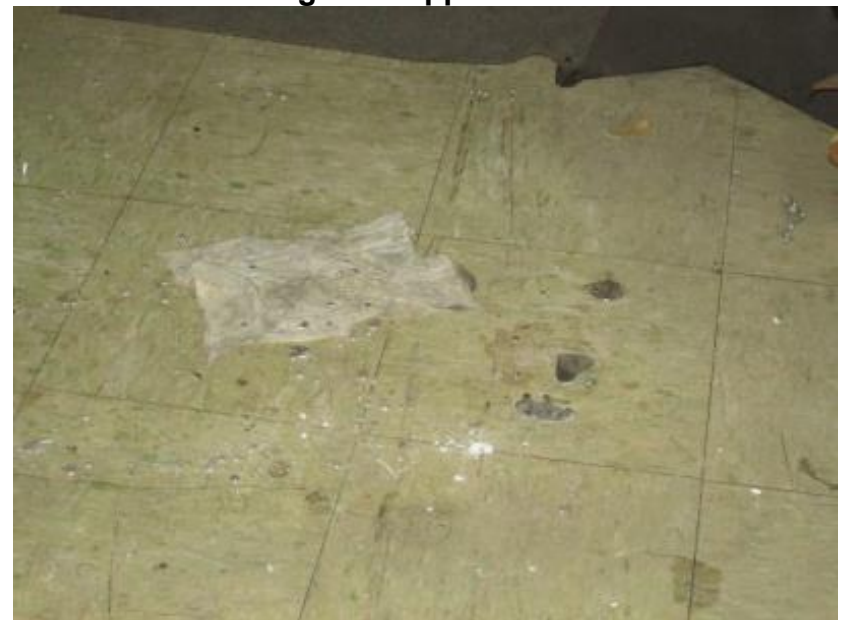
**A-20. Hangar 13 Upper Level Offices, Spilled Mercury**

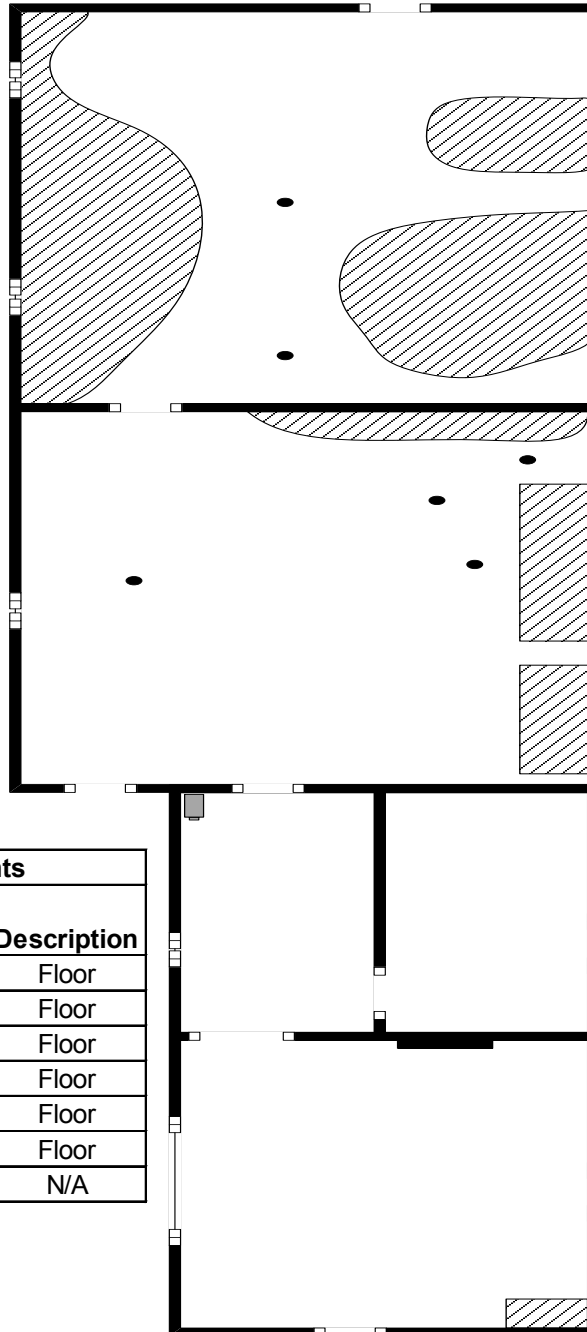
Gross Gamma Measurements				
Smear Location	Smear No.	kcpm	$\mu$ R/h @ 1 meter	Description
1	R0092	120	22	Floor
2	R0093	100	23	Floor
3	R0094	95	22	Floor
4	R0095	61	22	Floor
5	R0096	51	18	Floor
6	R0097	62	22	Floor
Ambient	N/A	14 - 42	12 - 25	N/A
