Humboldt Bay
Independent Spent Fuel Storage Installation
Site-Specific License Renewal Application

Pacific Gas and Electric Company

Revision 0 July 2018
NRC Docket No. 72-27

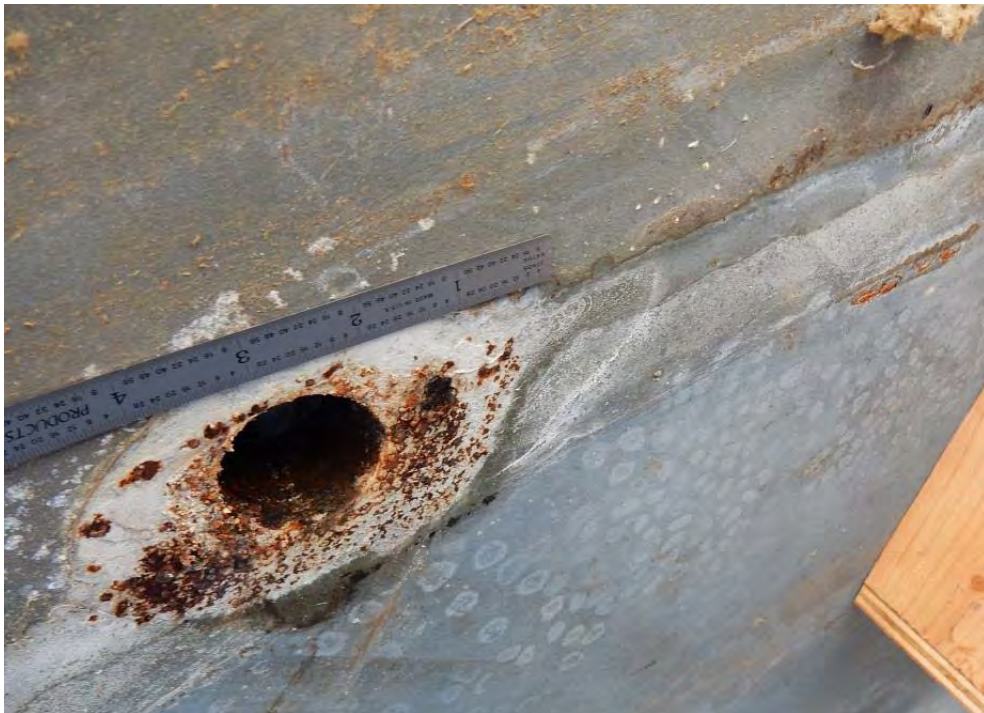
7. Underside hole #3 showing corrosion prior to cleaning

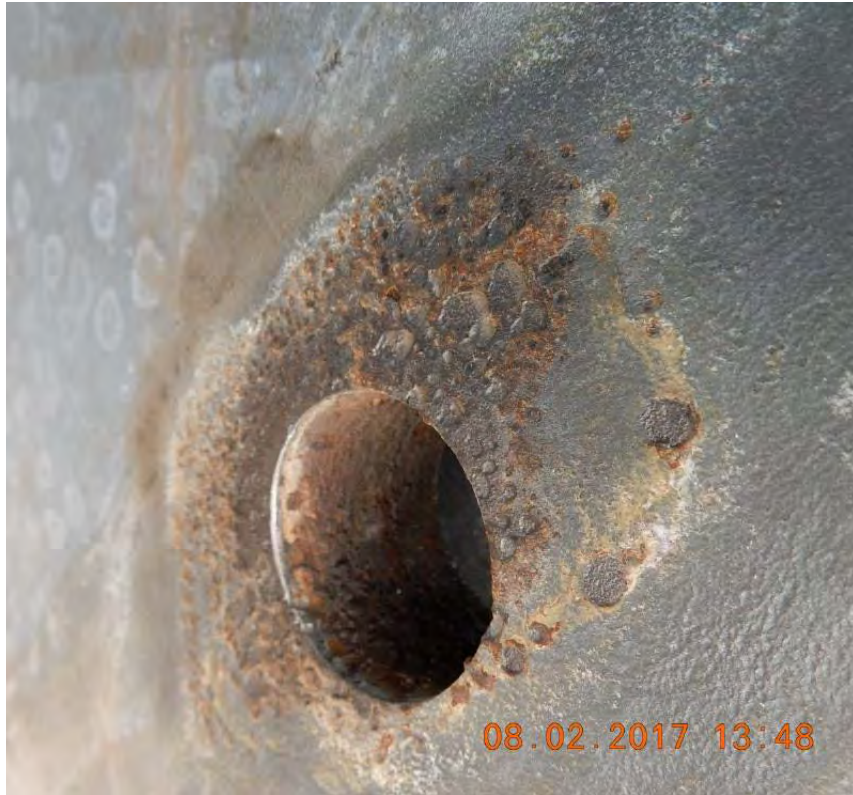
8. Underside hole #5 showing corrosion prior to cleaning

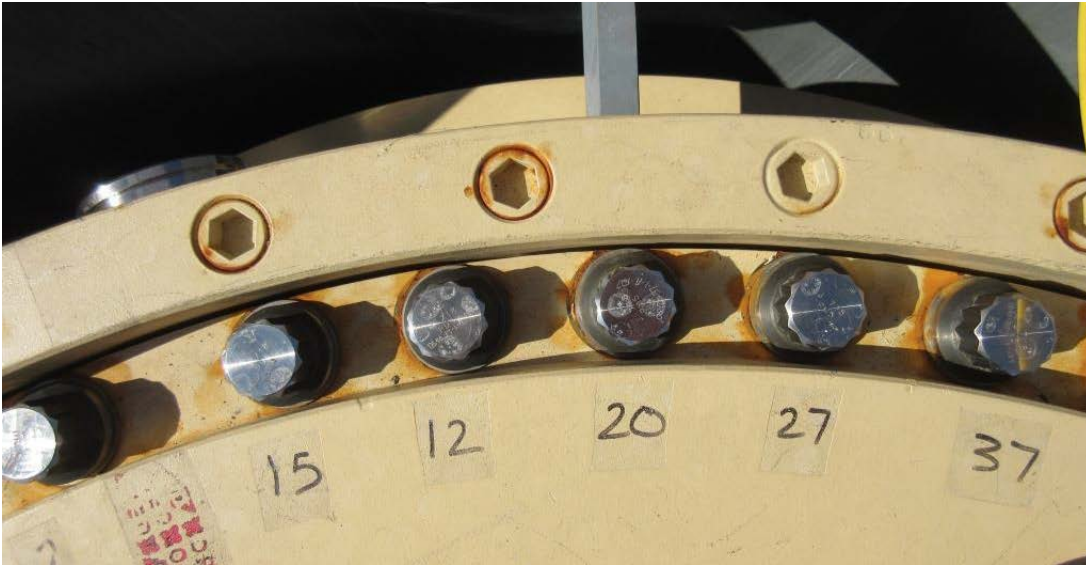
15. Rust staining around overpack lid closure bolting

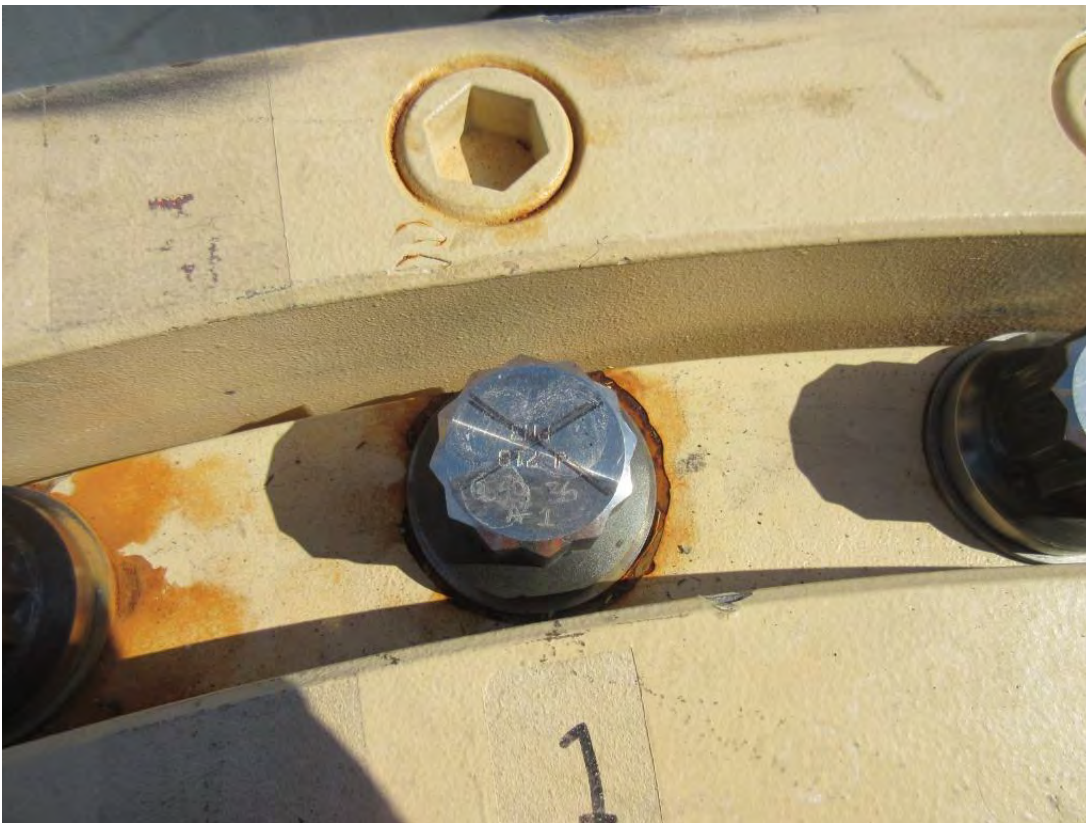
16. Rust staining around overpack lid closure bolting and around top flange plug set screws

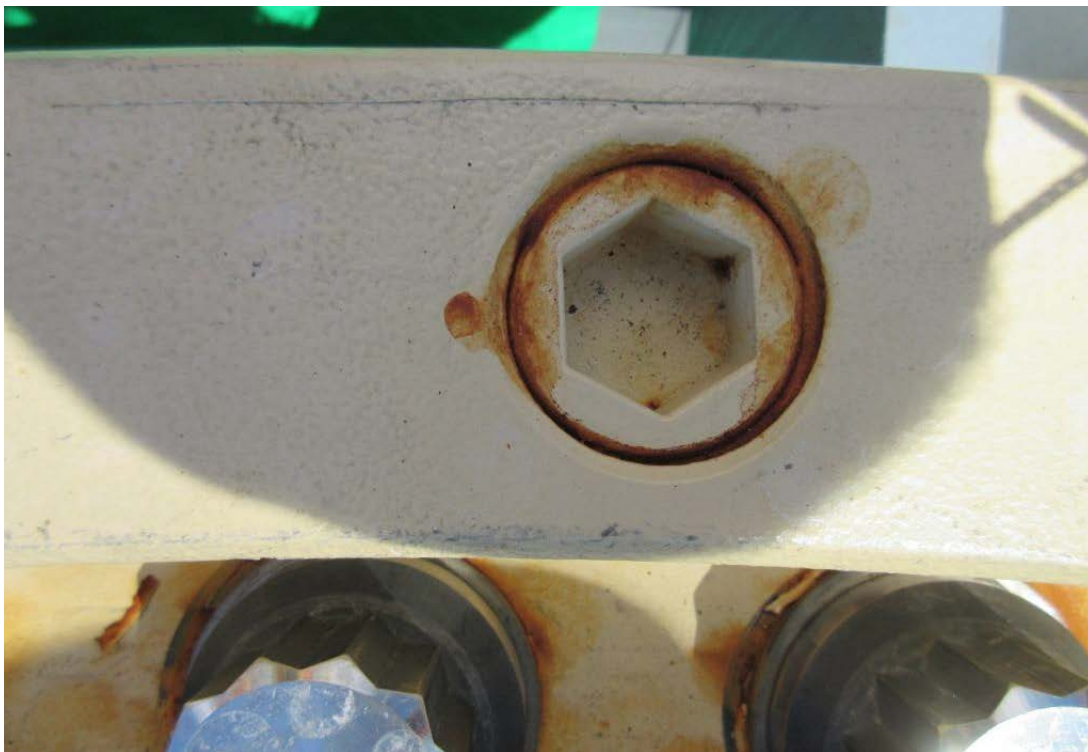
17. Rust staining around overpack lid closure bolting

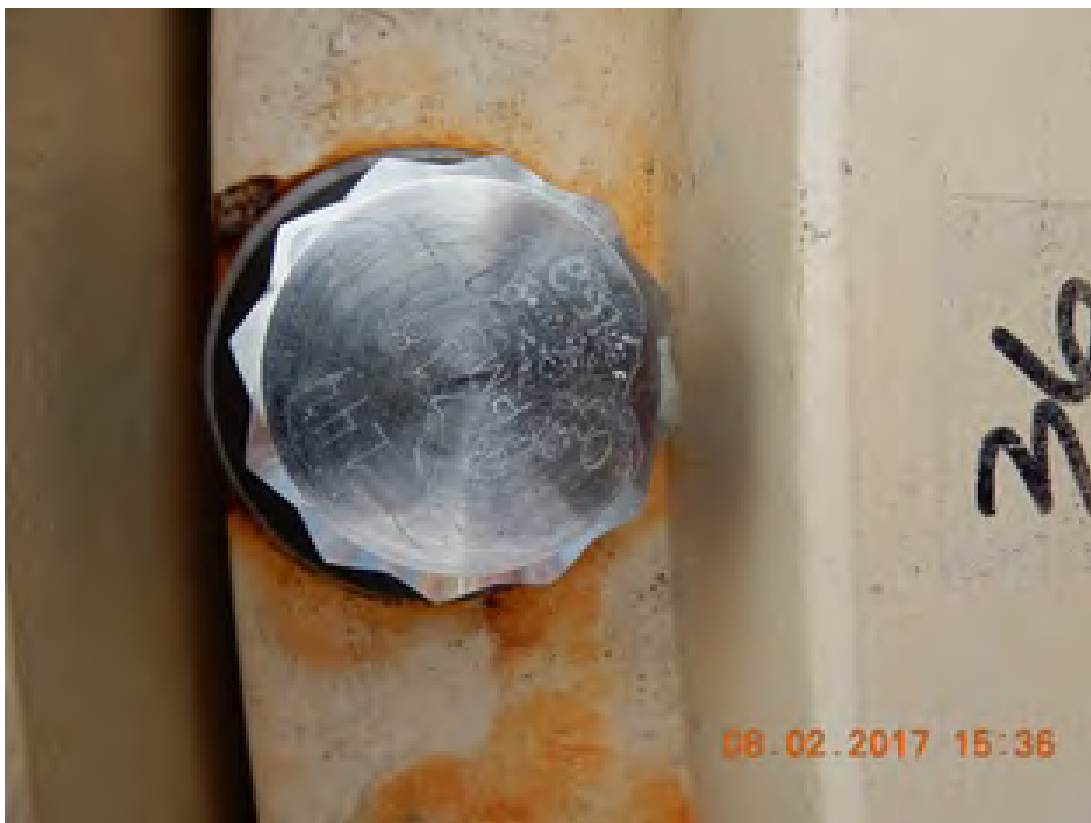
18. Typical rust staining around top flange closure plug set screws

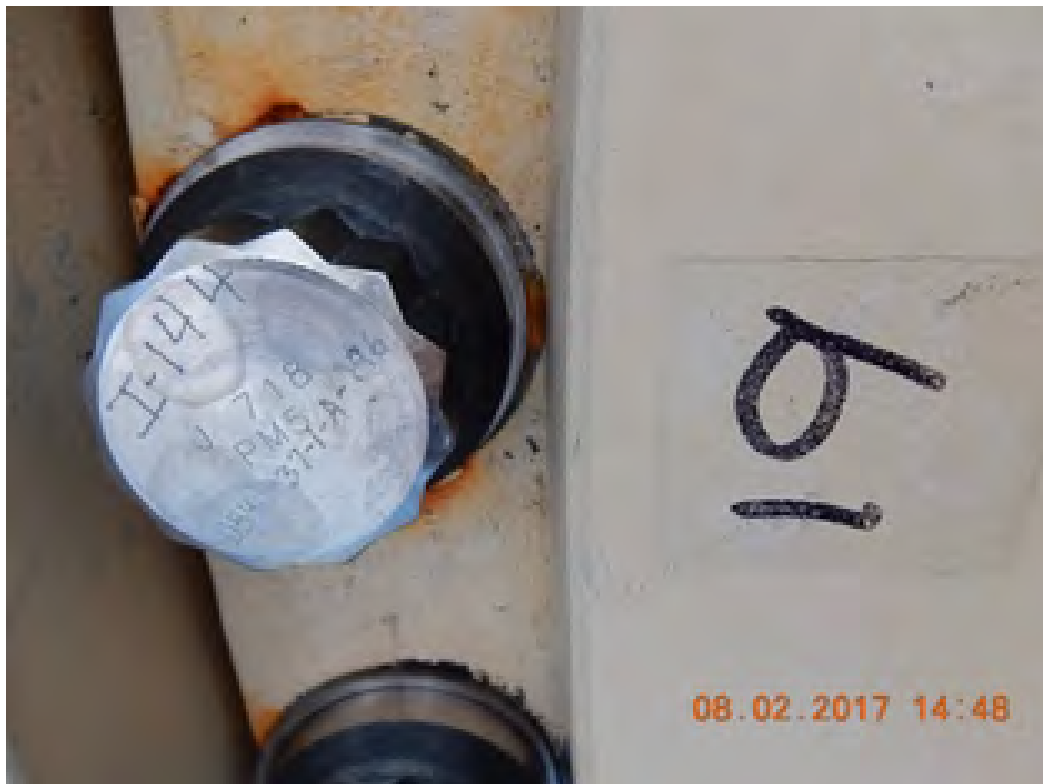
19. Chipped coating under overpack closure lid bolt (at 10 o'clock)

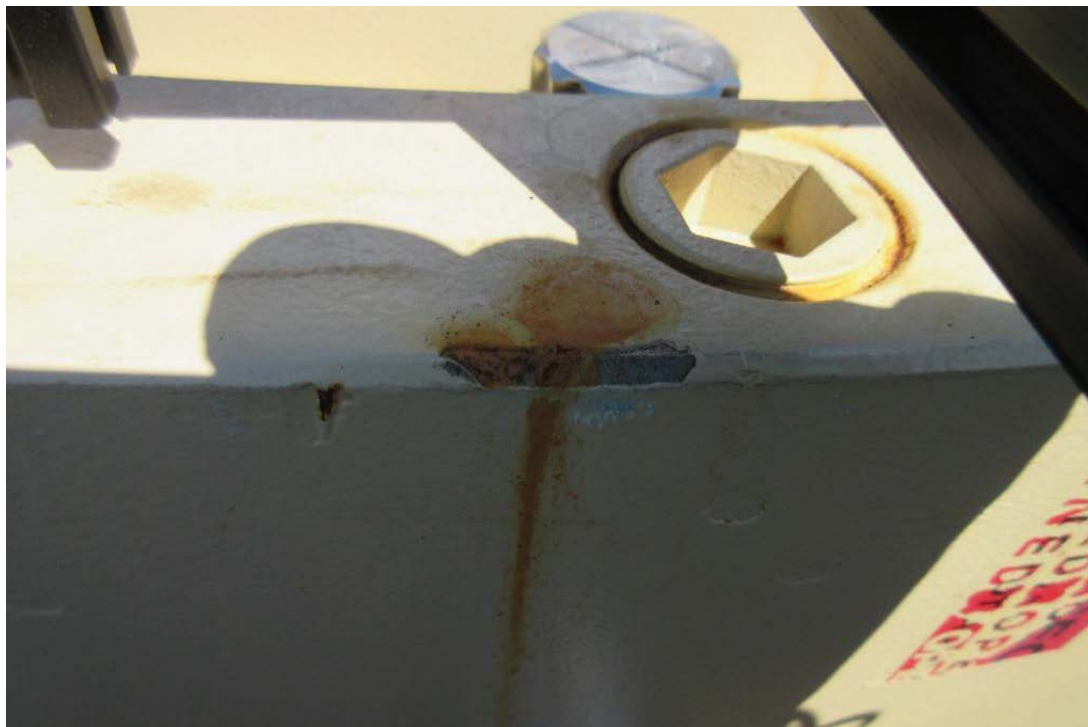
20. Cracked coating under overpack closure lid bolt

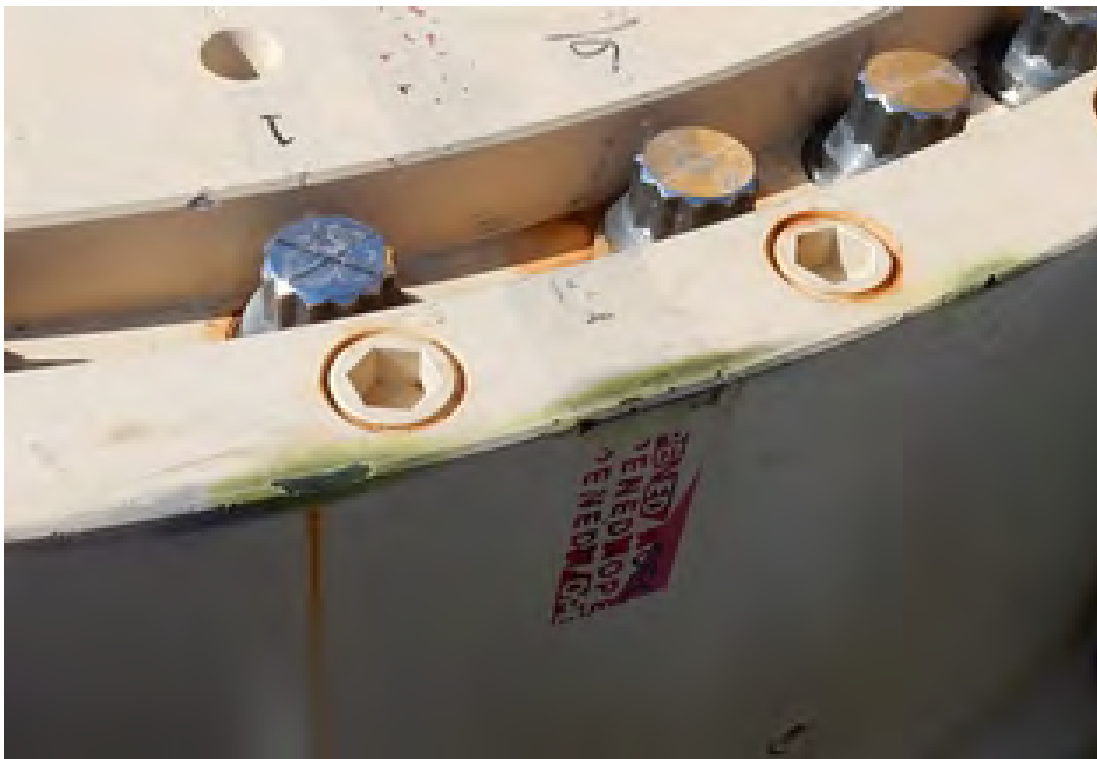
21. Coating chip with rust staining

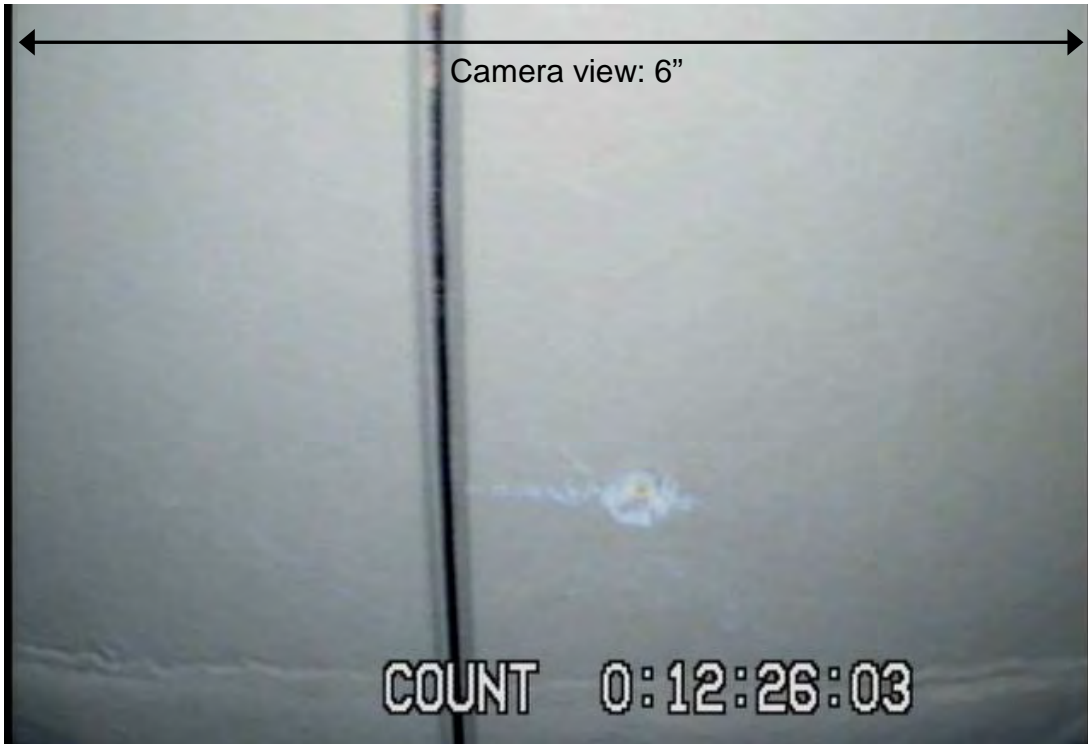
23. Rust staining from drain hole in overpack

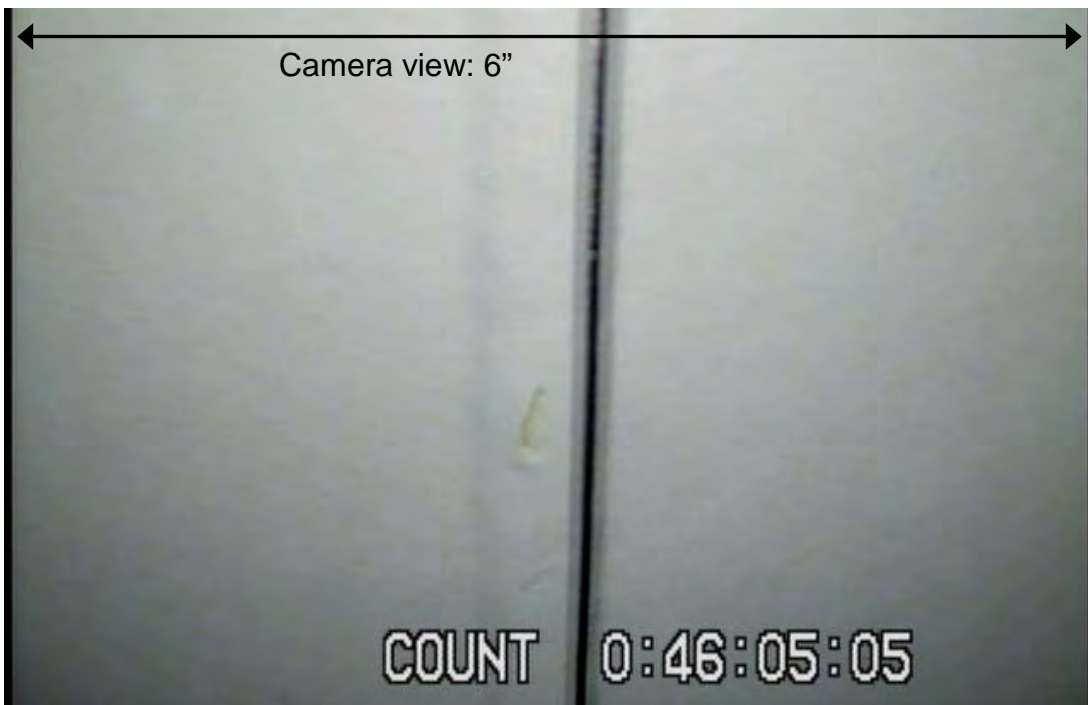
26. Scan 22 rub mark

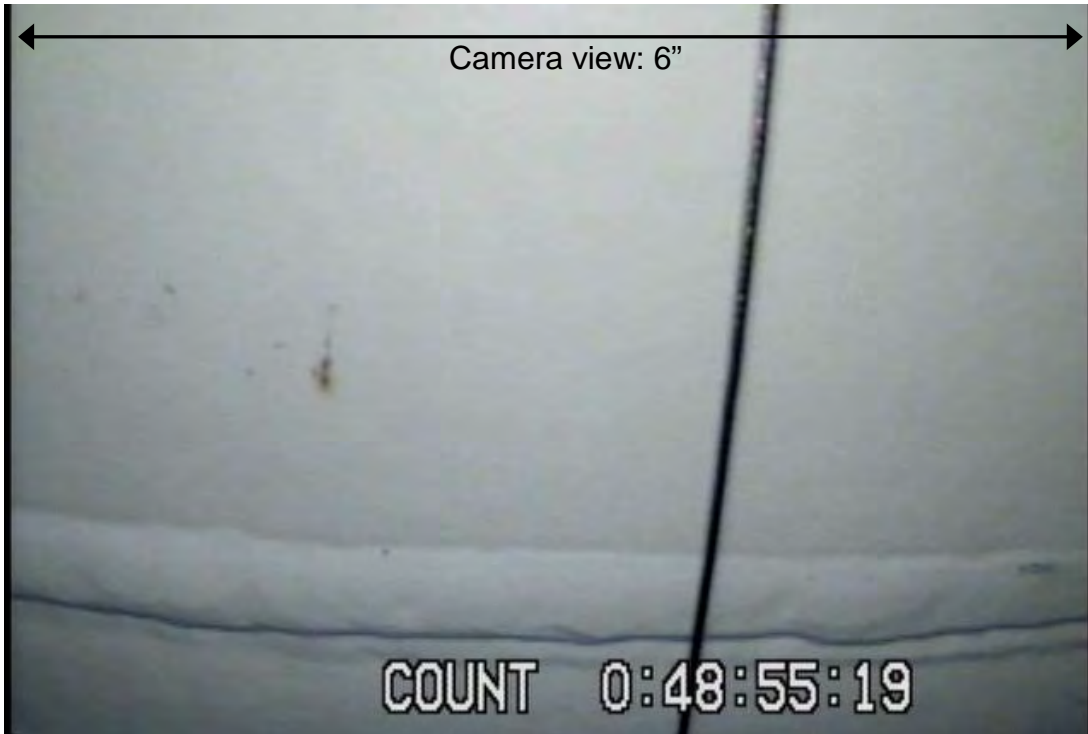
27. Scan 26 coating chip with slight rust discoloration

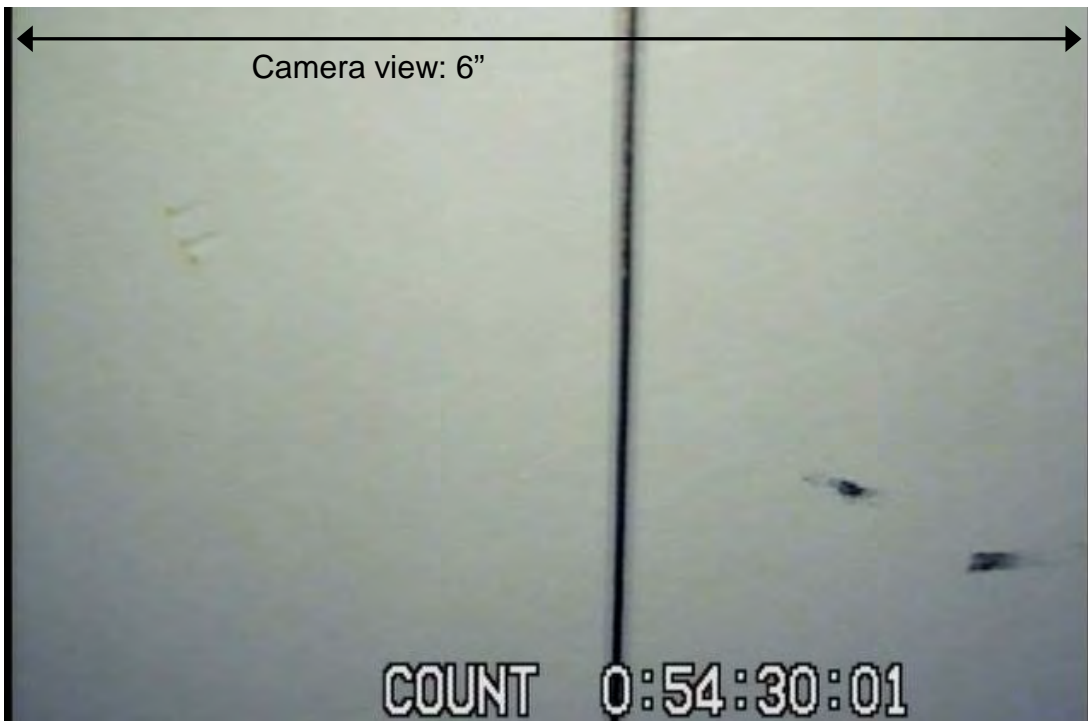
28. Scan 28 slight rust discoloration

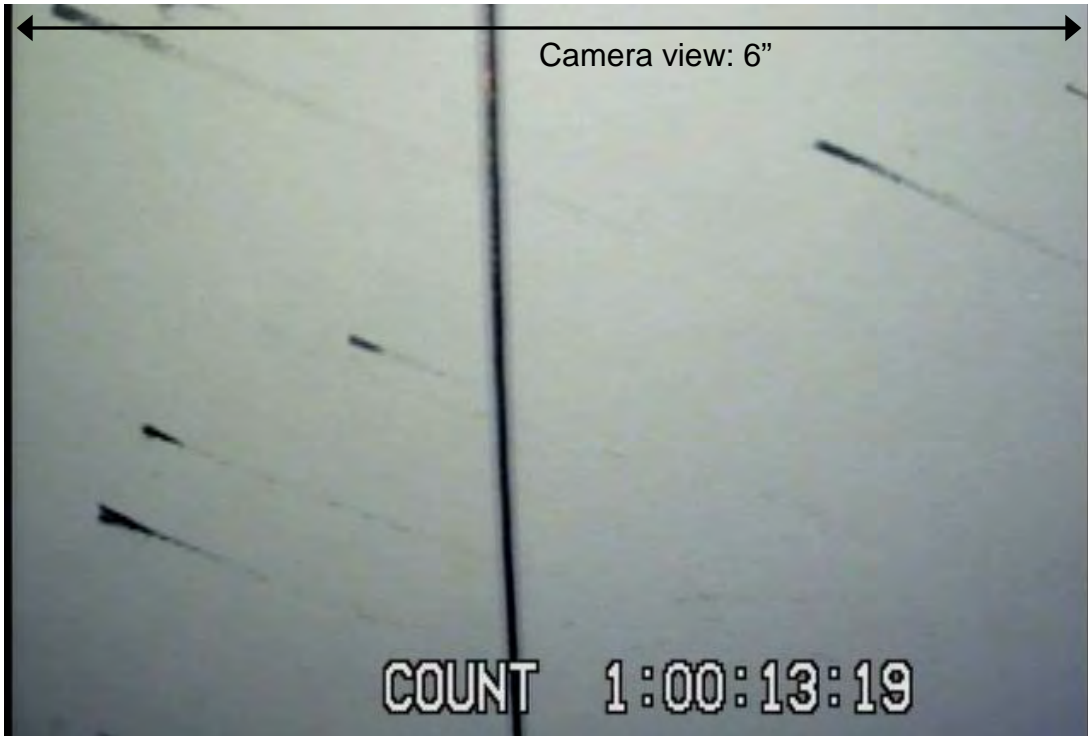
29. Scan 30 slight rust discoloration and black stains

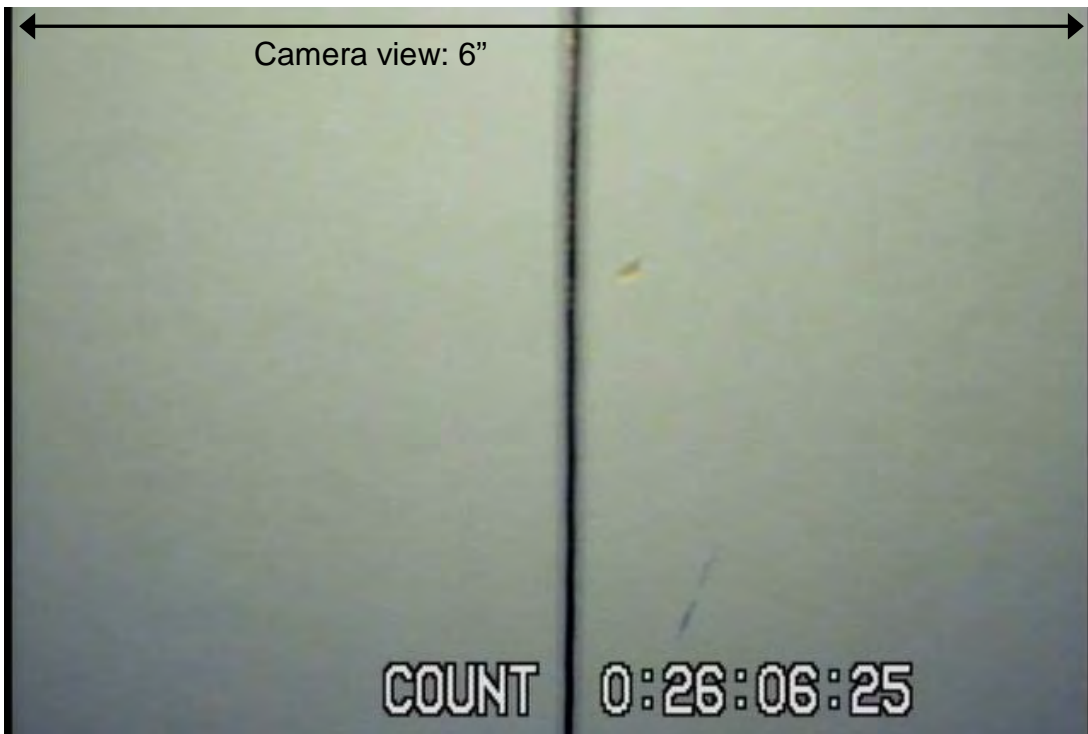
34. Scan 42 coating scrape

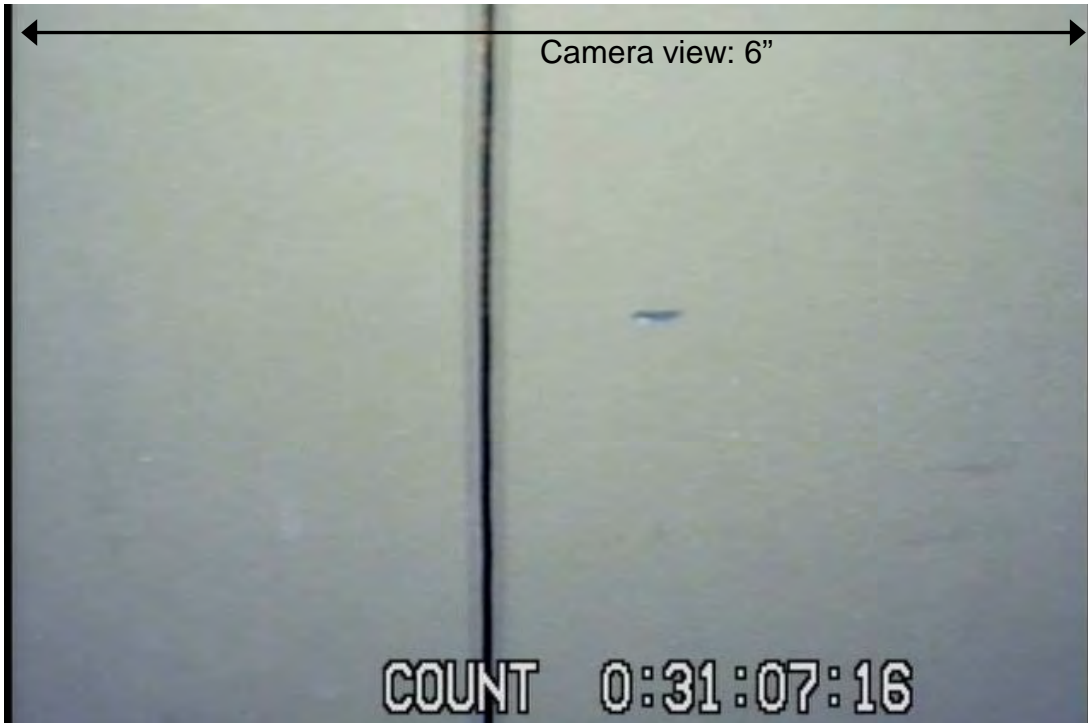
35. Scan 55 slight rust discoloration

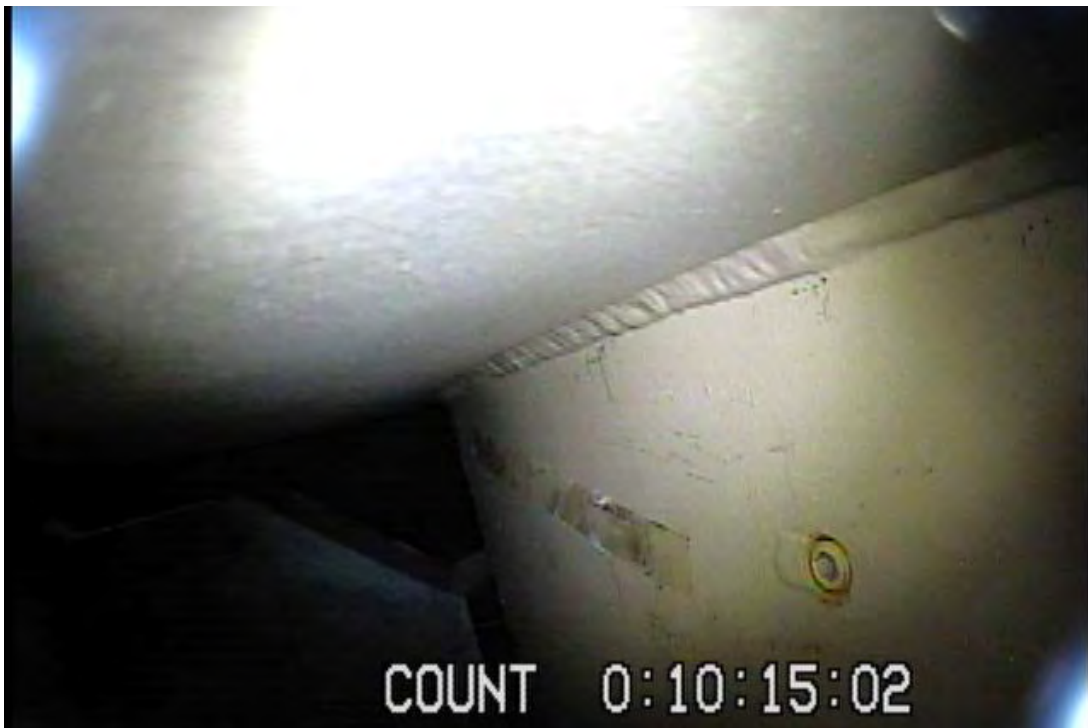
42. Overpack south east section coating scrape adjacent to seismic shim

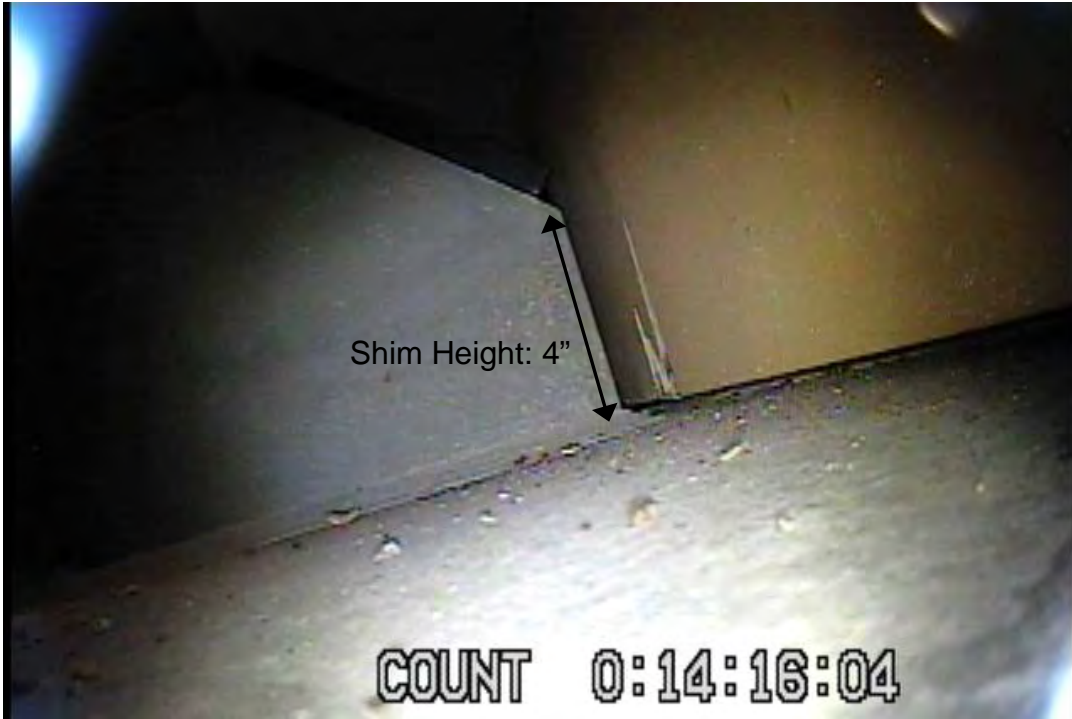
43. Overpack south east section (light rust around set screw)

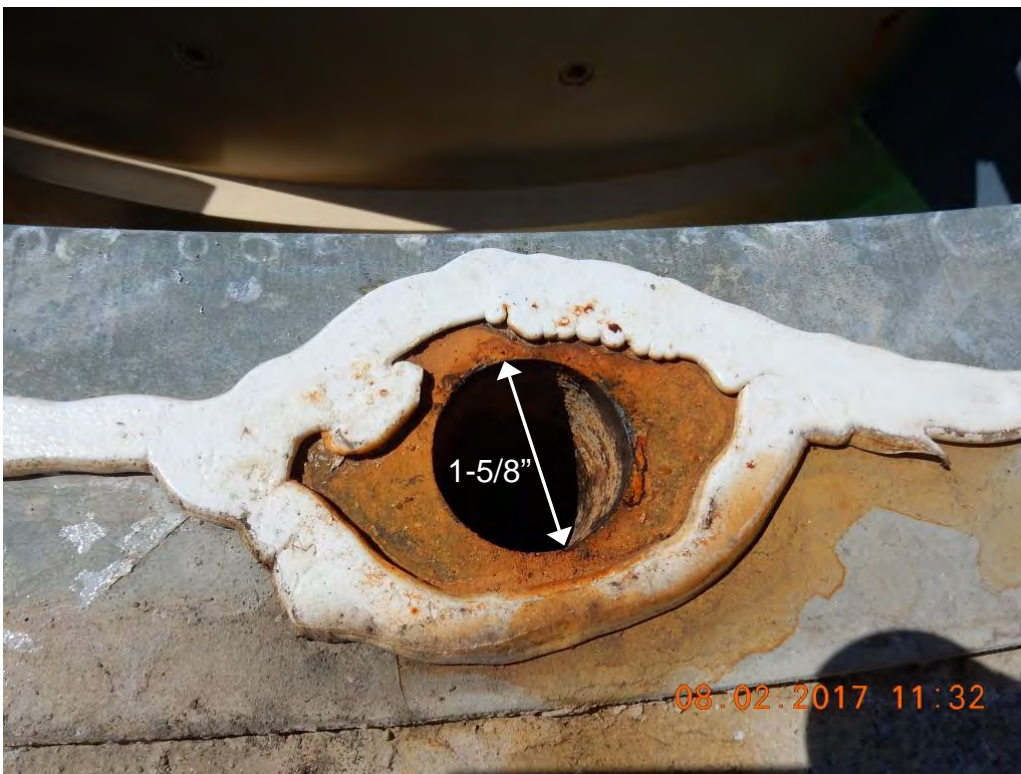
46. Vault lid ring bolt hole #3 corrosion products

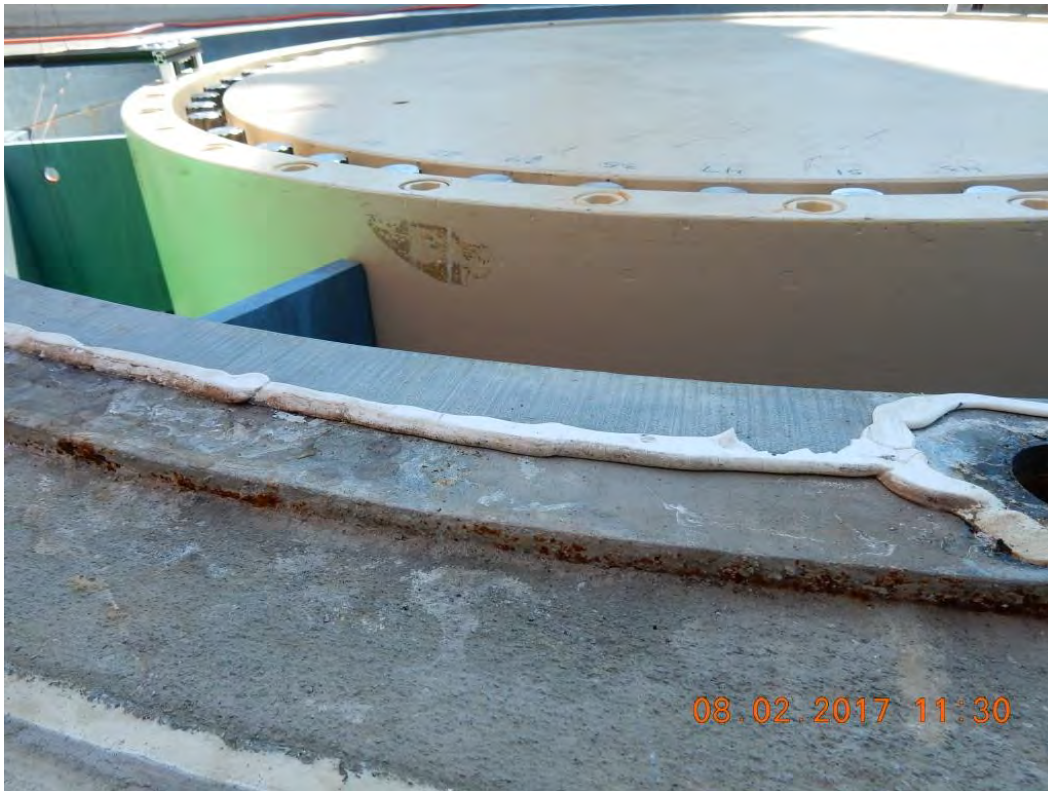
47. Vault lid ring bolt hole #6 corrosion products

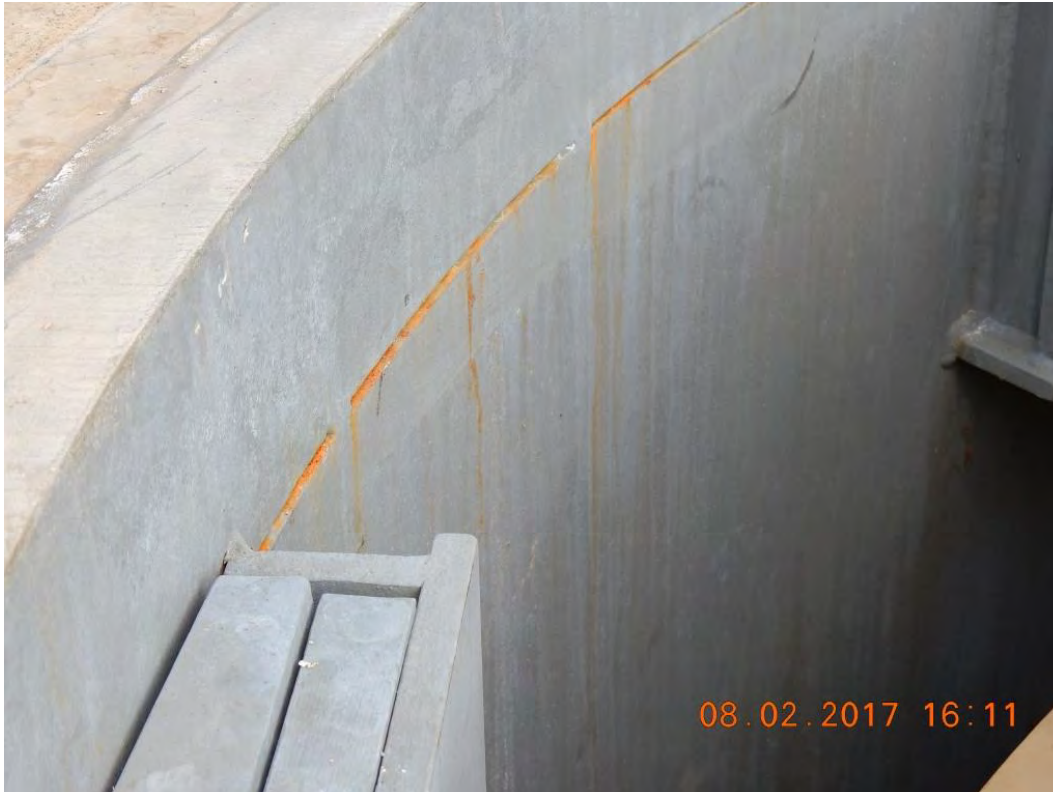
48. Rust at vault lid ring to concrete interface

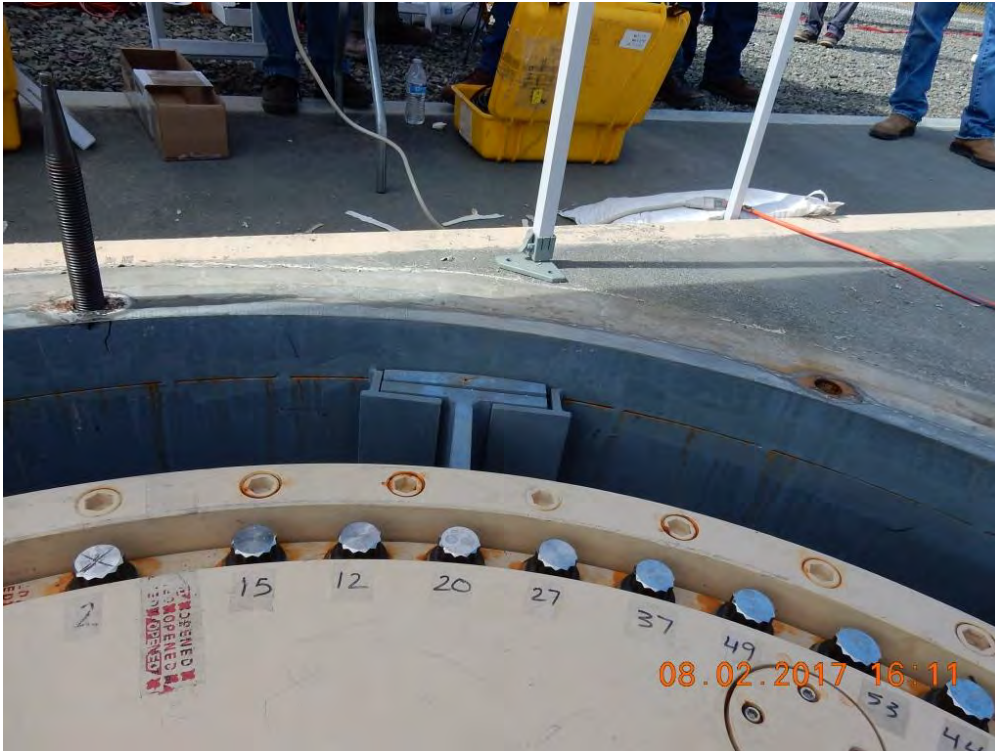
49. Rust staining at vault lid ring to vault liner interface

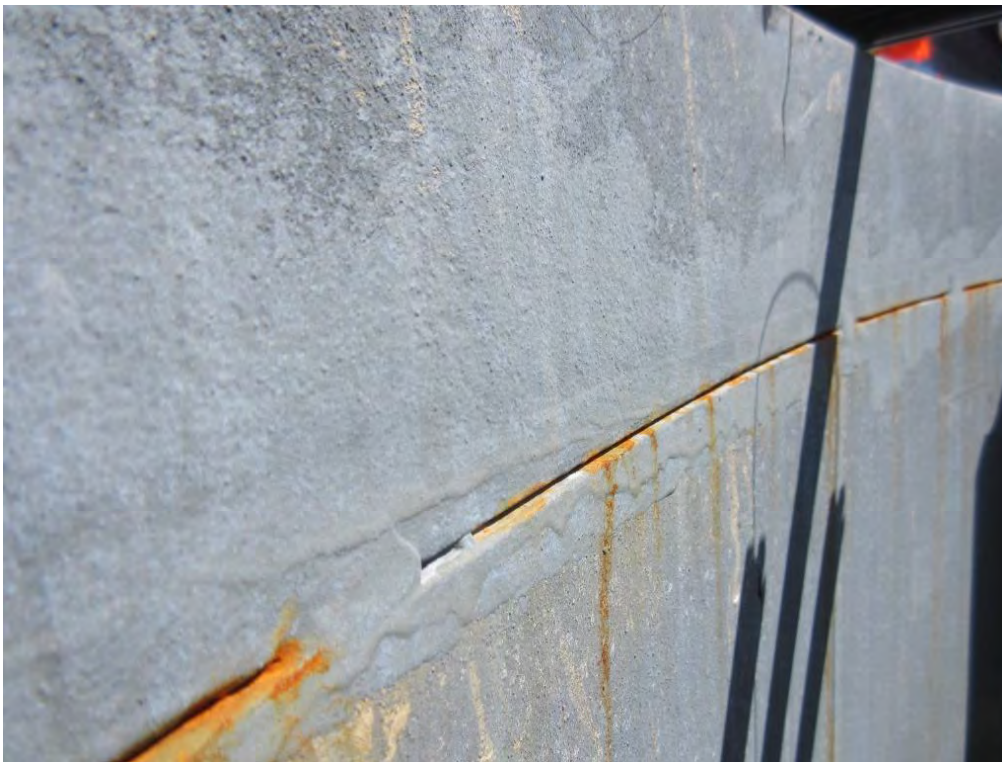
50. Rust staining at vault lid ring to vault liner interface

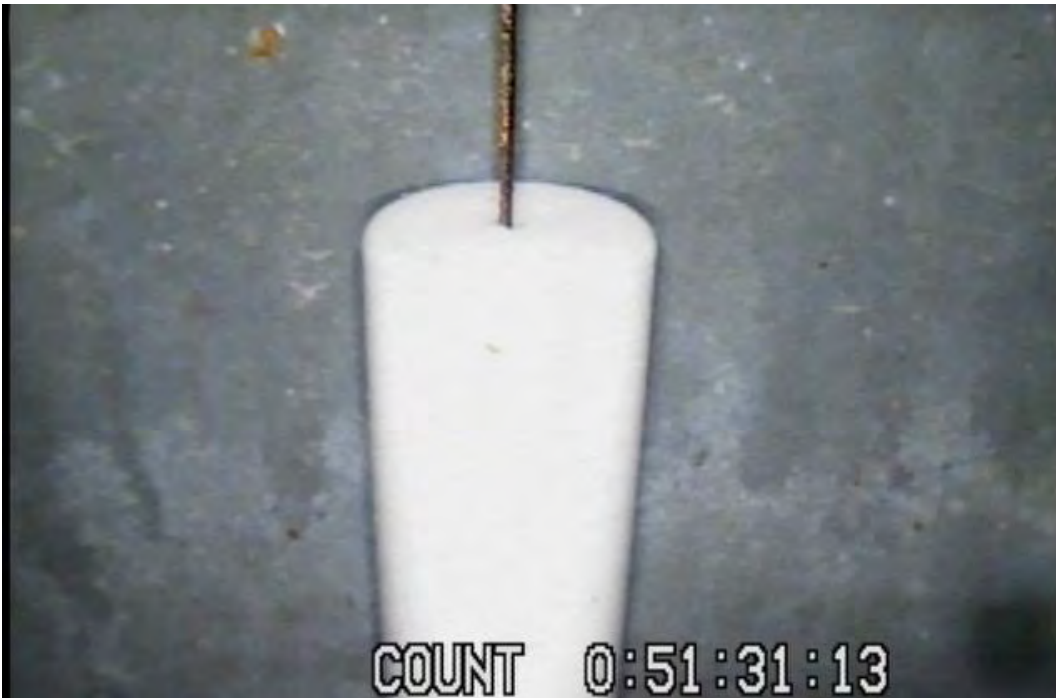
52. Rust staining at vault lid ring to vault liner interface
(view looking down along liner with seismic shim in upper portion of the picture)

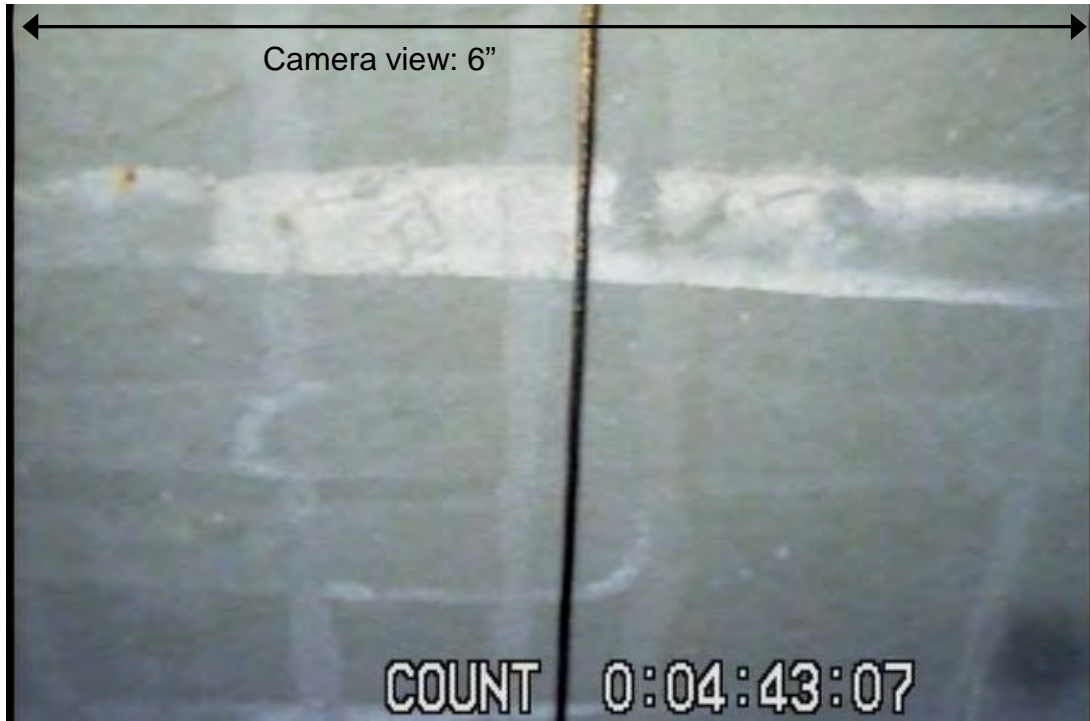
53. Scan 2 rust spot (for size comparison, the wire cable supporting the plumb bob is 1/32" dia.)

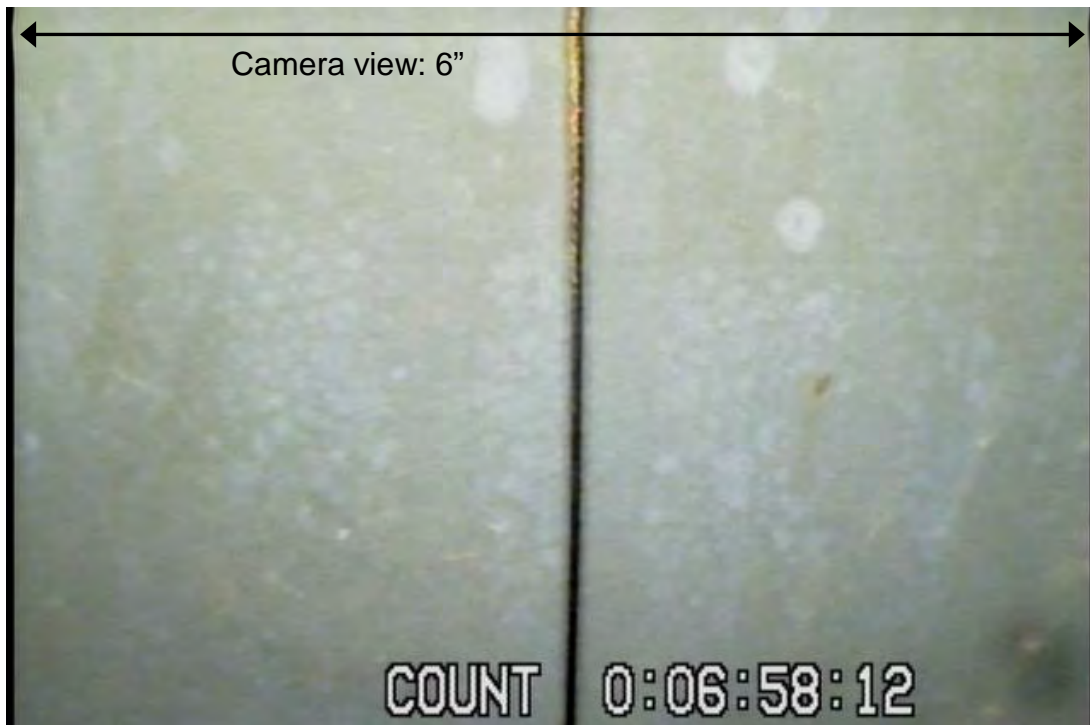
54. Scan 5 rust spot

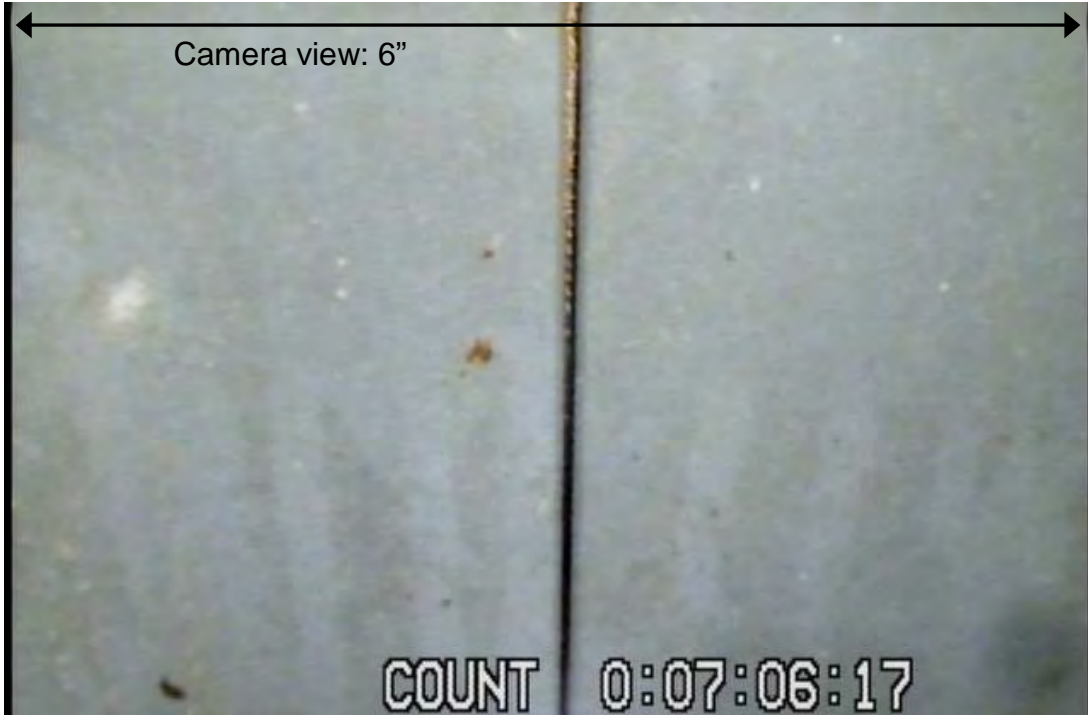
55. Scan 6 rust spot

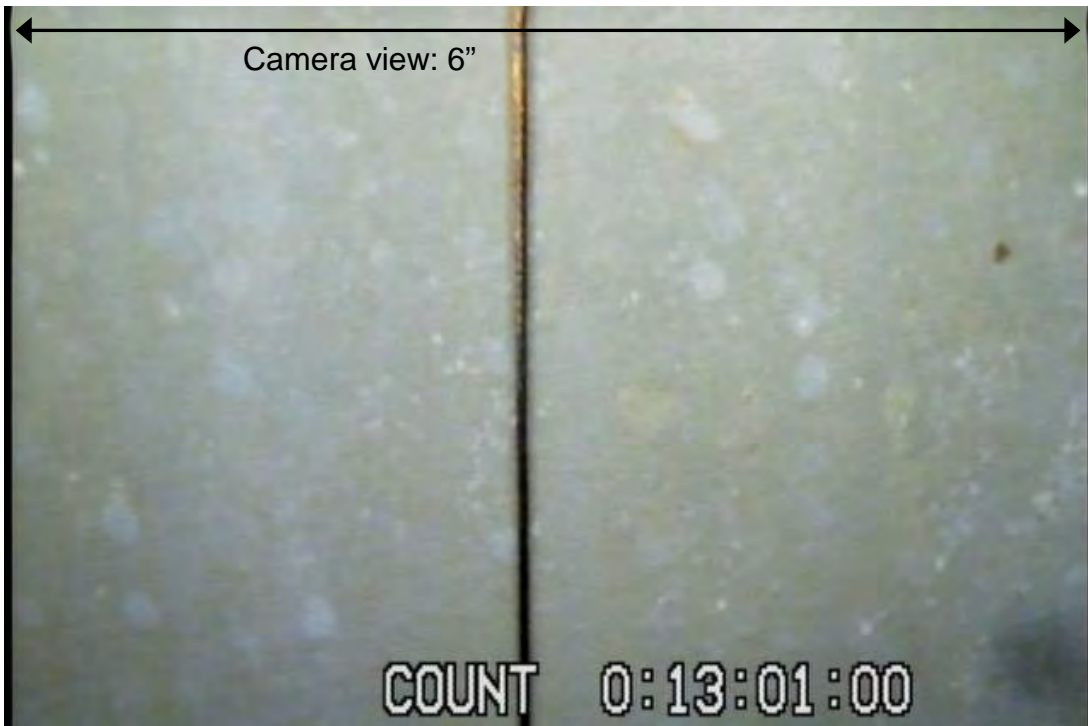
56. Scan 6 rust spots

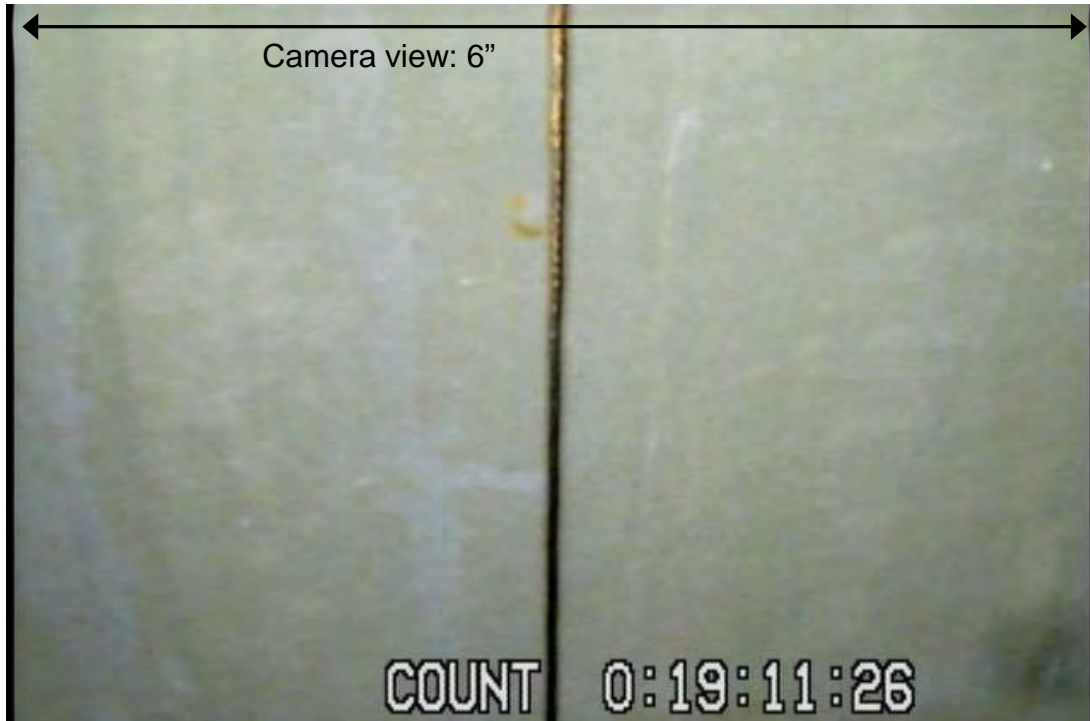
57. Scan 8 rust spot
