Humboldt Bay
Independent Spent Fuel Storage Installation
Site-Specific License Renewal Application

Pacific Gas and Electric Company

Revision 0 July 2018
NRC Docket No. 72-27

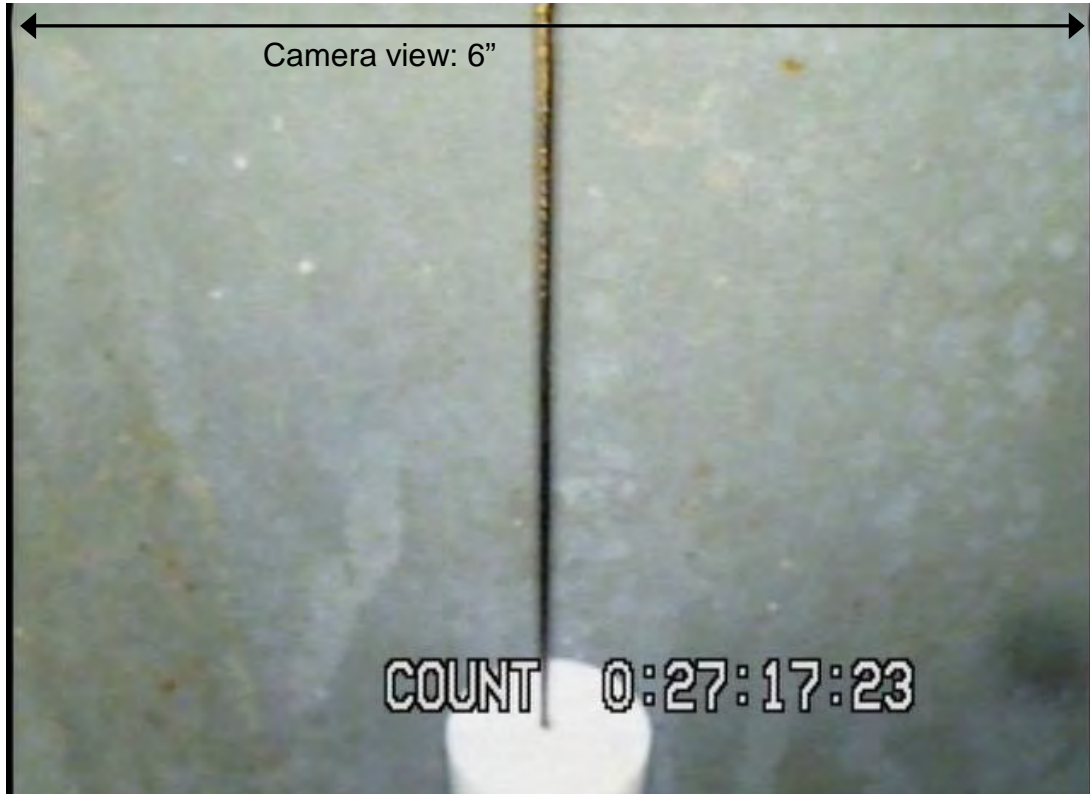
58. Scan 10 rust spot

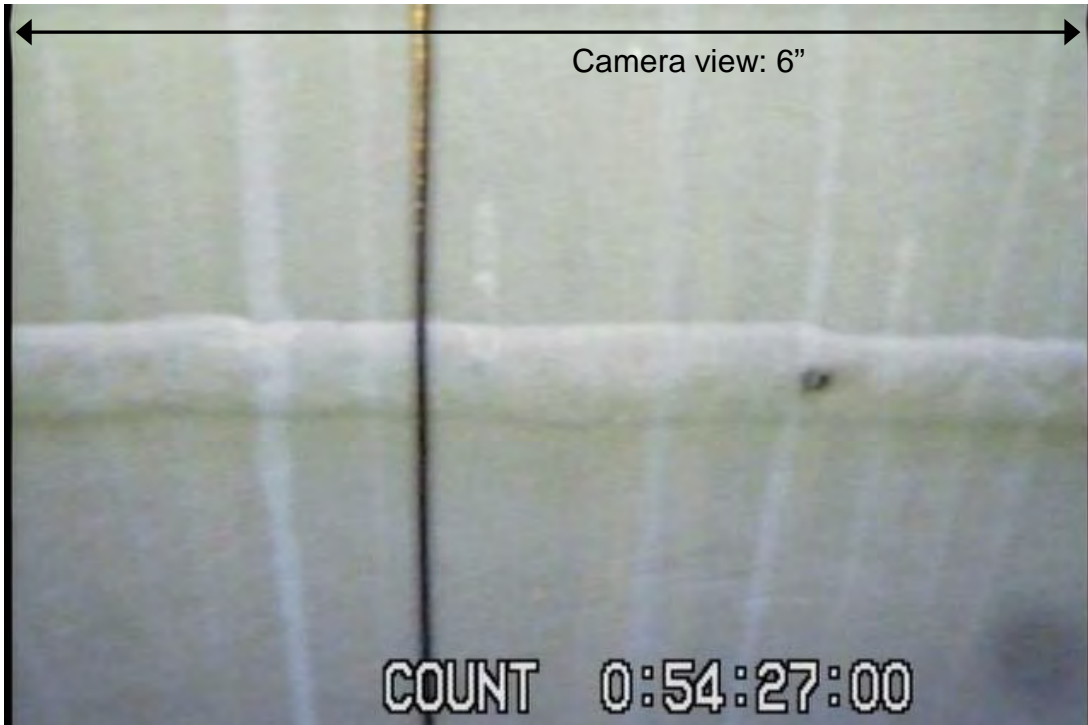
59. Scan 16 rust spot

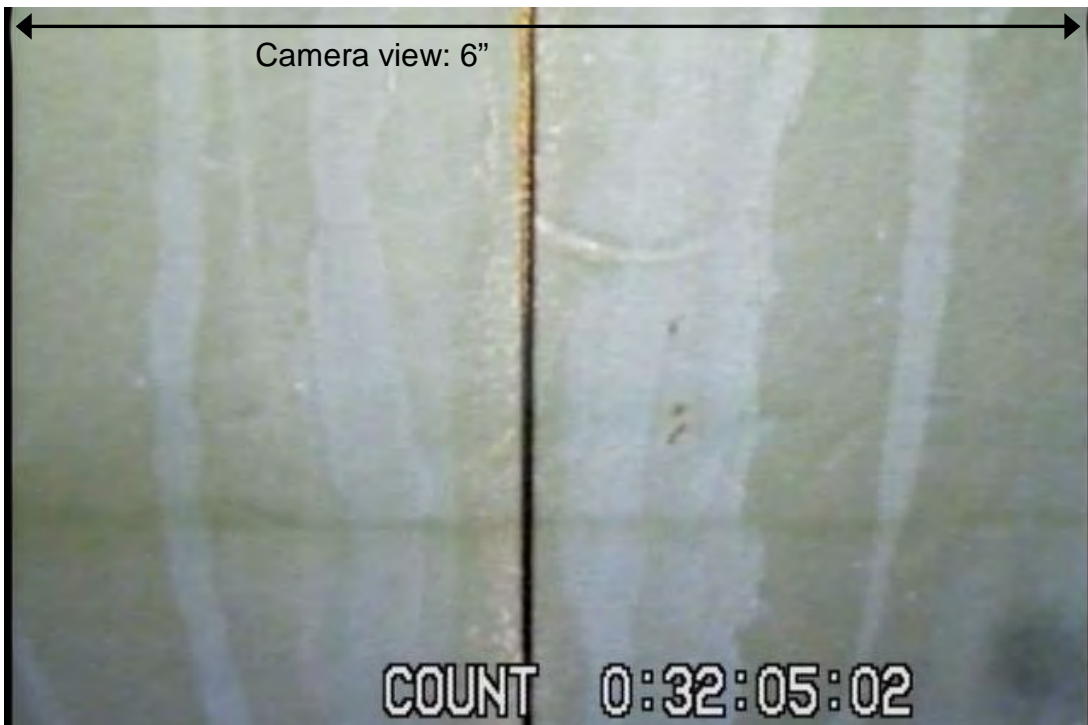
60. Scan 38 Dark spot – possible coating damage – no rust discoloration

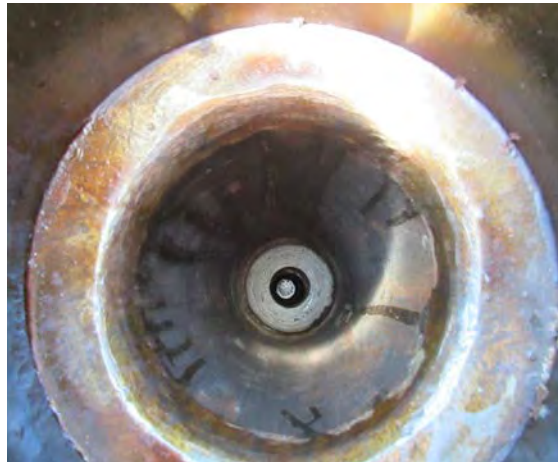
63. Underside of bolting pipe cap showing evidence of condensation

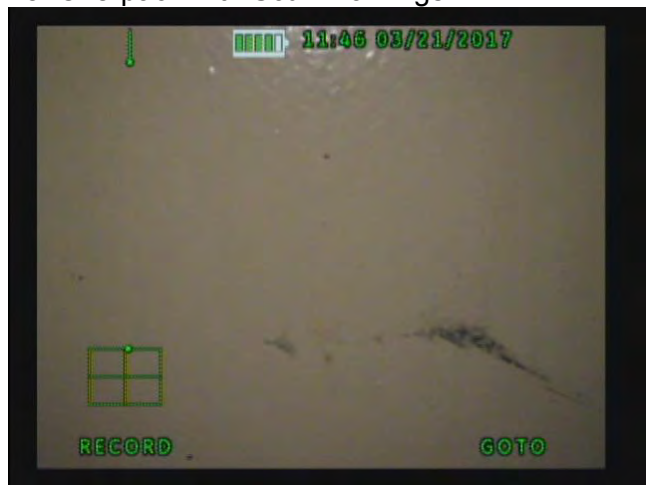
18. Overpack with Scuff Markings

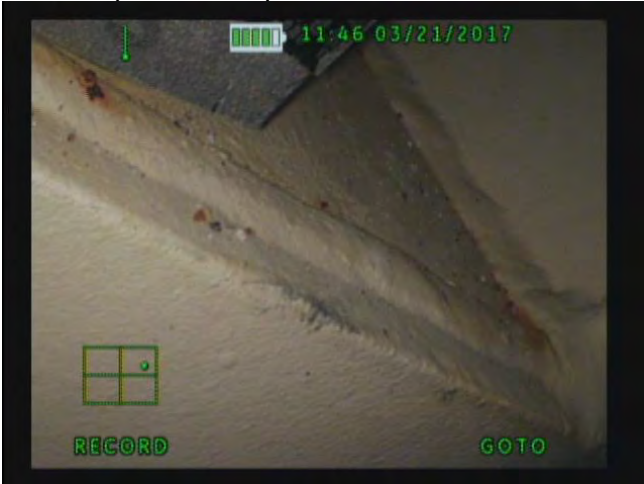
19. Overpack, rust spots

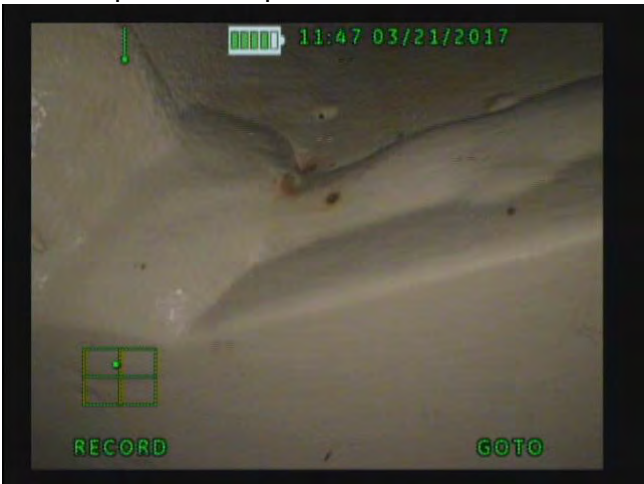
21. Overpack, rust spots
