**SUBJECT: ERRATA – WESTINGHOUSE ELECTRIC COMPANY – NUCLEAR
REGULATORY COMMISSION INTEGRATED INSPECTION REPORT NUMBER
70-1151/2018-004 AND NOTICE OF VIOLATION**

Report No.: 70-1151/2018-004

Facility: Columbia Fuel Fabrication Facility

Westinghouse Electric Company
Columbia Fuel Fabrication Facility
Nuclear Regulatory Commission Integrated Inspection Report 70-1151/2018-004
September 18 through September 21, 2018

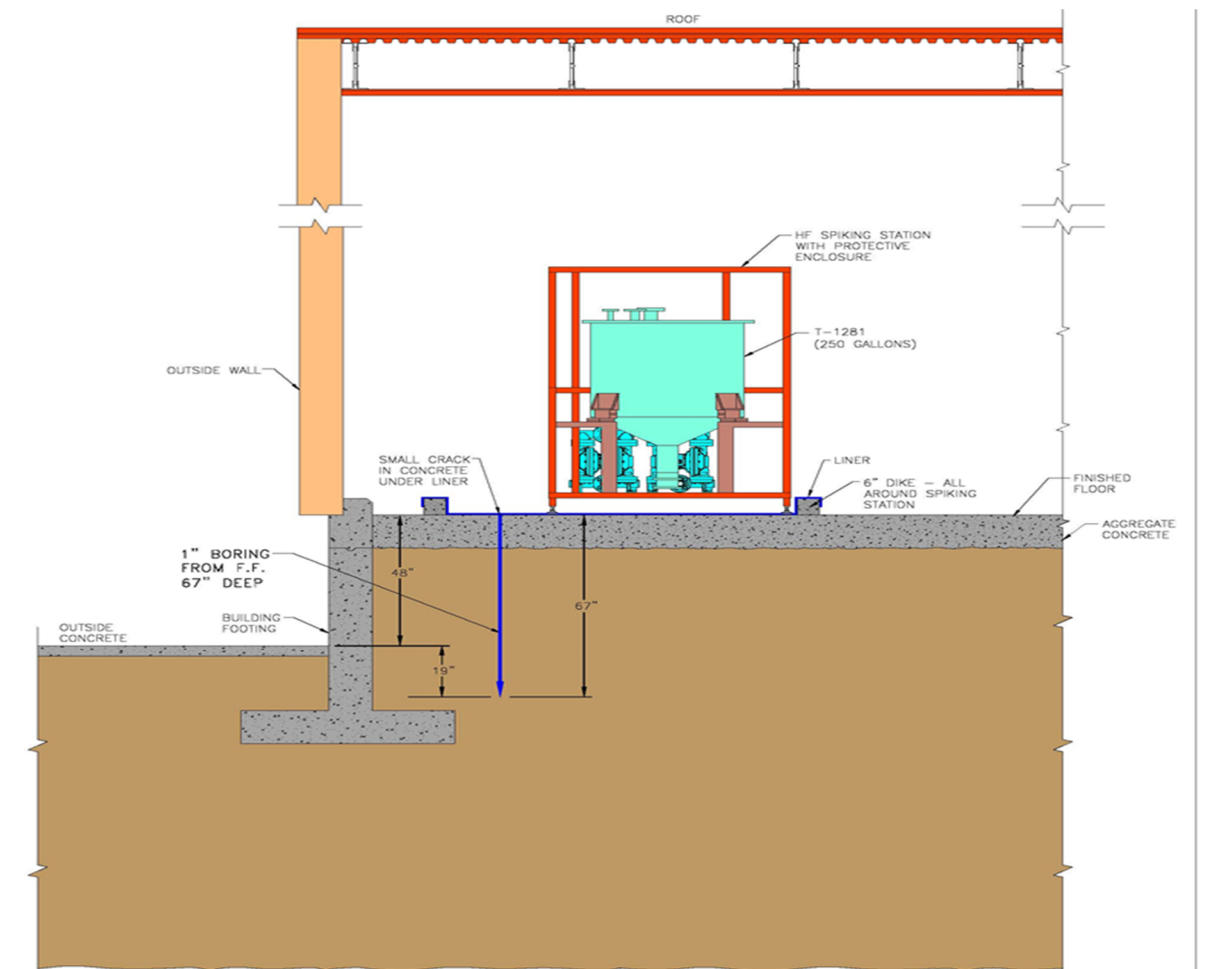
Cross-sectional View of HF Spiking Station

- The liner was removed so the diked area could be cleaned and inspected. Upon removal of the liner, maintenance noticed a small hole about the size of a quarter in the epoxy coating over the concrete. Prodding to investigate further resulted in a ~3 inch hole in the concrete surface.
- Maintenance was able to insert a wire down to ~30 inches into the building backfill before meeting resistance. They also noticed that the concrete was degraded around the immediate area. It should be noted that the building sits ~4 feet above the natural ground level.

The inspectors reviewed the 60-day event (EN 53504) follow-up report (ML18255A276) and the licensee's Apparent Cause Analysis (ACA) report (2018-12123) and noted that the stated apparent cause was a gap in plant standards regarding design, design changes, operations (including system leaks), and maintenance of the spiking station liner that provide a safety barrier to the environment. The licensee determined that prolonged contact with hydrated uranyl nitrate (UNH) process fluid deteriorated the concrete as it was known that UNH solution is highly corrosive to typical concrete mixtures. Acceptance of frequent system leaks and liner degradation from foot traffic, operations, and maintenance activities allowed process fluid to contact the liner resulting in the trapping of moisture between the liner and the diked area concrete surface.

In 2002, when the liner design was implemented and installed on the spiking stations, maintenance practices were not developed to inspect the condition of the epoxy coating for the detection of the potential condition of non-visible concrete degradation beneath the epoxy coating. In addition, when the liner was installed, there were gaps with the processes and procedures for the identification of design risks and the development of preventative maintenance practices when system or component design changes were made to SSCs.

ADUHFS-902 was considered degraded as indicated by cracks and degradation of the concrete dike wall. The inspectors noted that there was no policy or procedure in place to periodically inspect the area below the liner for indications of degradation of the concrete floor due to liner leaks.

- OM81215 was updated to 1) clarify the steps needed to perform the liner leak check, 2) require notification to Environmental Health and Safety (EH&S) of any degradation, and 3) change the frequency of the inspection from annual to quarterly and following any repair.
- The Spiking Station was barricaded and posted with instructions to put down walking pads prior to stepping on the liner to prevent liner damage.
- Hourly inspections of the liner have been commenced while the spiking station is in operation.

- Develop and implement an improved design for the spiking station system and dike area including a design review to prevent UNH solution from impacting the environment.
- Assess similar design configurations of a liner/environmental barrier relied on for secondary containment for proper post-maintenance and time-based PMs.
- Conduct an extent of condition for similar couplings used throughout the facility to verify PMs have been established.
- Additional long term corrective actions are detailed in ACA 2018-12123.
