SUBJECT: ERRATA—CLINTON POWER STATION—NRC INSPECTION REPORT
05000461/2018051 AND PRELIMINARY WHITE FINDING

Report Number: 05000461/2018051

Facility: Clinton Power Station

Dates: August 3 through September 4, 2018

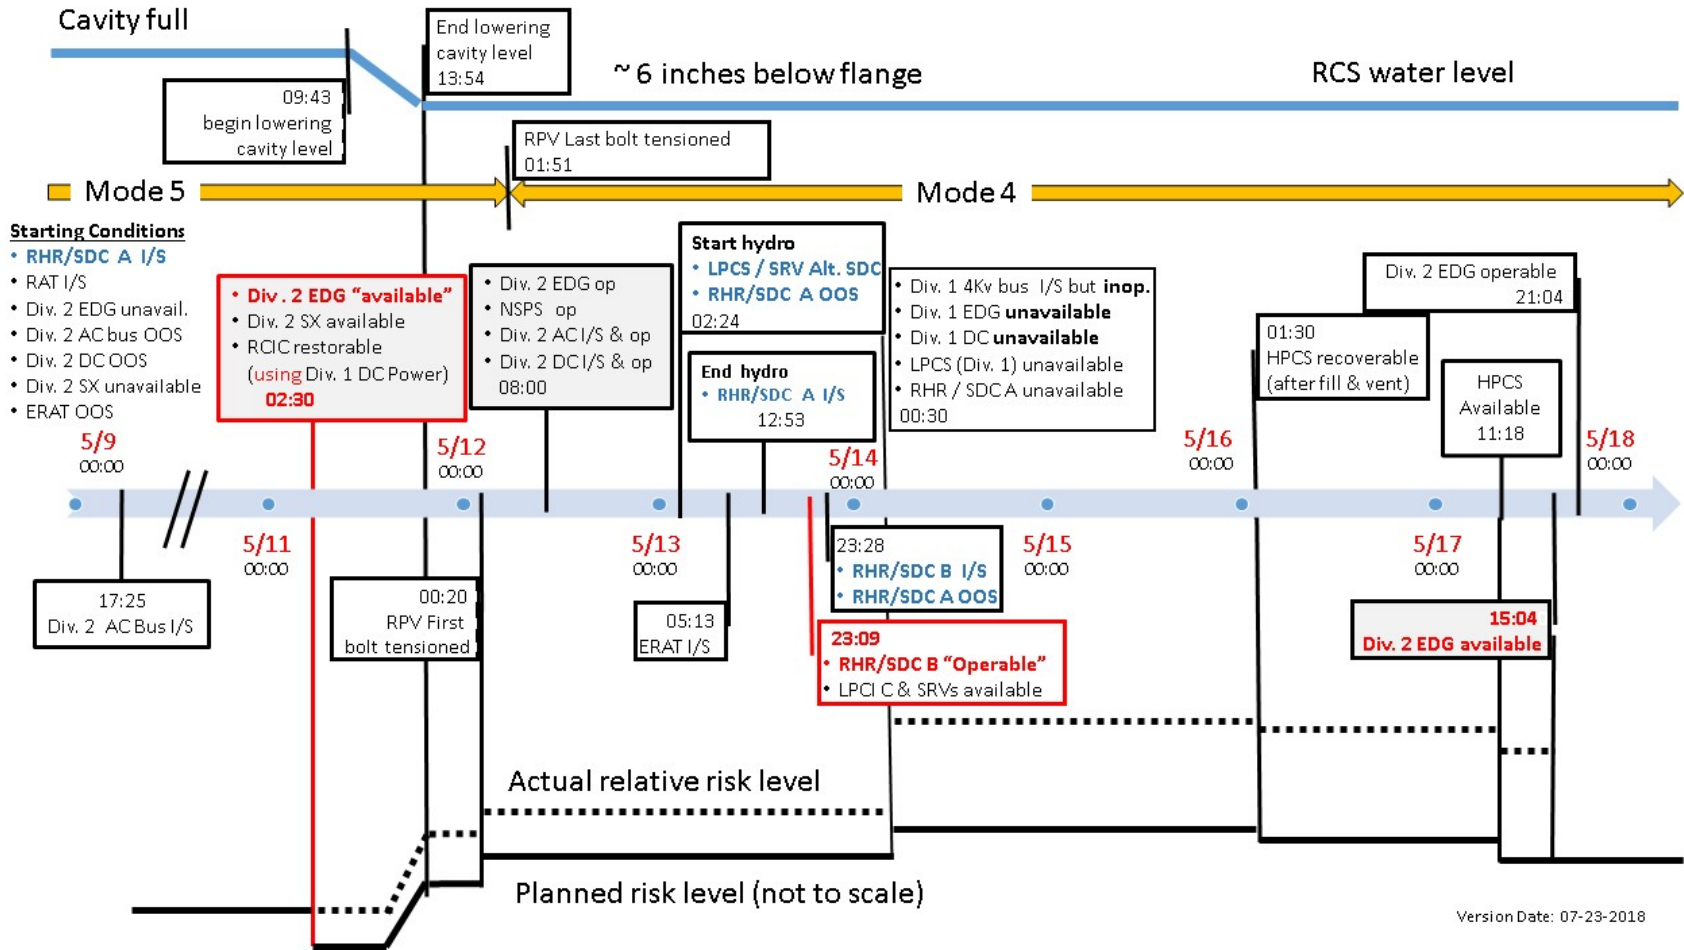
The Division 2 EDG unplanned unavailability started after the reactor had been refueled and the associated reactor cavity was full. That is, there was over 23 feet of water above the reactor core. Early in the unavailability, the licensee installed the reactor pressure vessel (RPV) internals, lowered water level to about six inches below the RPV flange, installed and tensioned the reactor vessel head. The unit entered cold shutdown or Mode 4 when the last reactor head bolt was tensioned. See Figure 1 for a time line of these events.
