Flow Control

This notification is being submitted pursuant to the guidelines of 10 CFR Part 21 to report that a 24" Class 150 Globe valve for RHRSW HX Isolation MOV, E1150F068A at Detroit Edison - Fermi 2, failed to fully open due to the failure of the anti-rotation key.

10 CFR PART 21 EVALUATION
Evaluation of Deviation or Potential Failure to Comply

DOCUMENT
10CFR21 01-18-19

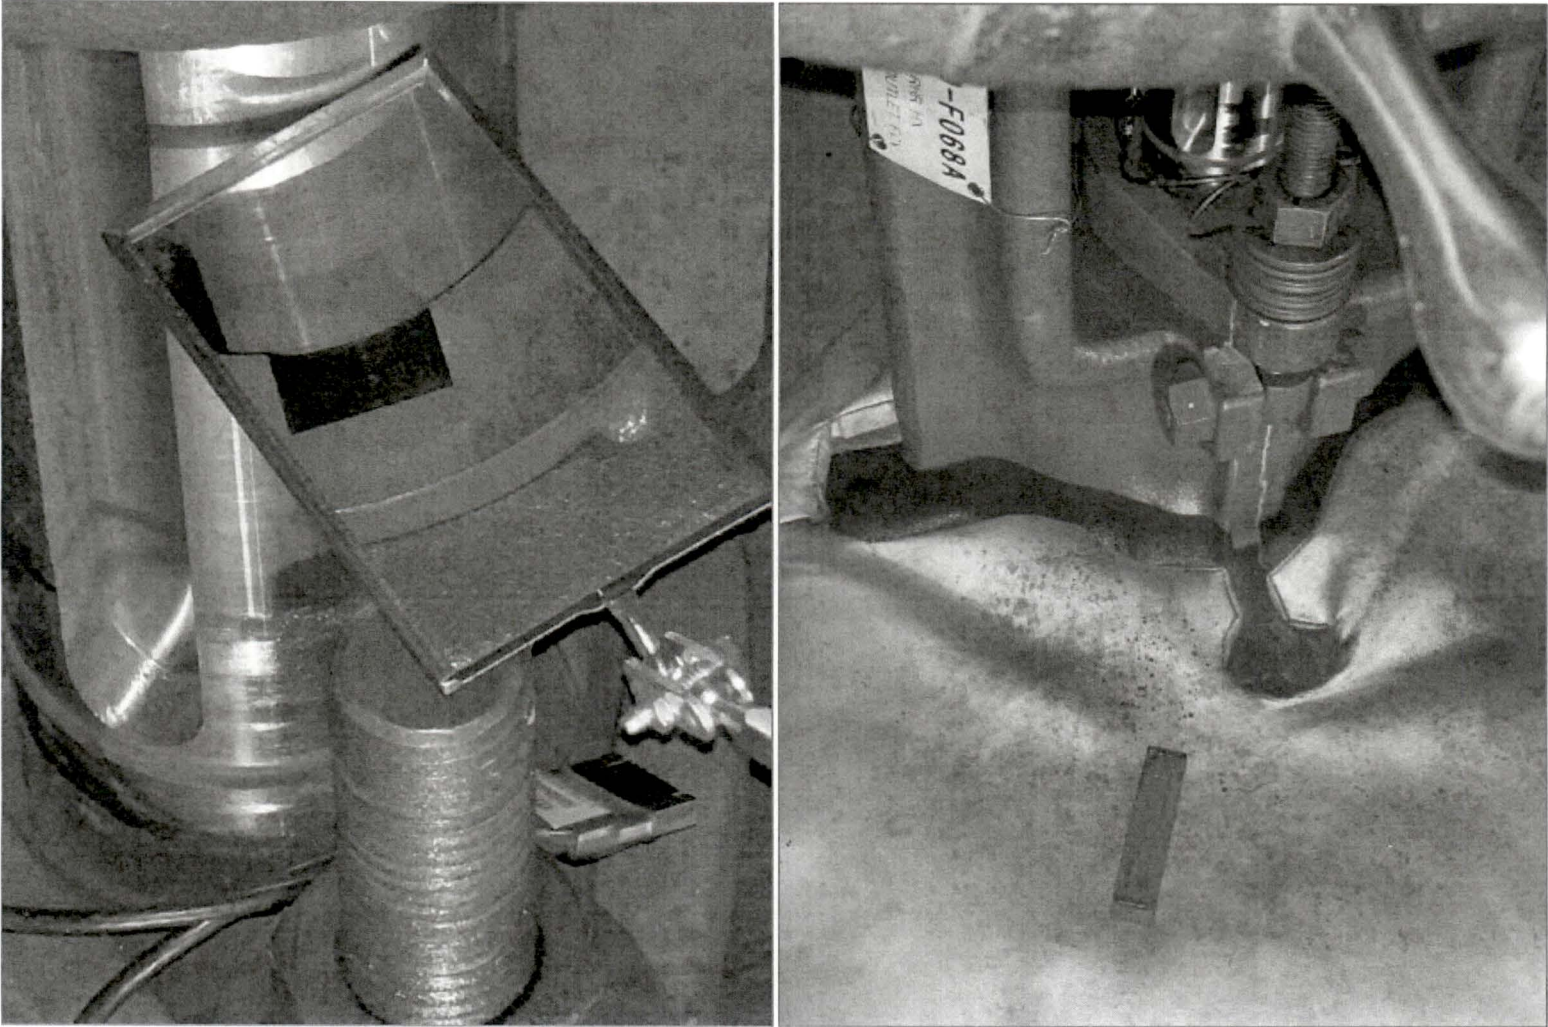
2C Provide A) Technical Justification of Unit Acceptability; or B) Proposed Technical Solution
Abnormal gap between a key and bushing key slot led to a failure of the stem anti-rotating feature of the valve. This gap contributed to the premature failure of the welds and the subsequent dropping of the anti-rotation key during system operation/vibration. The key is designed to carry the full torsional force of the actuator and allow for stem displacement in the open and close direction. Due to the gap, a torsional load from the stem induced bending stress to the fillet welds. The fillet welds are only design to support, in pure shear, the weight of the key and any friction force between the stem and the key as the valve opens and closes. The aforementioned bending stress was enough to cause the fillet welds to fail which allowed the key to fall out of the bearing assembly over time. After a thorough engineering review of the original Powell design and the Weir Valves and Controls (WVC) design documentation, two issues were identified below:

Failed Anti-Rotation Key Location and Misaligned Keyway

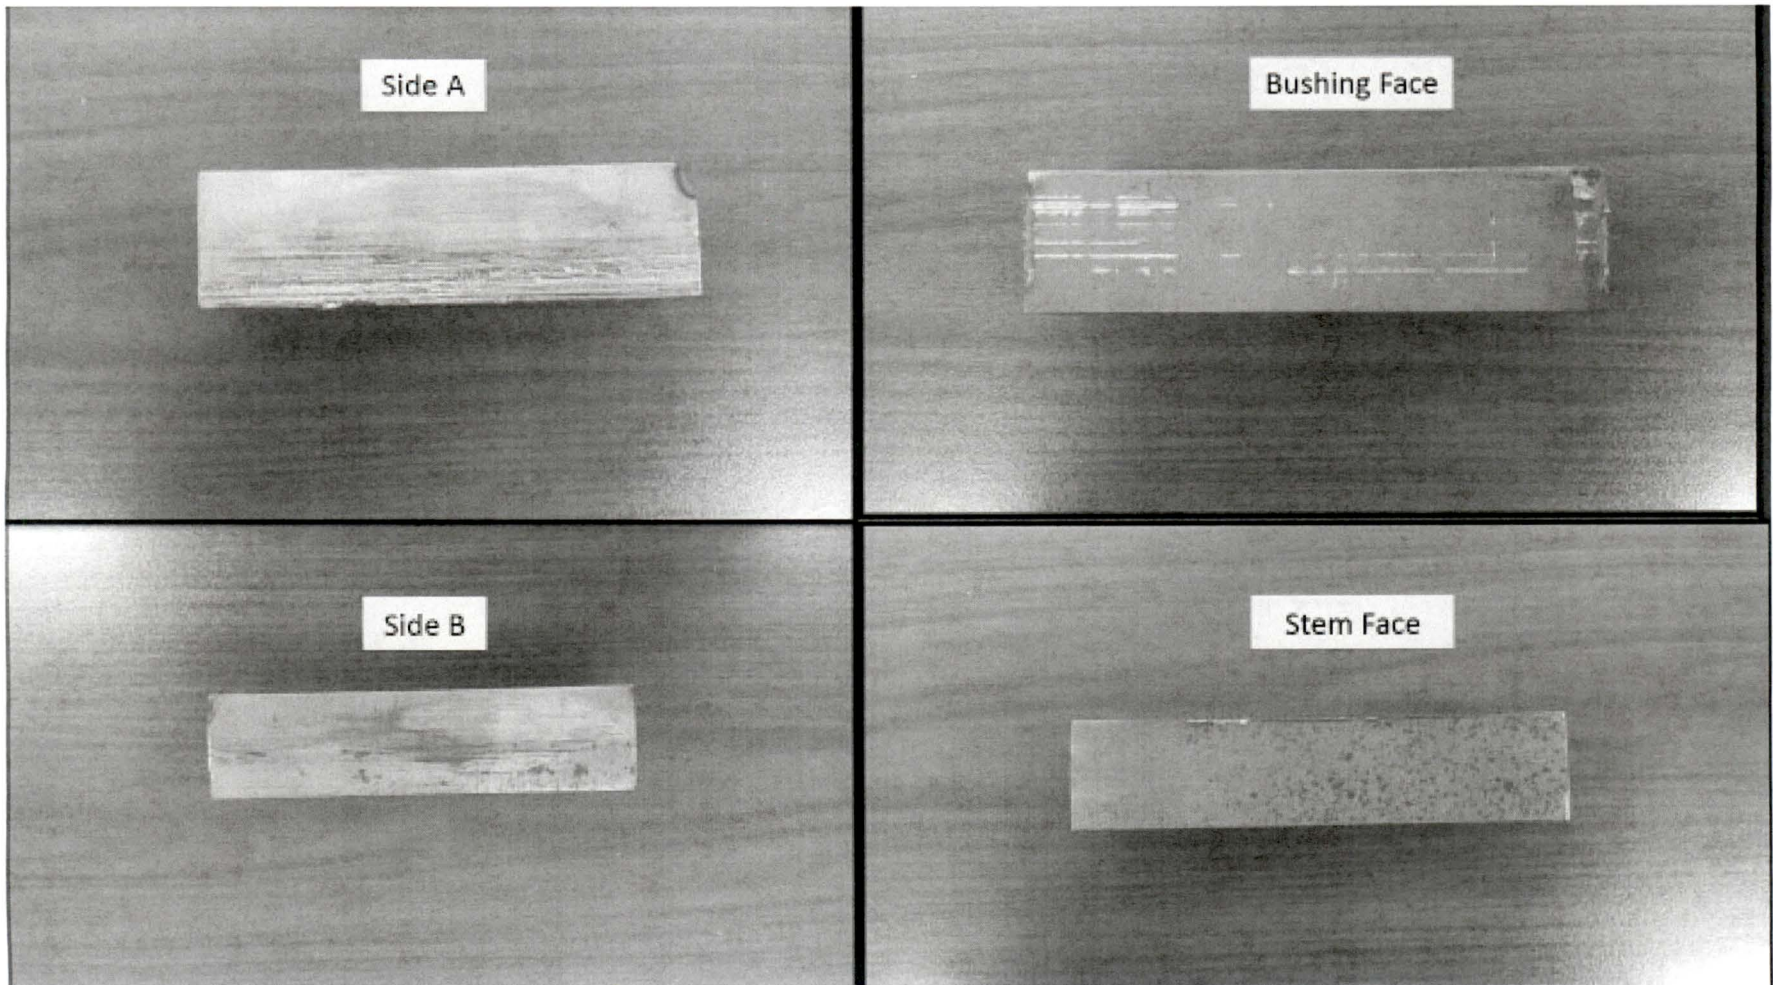
Attachment B
Failed Anti-Rotation Key Profile

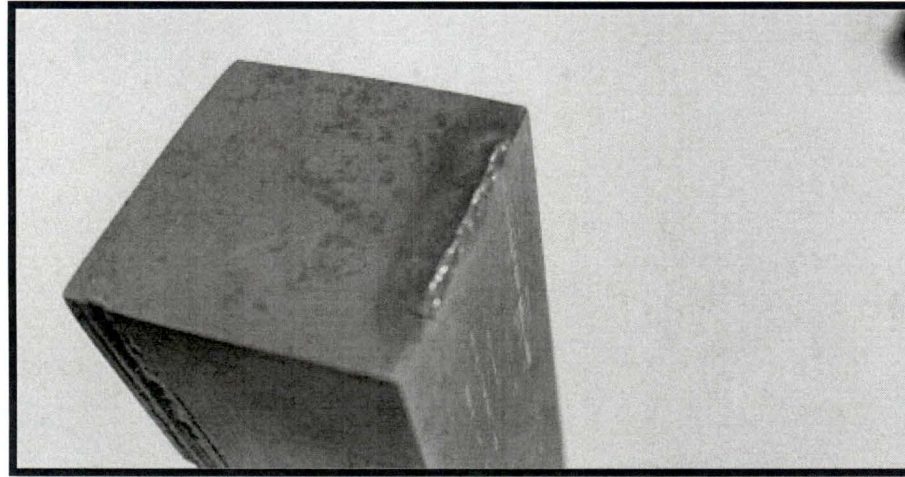
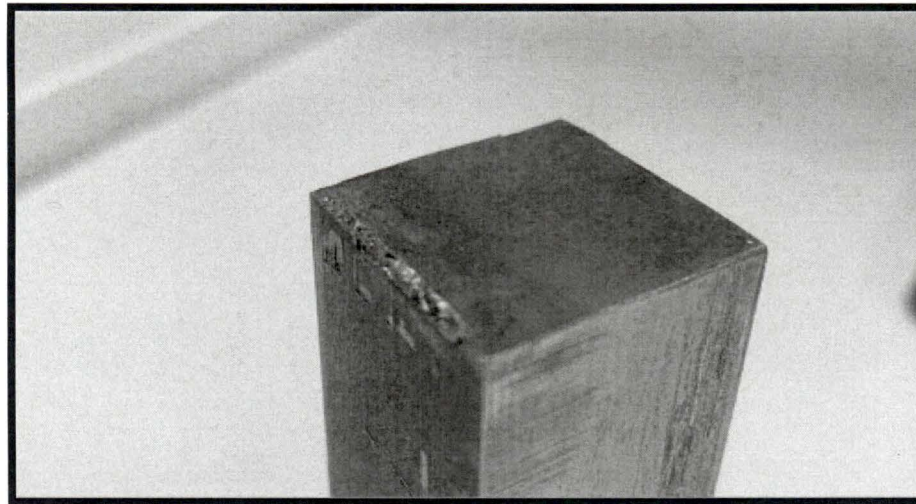
1. It was determined, in the original Powell design, the key and key slots were to be machined with the same tolerance to create a zero clearance fit. The WVC bearing assembly drawing specifies that the keyway tolerance shall be in accordance to ANSI B17.1 which allows for maximum gap of 0.007 inches.
2. The original Powell design specified A108 grade 1020 for key material. 1020 p-number is 1 which is the same as the bushing (A106B). WVC design changed the key material to AISI 4140 which does not have a designated P-No. However its composition (Cr-1/2Mo) would place it somewhere close to P-3. Welding 4140 steel requires preheat. No evidence was found that the keys were properly preheated before they were welded to the bushing.

Attachment B
Failed Anti-Rotation Key Tack Welds

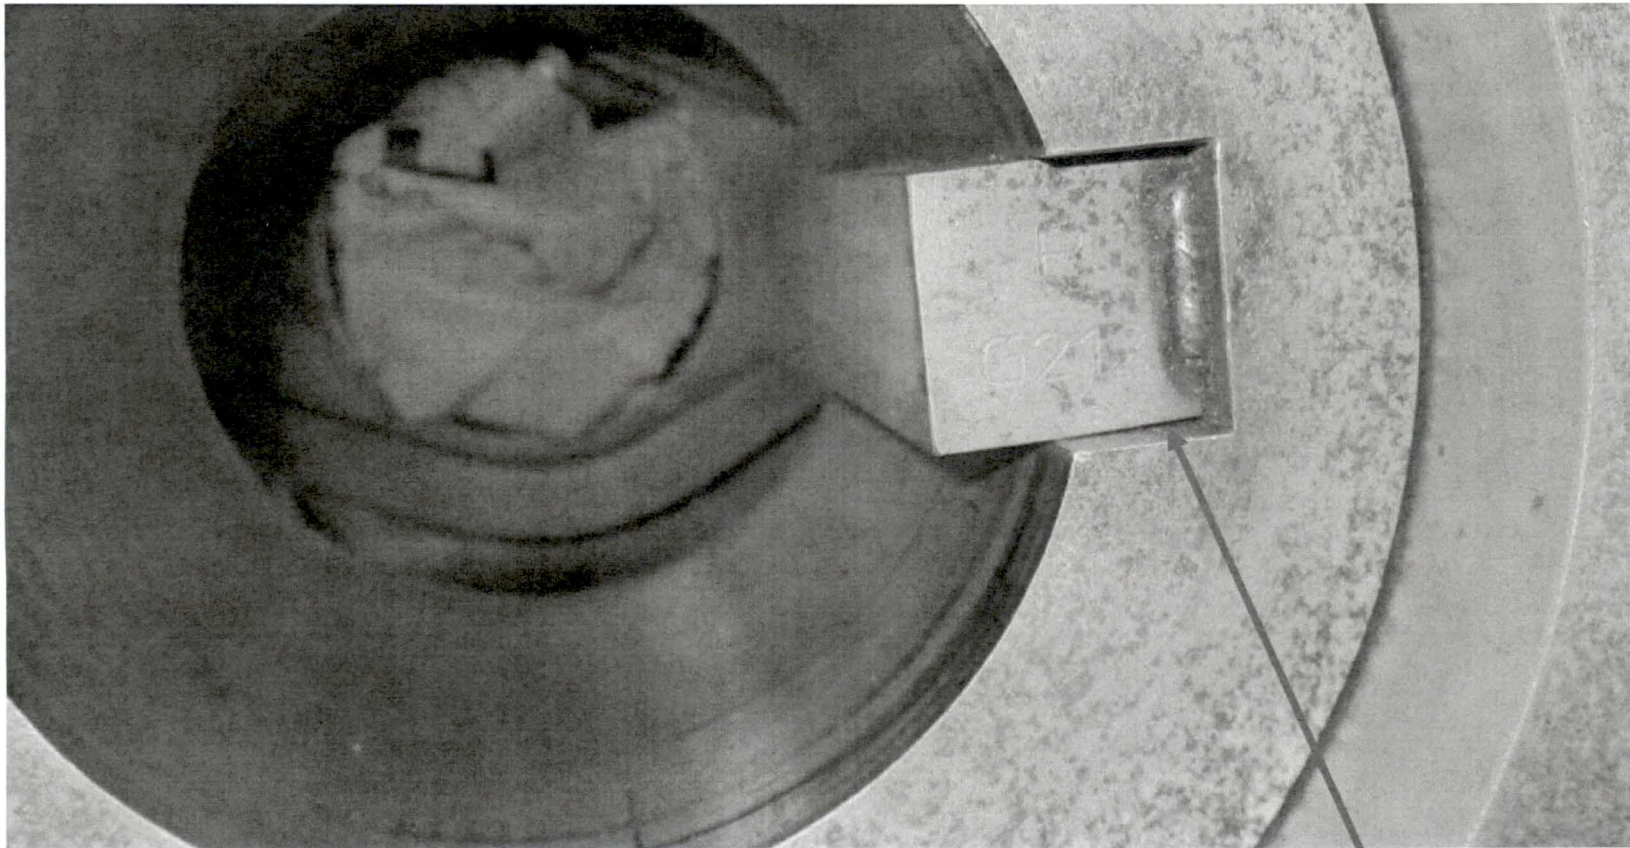
Attachment C
Warehouse Photo of Installed Anti Rotation Bushing and Key

Abnormal Gap
