Subject: 10CFR21 Reporting of Defects and Non-Compliance -
Engine Systems, Inc. Report No. 10CFR21-0124, Rev. 0

Excitation Transformers for Vickers Voltage Regulator System

Report No. 10CFR21-0124

COMPONENT: Excitation Transformers for Vickers Voltage Regulator System

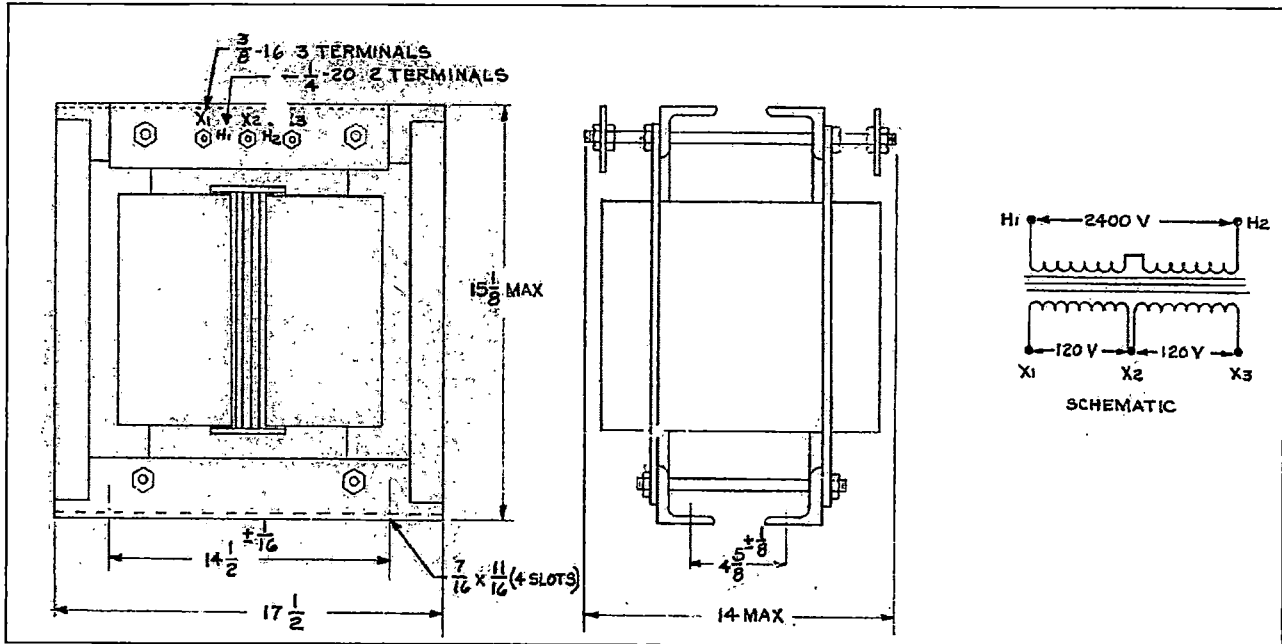
Figure 2: EPT Outline Drawing

Part Number	Device	Description of Defect
<i>8408213-ESI</i>	<i>PCT</i>	<i>Insufficient core gap.</i>
<i>8408218-ESI</i>	<i>Reactor</i>	<i>Differences in coil winding and core lamination from original design.</i>
<i>8411387-ESI</i>	<i>EPT</i>	<i>Incorrect polarity.</i>

Three single-phase EPTs are wye connected on the primary and delta connected on the secondary. Per the system design, EPT primary H1 should have the same polarity of EPT secondary X1. Contrary to this requirement, EPT primary H1 has the same polarity as secondary X3.

Return to ESI for rework to have EPT primary terminal markings (H1 & H2) re-labeled.

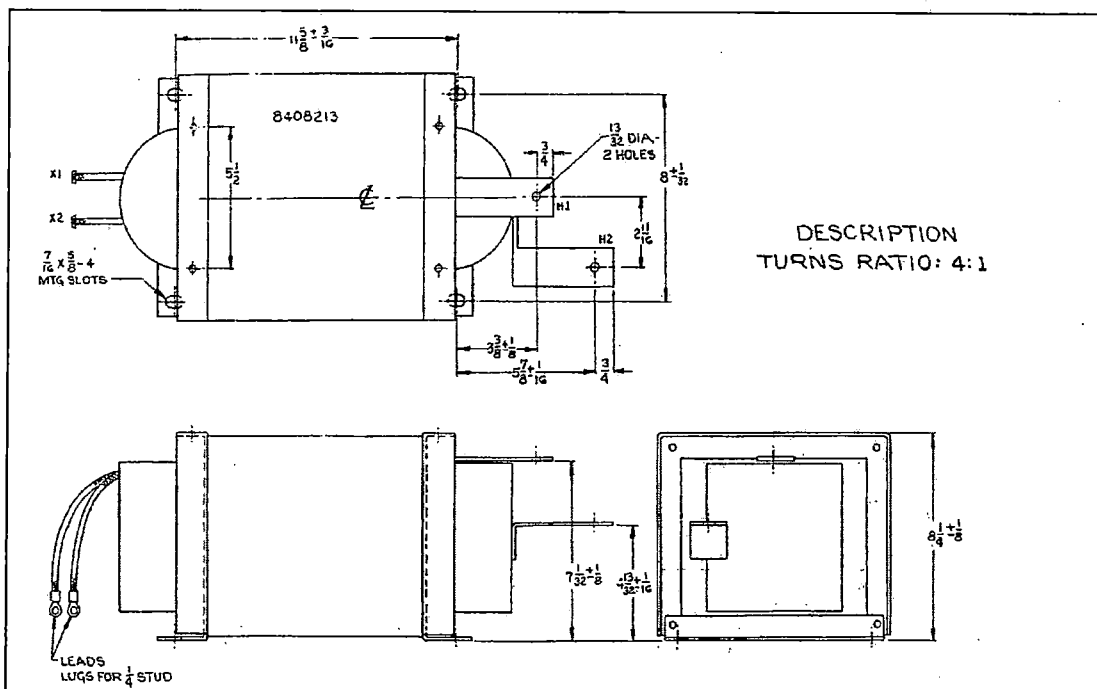
Figure 3: PCT Outline Drawing

Three single-phase PCTs provide a secondary voltage proportional to the primary current. The PCT, in conjunction with the EPT, provide the power to support generator field excitation. Certain characteristics of the PCT secondary voltage are determined by the magnitude of an air gap in the core construction. It has been determined the PCT supplied by ESI has a gap of 0.030" whereas the original design PCT has a gap of 0.080".

Return to ESI for rework. The PCT requires additional insulating material to increase the core gap.

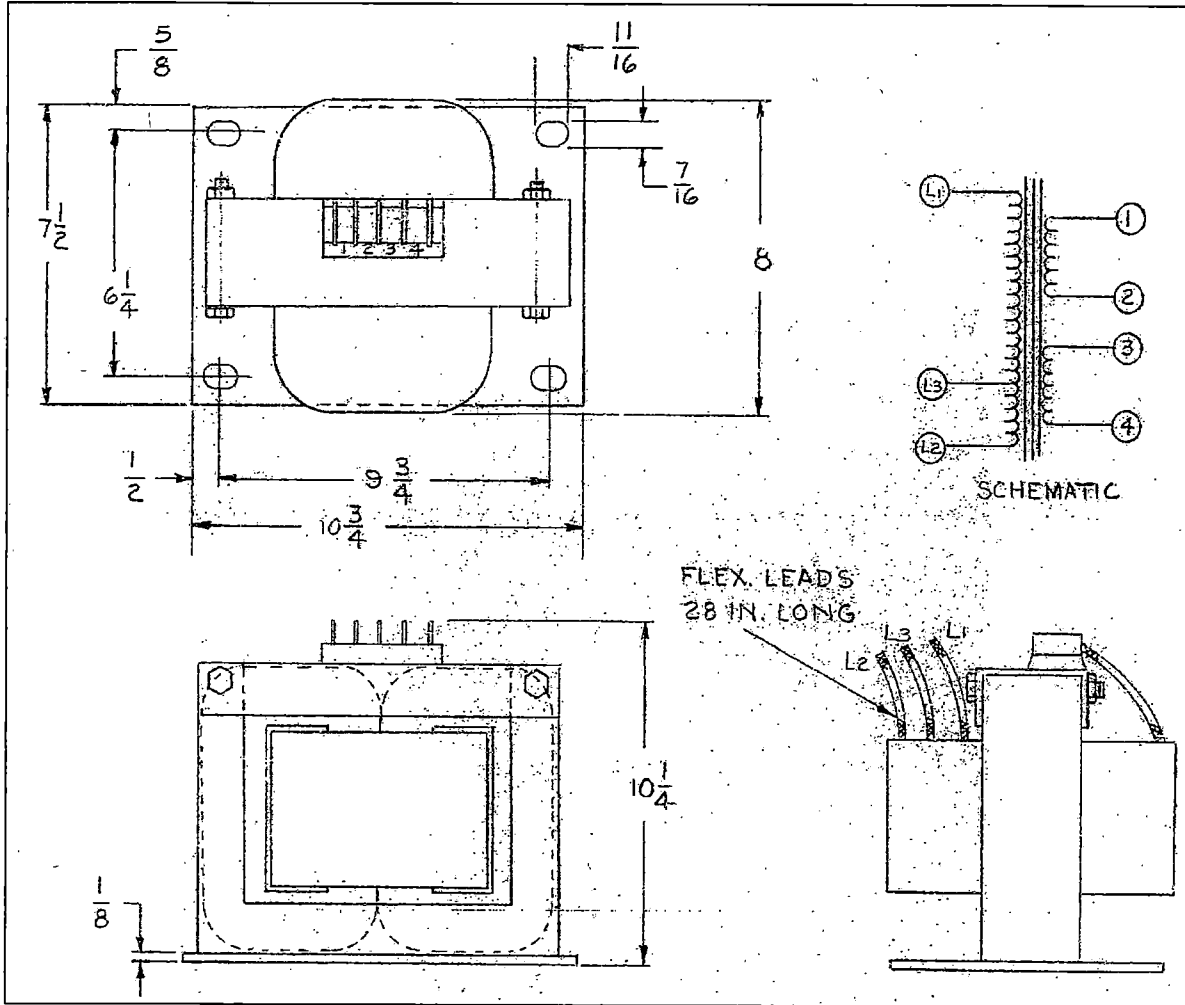
Figure 4: Reactor Outline Drawing

In conjunction with a rectifier diode, the saturable reactor acts as a magnetic amplifier. Six of these magnetic amplifier assemblies are used in the rectifier bridge of the voltage regulator system. The reactor receives a bias and control current from the voltage regulator which varies the level of saturation in the reactor core. As the level of saturation changes, the reactor impedance varies which increases or decreases generator field voltage. It has been determined the saturable reactor supplied by ESI has coil winding and core winding differences from the originally supplied reactor that may cause subtle, but undesired performance differences.

Return to ESI for replacement.
