LICENSEE EVENT REPORT

TOLEDO EDISON COMPANY
DAVIS-BESSE NUCLEAR POWER STATION UNIT ONE
SUPPLEMENTAL INFORMATION FOR LER NP-32-82-03

DATE OF EVENT: April 19, 1982

FACILITY: Davis-Besse Unit 1

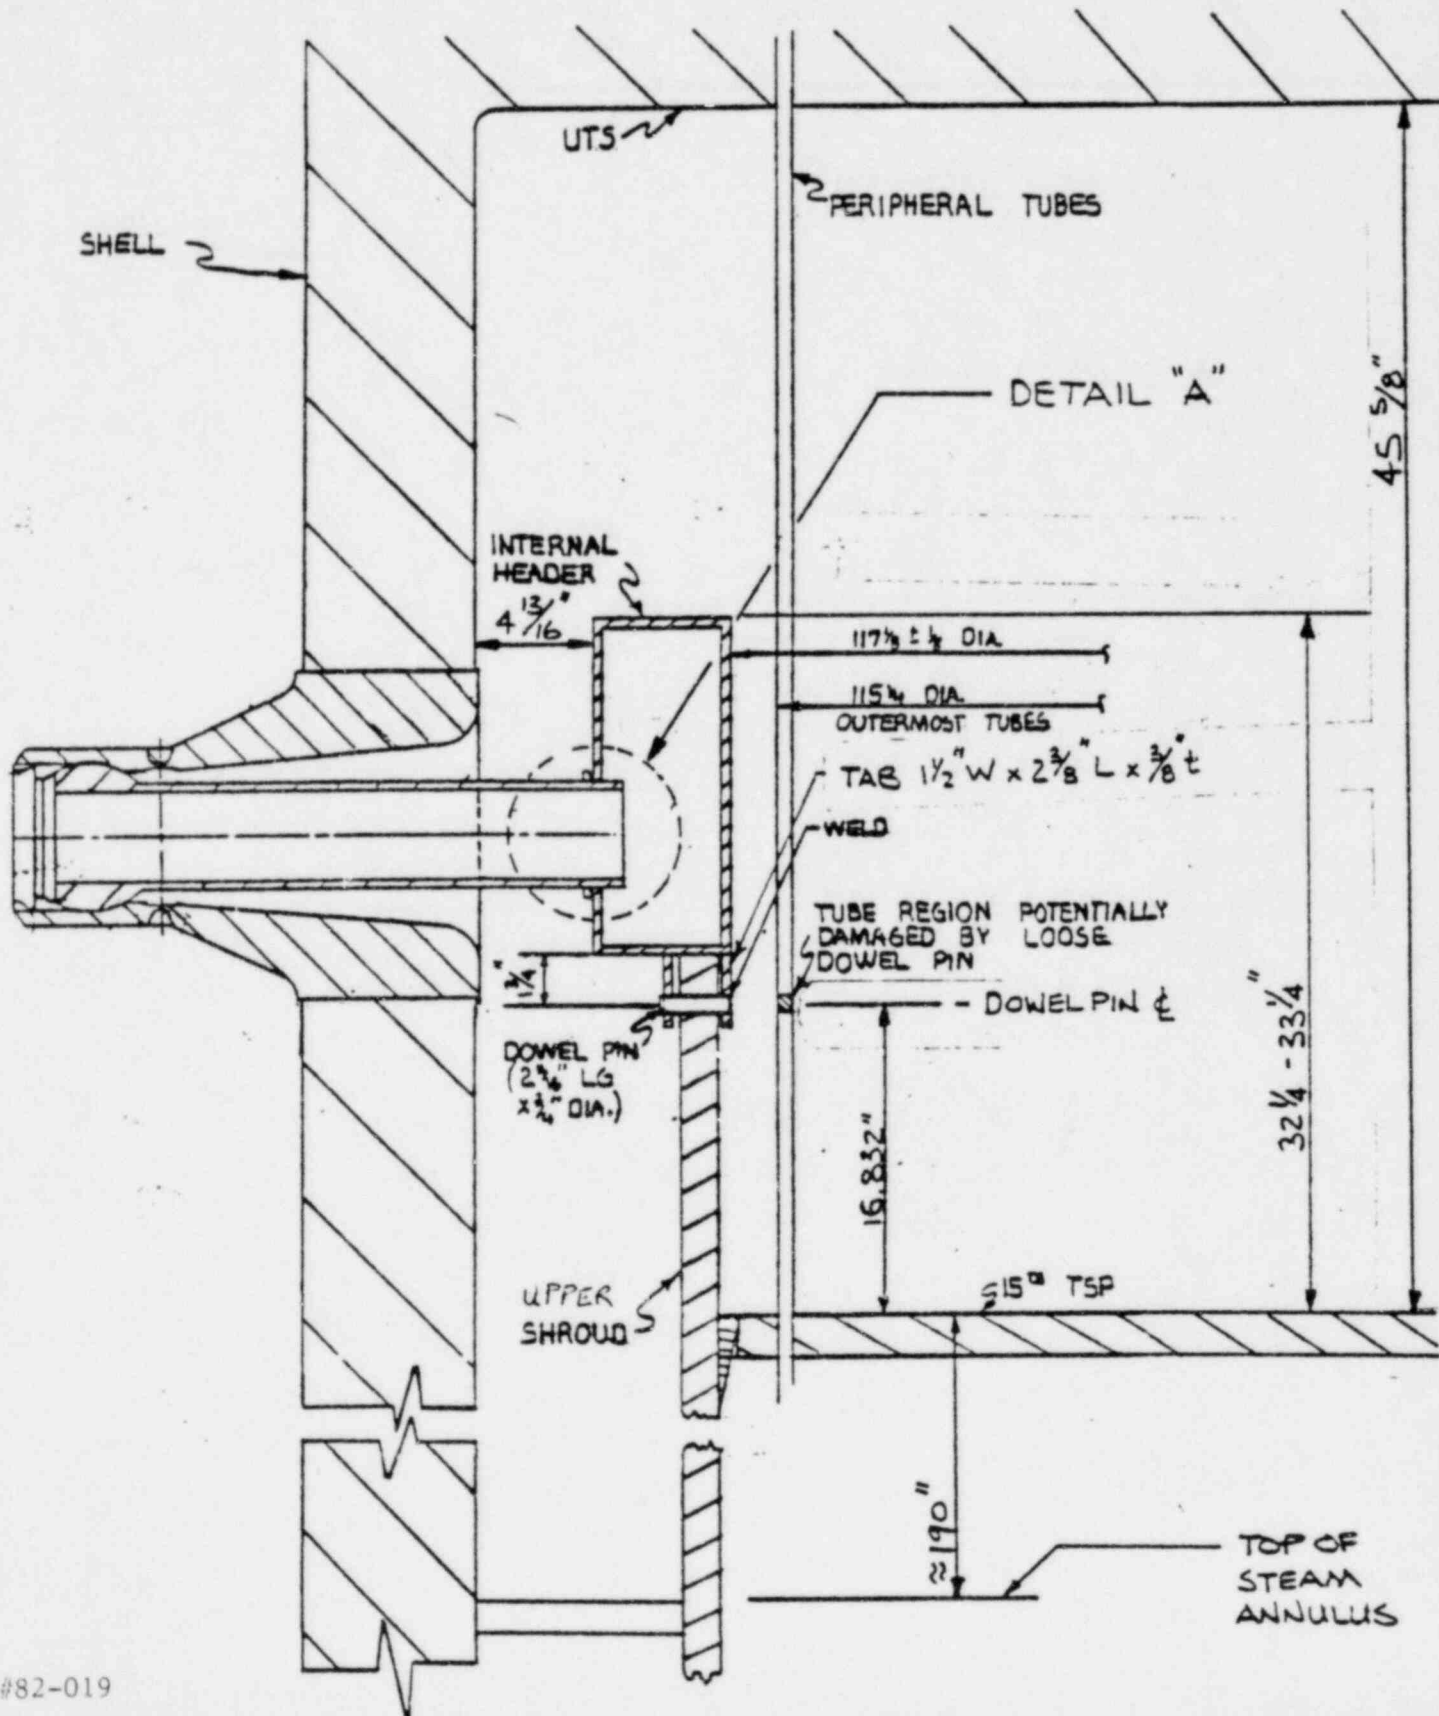
LONGITUDINAL SECTION AT DOWEL PIN

- (6) Dowel pins are missing at six of eight locations inspected. Three dowel pins and two brackets have been retrieved from the steam annulus area in 1-2 SG.

- (7) There is evidence of wear on dowel pins and brackets.
- (8) The auxiliary feedwater nozzle thermal sleeve was not in alignment with the header on Unit #1 (1-1 SG).

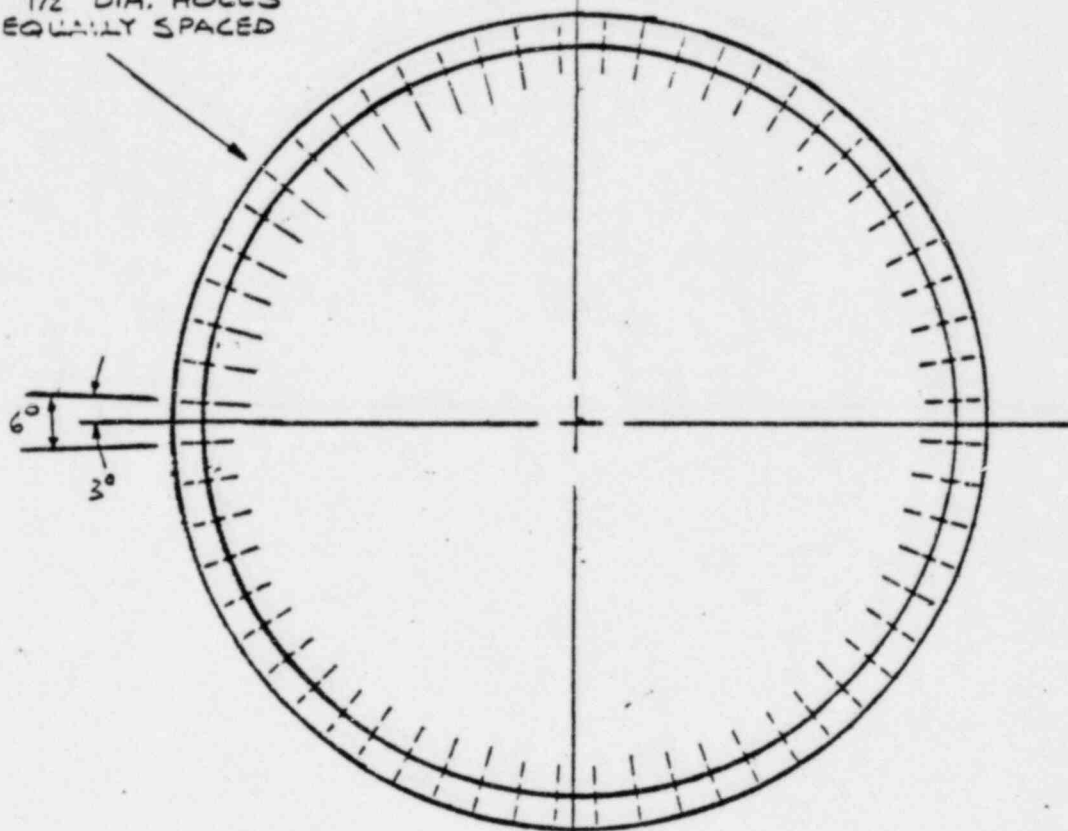
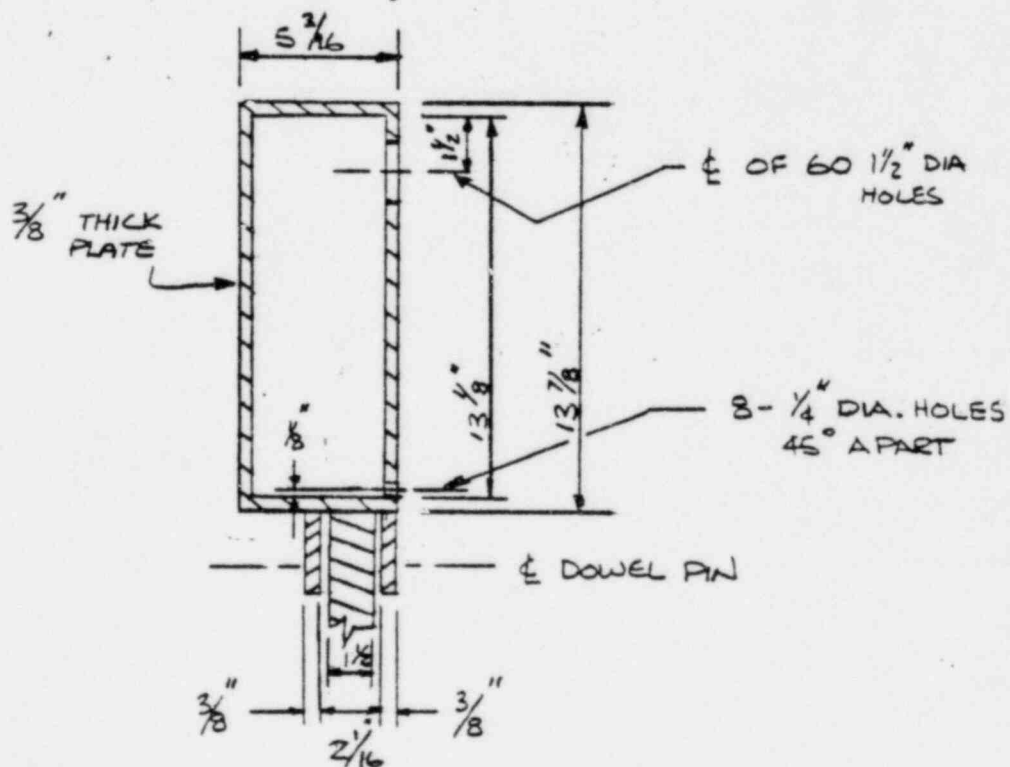
LOCATION OF AUXILIARY FEEDWATER

- (4) The outward wall of the header is distorted inward (concave) as much as $4\frac{1}{2}$ ".
- (5) Certain header support brackets are bent, and on some the bottom ligaments are torn out or have broken off.
