U. S. NUCLEAR REGULATORY COMMISSION  
REGION I

Report Nos. 50-317/90-10  
50-318/90-10

Facility Name: Calvert Cliffs

Inspection Summary: Routine Unannounced Inspection on May 14-18, 1990  
(Inspection Report No. 50-317/90-10)

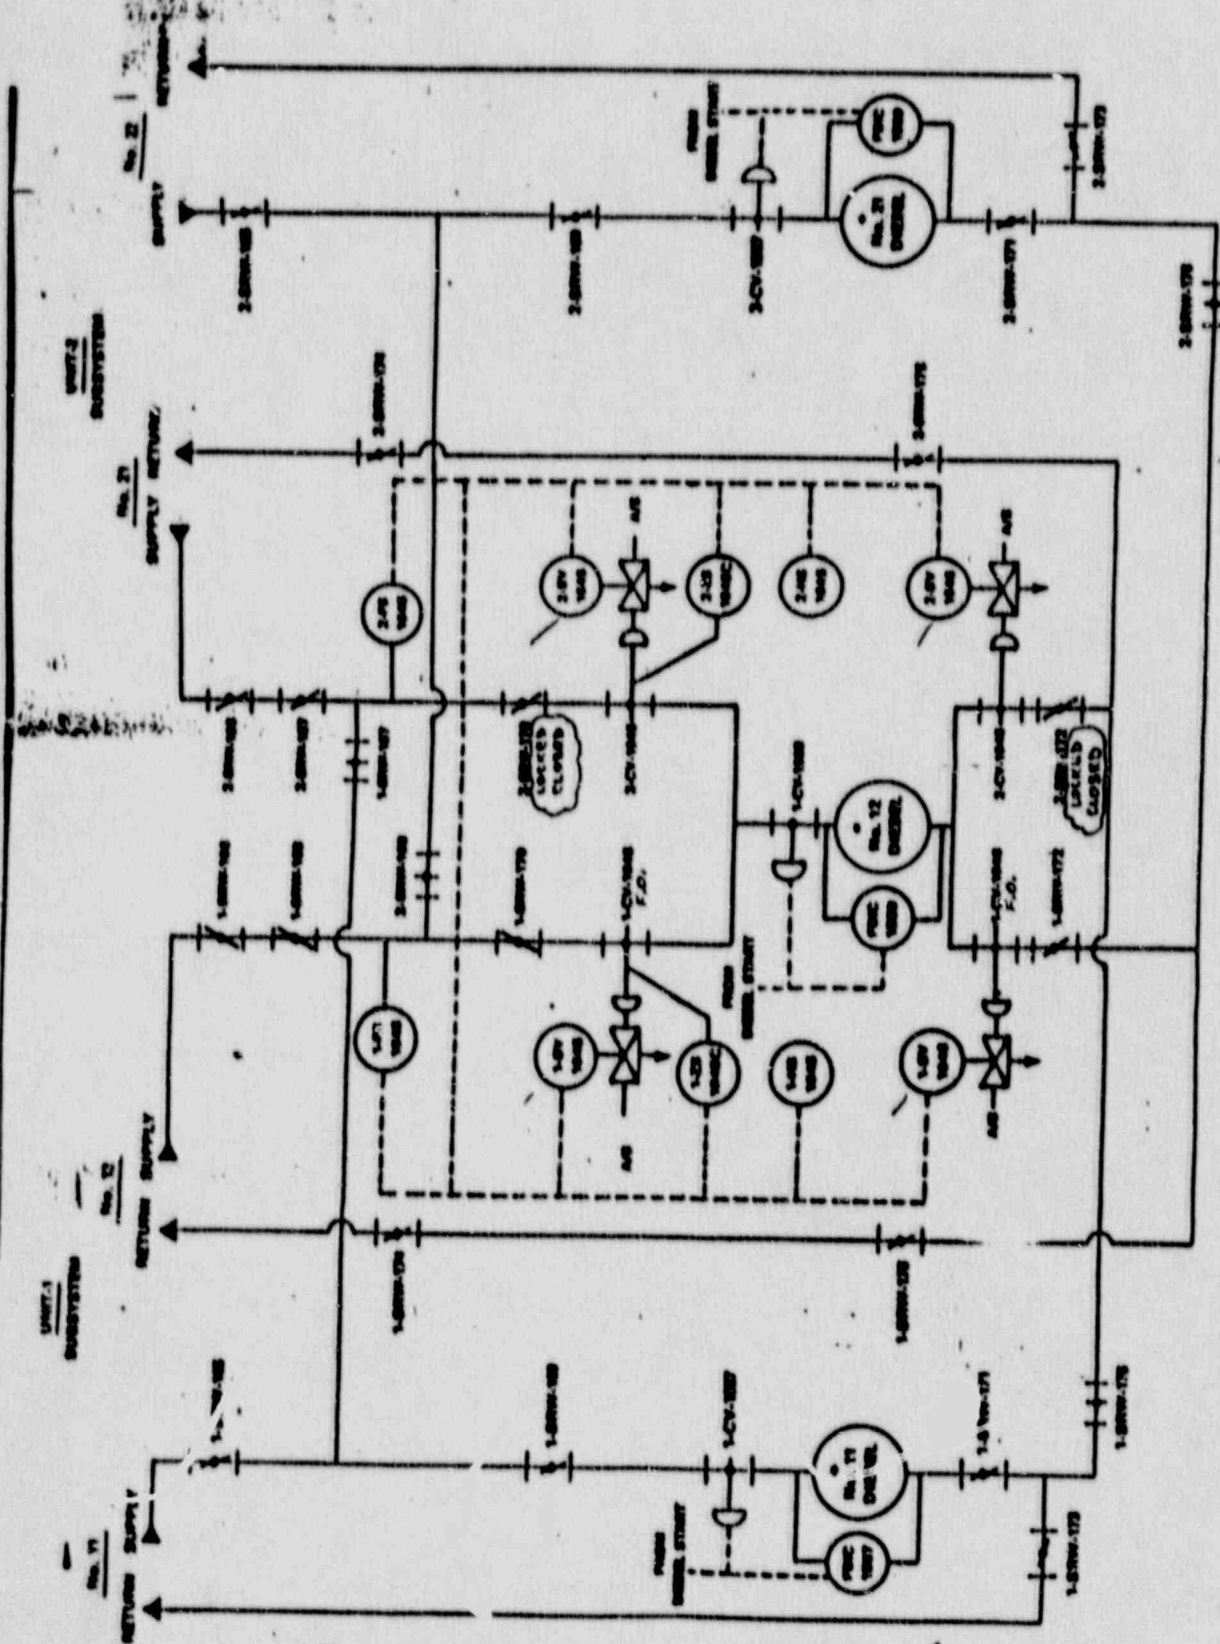
## SERVICE WATER PIPING DIAGRAM

The licensee has in place a temporary modification (1-89-77) to ensure that a service water break in the common header will not affect units 1 and 2. Temporary modification 1-89-77 locks shut 2-SRW-170 and 2-SRW-172. This locked shut condition isolates the unit 2 service water supply at 1-IA-811 and 814. This will enable valves 1-CV-1645 and 1646 to remain open, so that unit 1 service water will supply cooling water to EDG No. 12 or vice versa depending upon the location of the break along the header. This temporary modification will be in place until the permanent modification described in section 3.1 of this report is completed in its entirety.

Attachment A of this report shows a p. & I. D. of the permanent as well as the temporary modification
