Subject: Quad Cities Nuclear Power Station Unit 2
Intergranular Stress Corrosion Cracking
(IGSCC) Susceptible Piping Inspection
NRC Docket No. 50-265

Enclosure: System Materials Analysis Department Report
on 02J-S3 Riser Weld Overlay Boat Sample from
Quad Cities Station Unit 2

SYSTEM MATERIALS ANALYSIS DEPARTMENT REPORT
ON
O2J-S3 RISER WELD OVERLAY BOAT SAMPLE
FROM
QUAD CITIES STATION UNIT 2

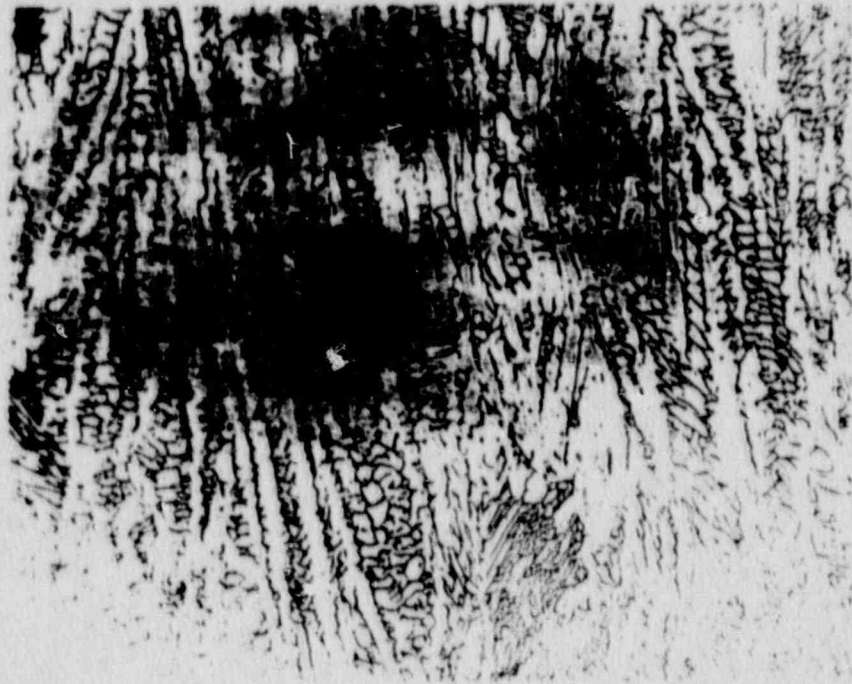
Metallographic examination of the weld metal was performed in the unetched and etched conditions. This was done to identify any possible sources of a UT reflector. No evidence of any welding related defect was observed. Figure 3 is a photomicrograph of the weld metal microstructure. The delta ferrite content of the weld was determined with the aid of a computer enhanced image analyzer. The average delta ferrite content was 12.7%.

Figure 3. The typical weld metal microstructure. The delta ferrite content of the weld was determined to be 12.7% using a computer enhanced image analyzer.
