Re: Docket No. 50-275, OL-DPR-80
Diablo Canyon Unit 1
Licensee Event Report 1-90-015-01
ESF Actuation, P-14 (High-High Steam Generator Water Level),
Due to Feedwater Regulating and Bypass Valves Leakage

LICENSEE EVENT REPORT (LER)

LE (4) **UNIT 1 ESF ACTUATION, P-14 (HIGH-HIGH STEAM GENERATOR LEVEL), DUE TO FEEDWATER VALVE LEAKAGE**

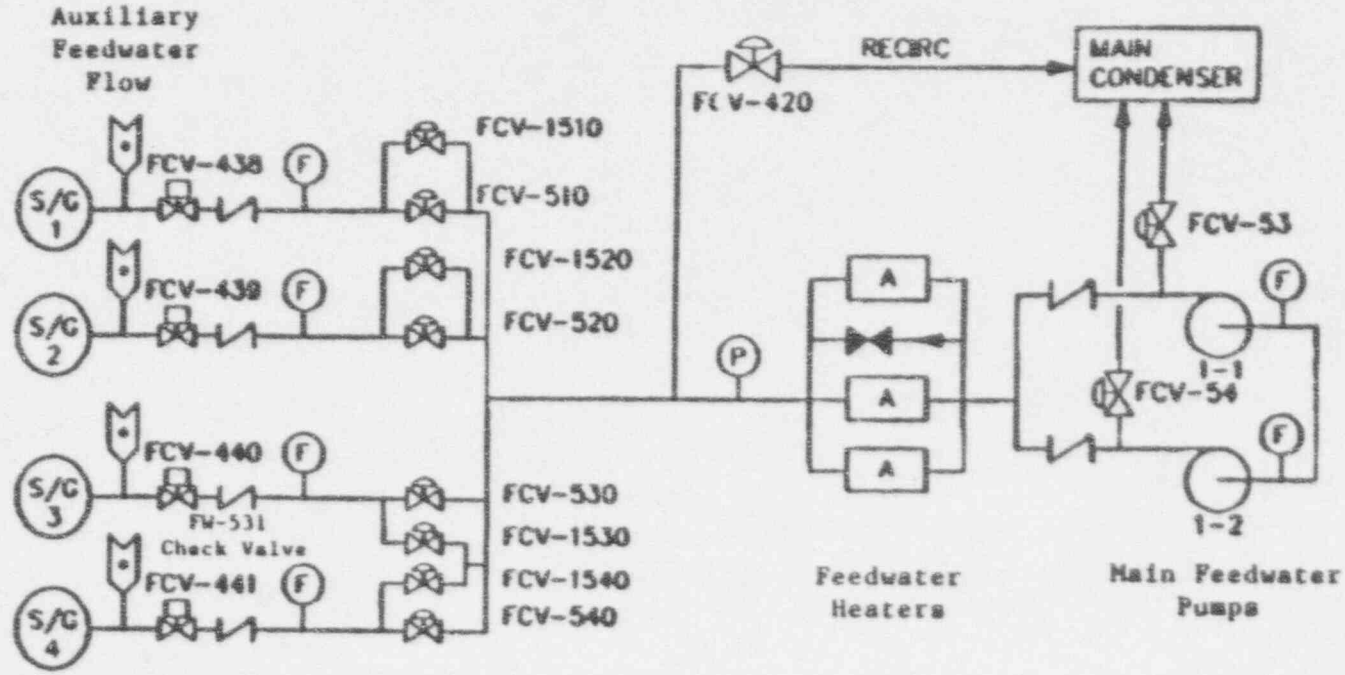
MAIN FEEDWATER SYSTEM ONE LINE DIAGRAM

Figure 1 provides a schematic of the main feedwater system.
