NUCLEAR SAFETY-RELATED  
CONTAINMENT COOLING SERVICE WATER  
PUMP ROOM COOLER HEAT LOAD STUDY  
DRESDEN STATION - UNITS 2 AND 3

Report Prepared for  
Commonwealth Edison Company

Report SL-7120

July 12, 1988

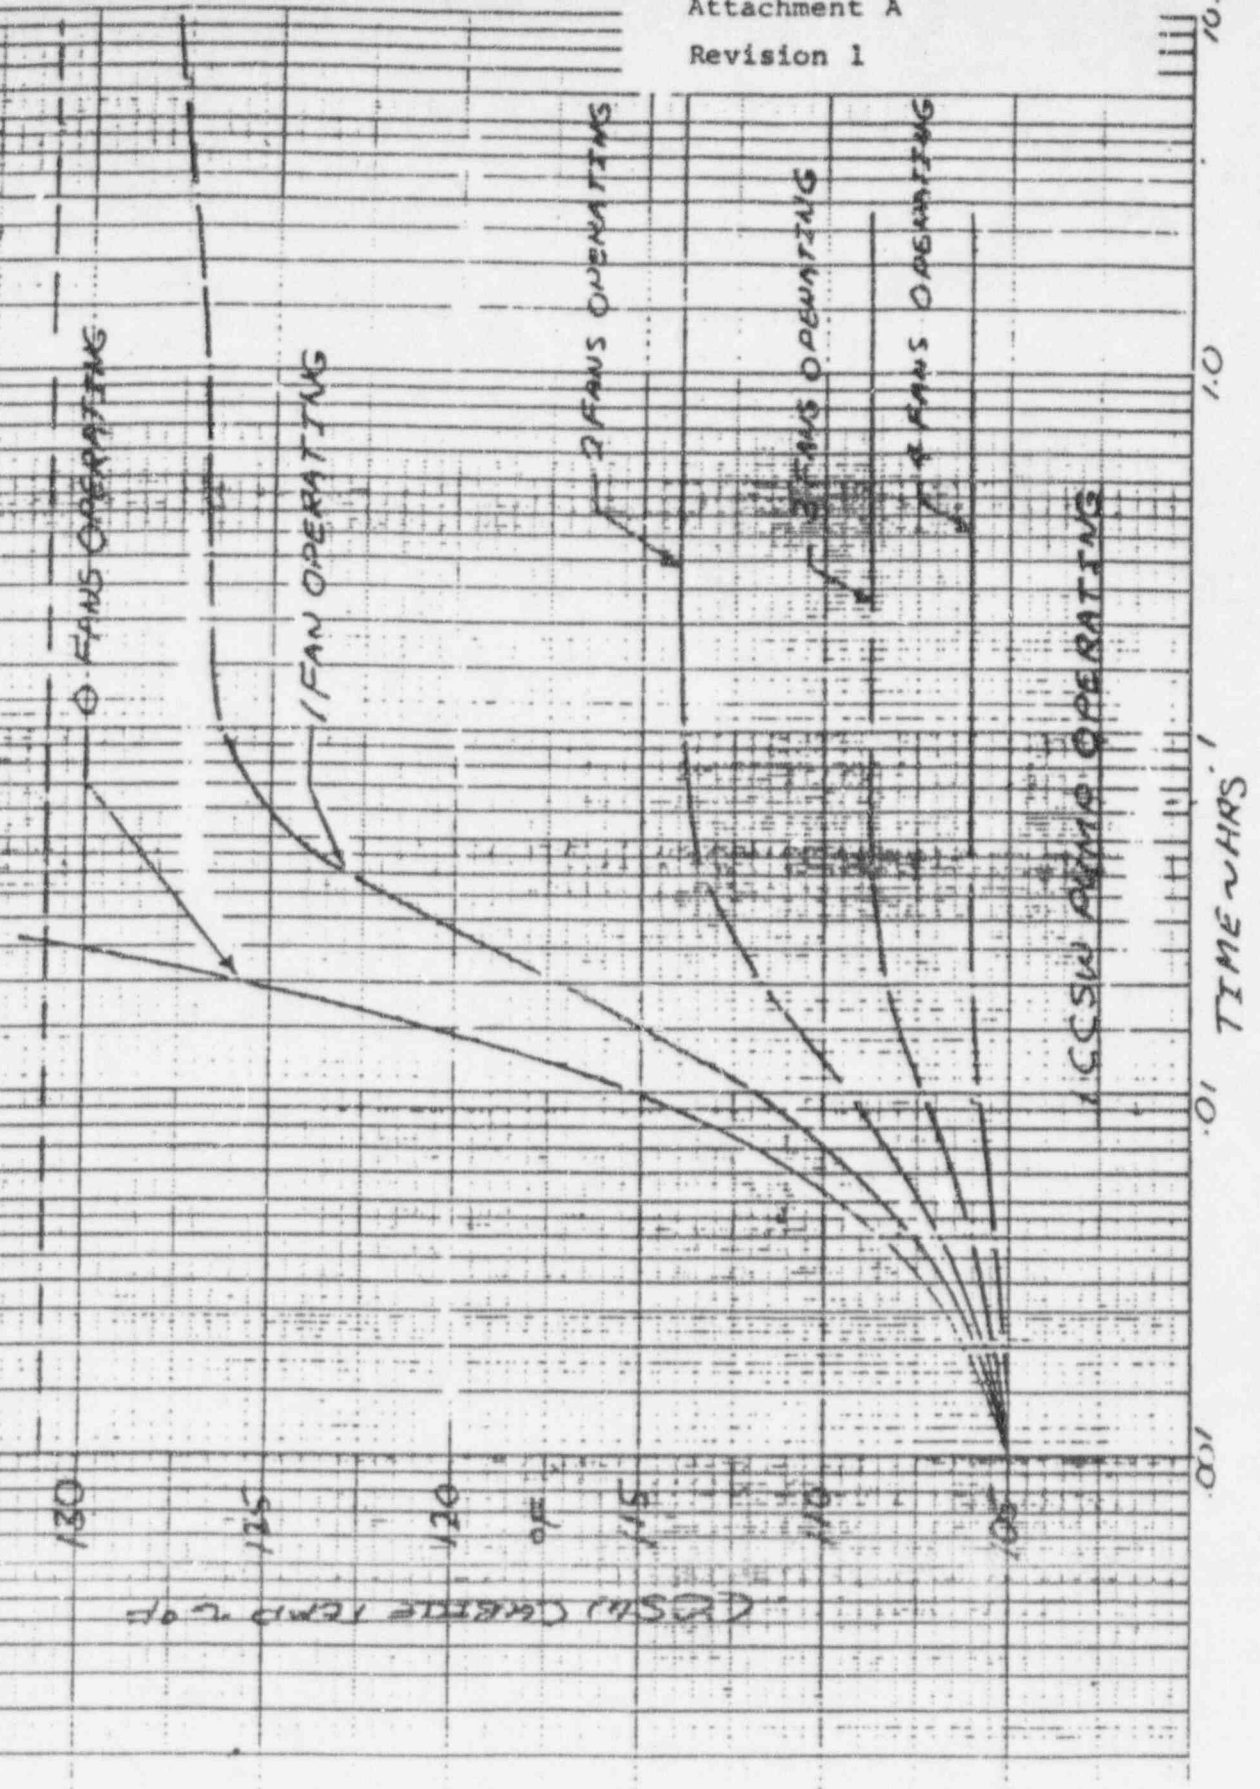
FIGURE 1 - CCSW PUMP ROOM TEMPERATURES - 0.5% INERT WATER TRAMP

Figures 1, 2 and 3 are plots of the transient CCSW cubicle temperature for 95°F, 85°F and 75°F entering cooling water temperature, respectively. Figure 1 presents five curves describing the transient temperature as a function of time with 0, 1, 2, 3 or 4 fans operating. From this figure it is seen that the CCSW cubicle will reach a temperature of 131°F in less than 2 minutes when no fans operate. Although not shown in this figure the CCSW cubicle temperature would exceed 160°F in 6 minutes with no fans operating. When 1 fan operates, the temperature at 10'

hours as shown in the figure is approximately 128°F. At 100 hours the additional temperature increase in the cubicle is less than 2 degrees above the 10-hour value. Efforts to qualify the CCSW pump motors to temperatures greater than 131°F would have marginal success because our results indicate that only a marginal increase in the operating time could be justified. The cubicle remains below 115°F for a 10-hour period for the conditions of 2, 3 or 4 operating fans. Also, the temperature rate of increase, at 10 hours, is minimal.

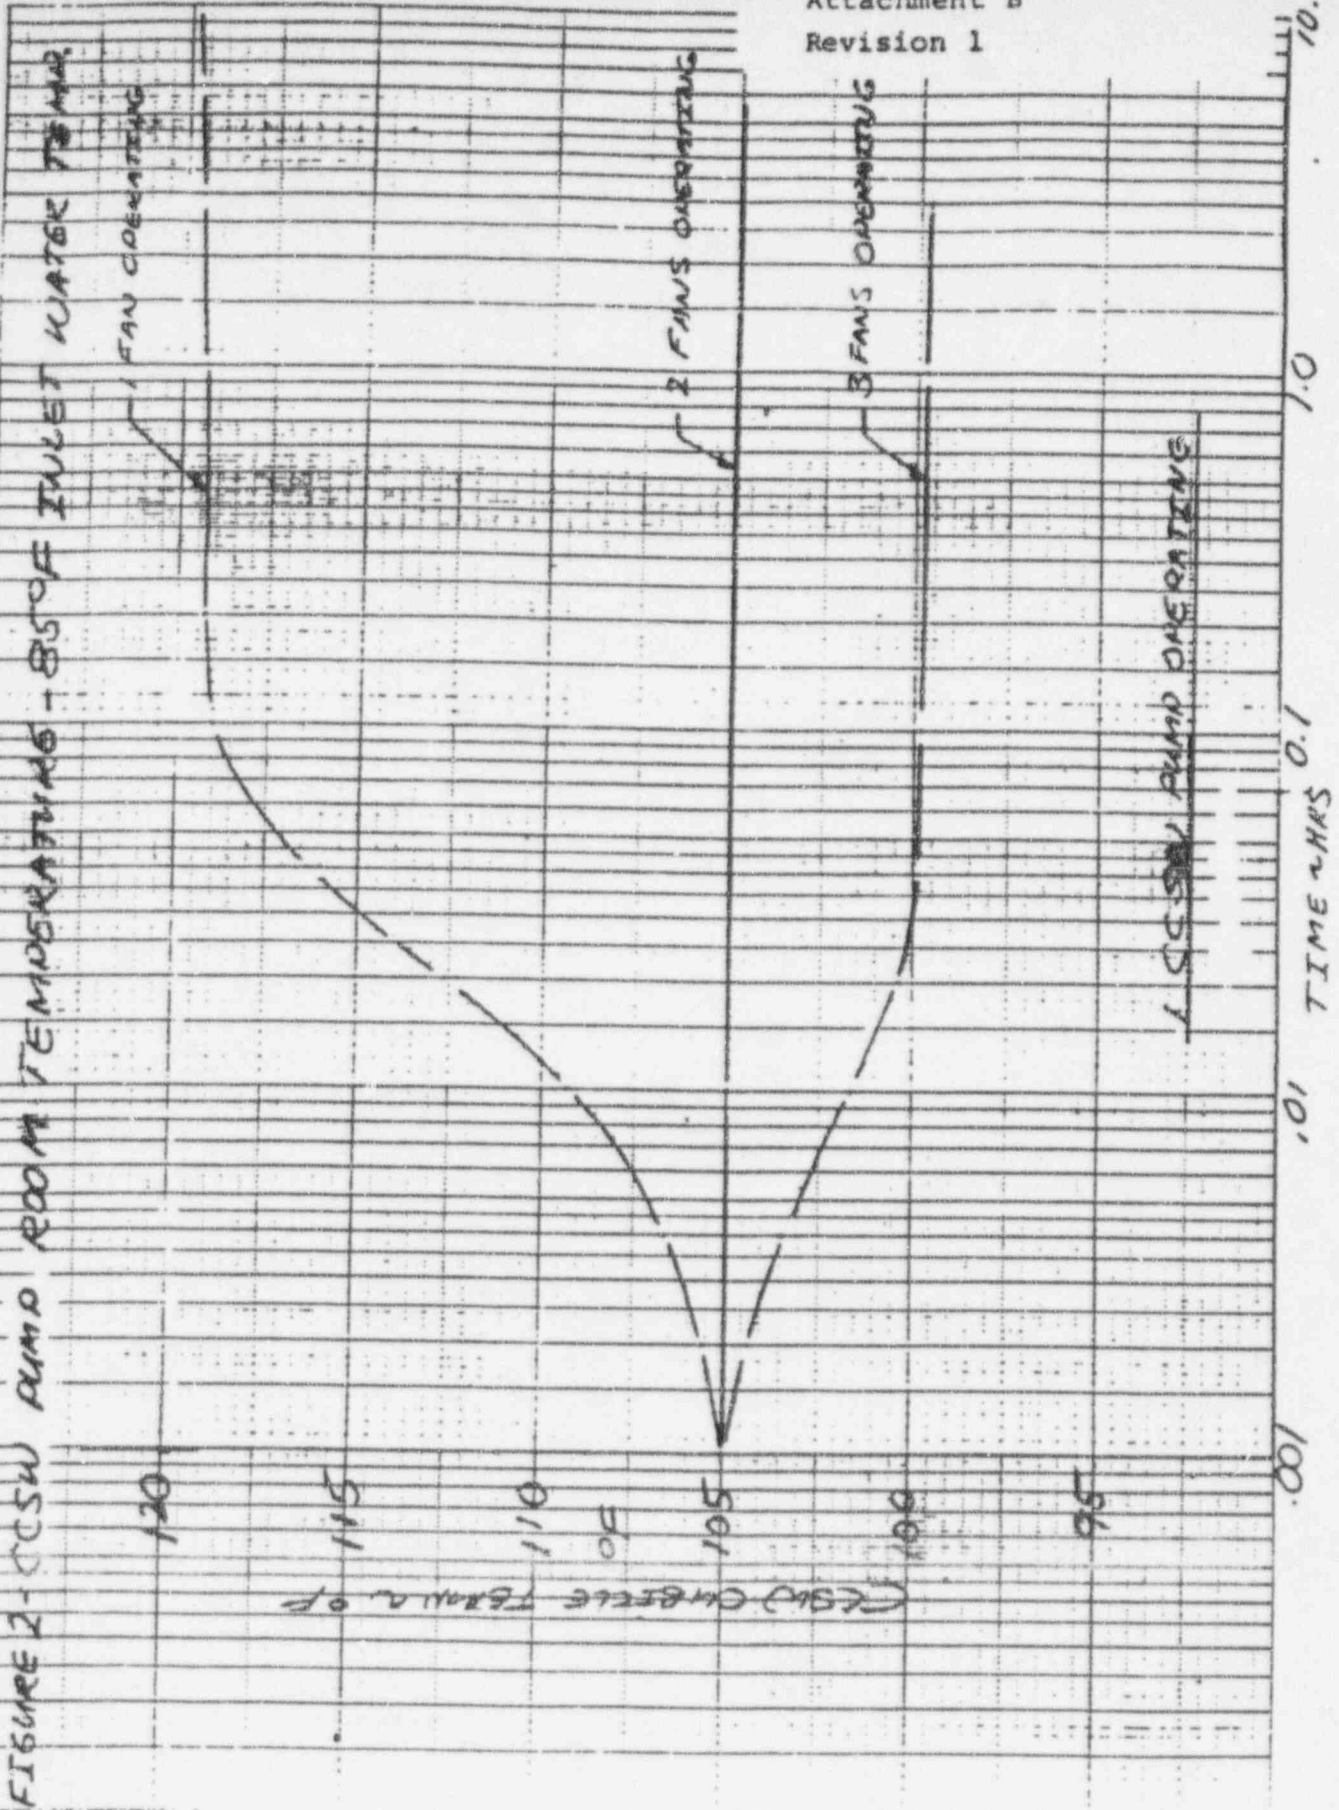
FIGURE 2 - CCSW PUMP ROOM TEMPERATURE - BS OF INLET WATER TEM

The 85°F inlet cooling water results are presented in Figure 2 and they indicate that the cubicle temperature will reach 120°F in approximately 10 hours with 1 fan operating. The heat removal rate in the 2 fan case balances the heat load in the room and the 3 fan case causes the cubicle temperature to decrease.

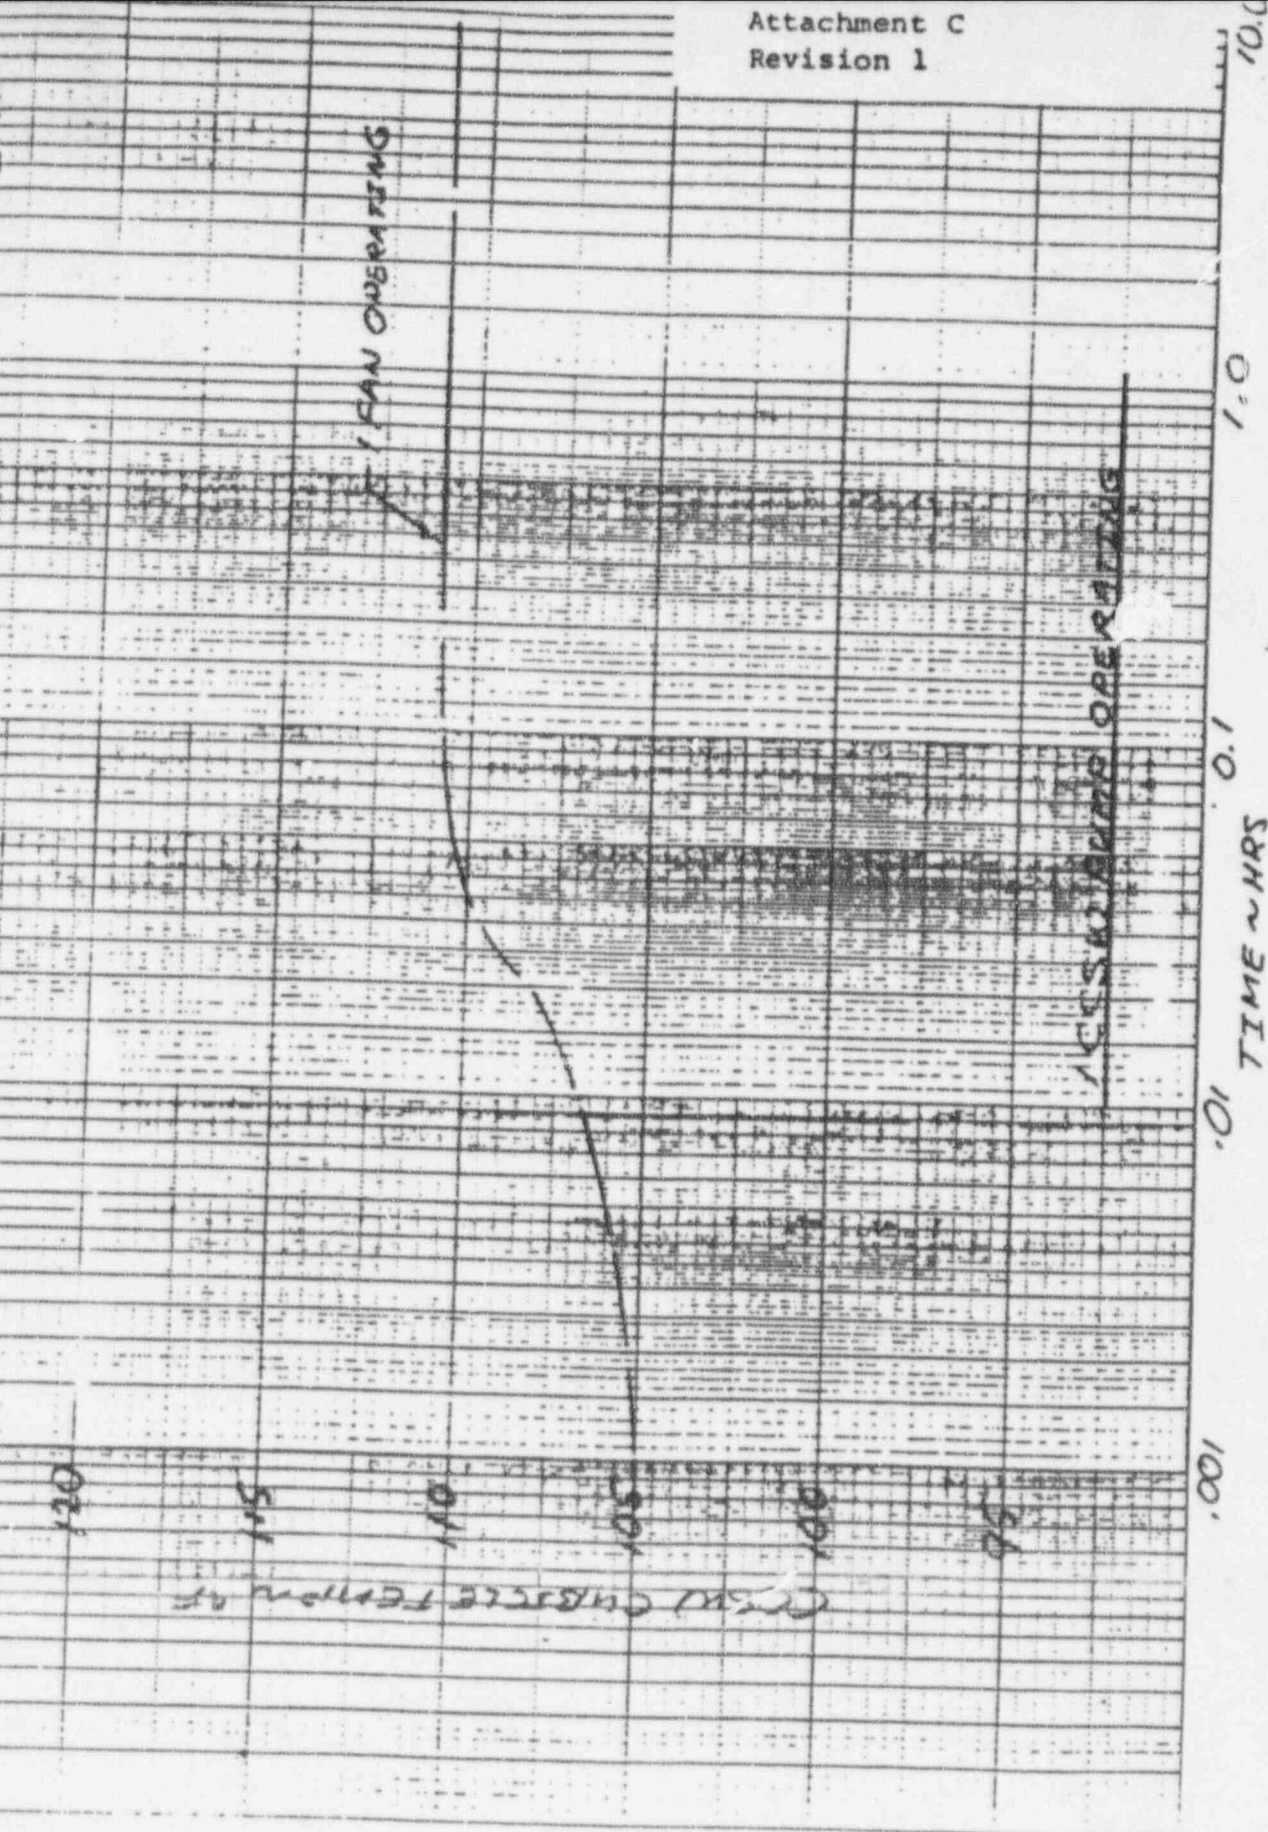
FIGURE 3 - CCSW PUMP ROOM TEMPERATURE - 75°F INLET WATER TEMP

Figure 3 presents the case of one fan operating with 75°F inlet water temperature. In this case, the CCSW temperature is approximately 112°F after 10 hours and is increasing slowly.

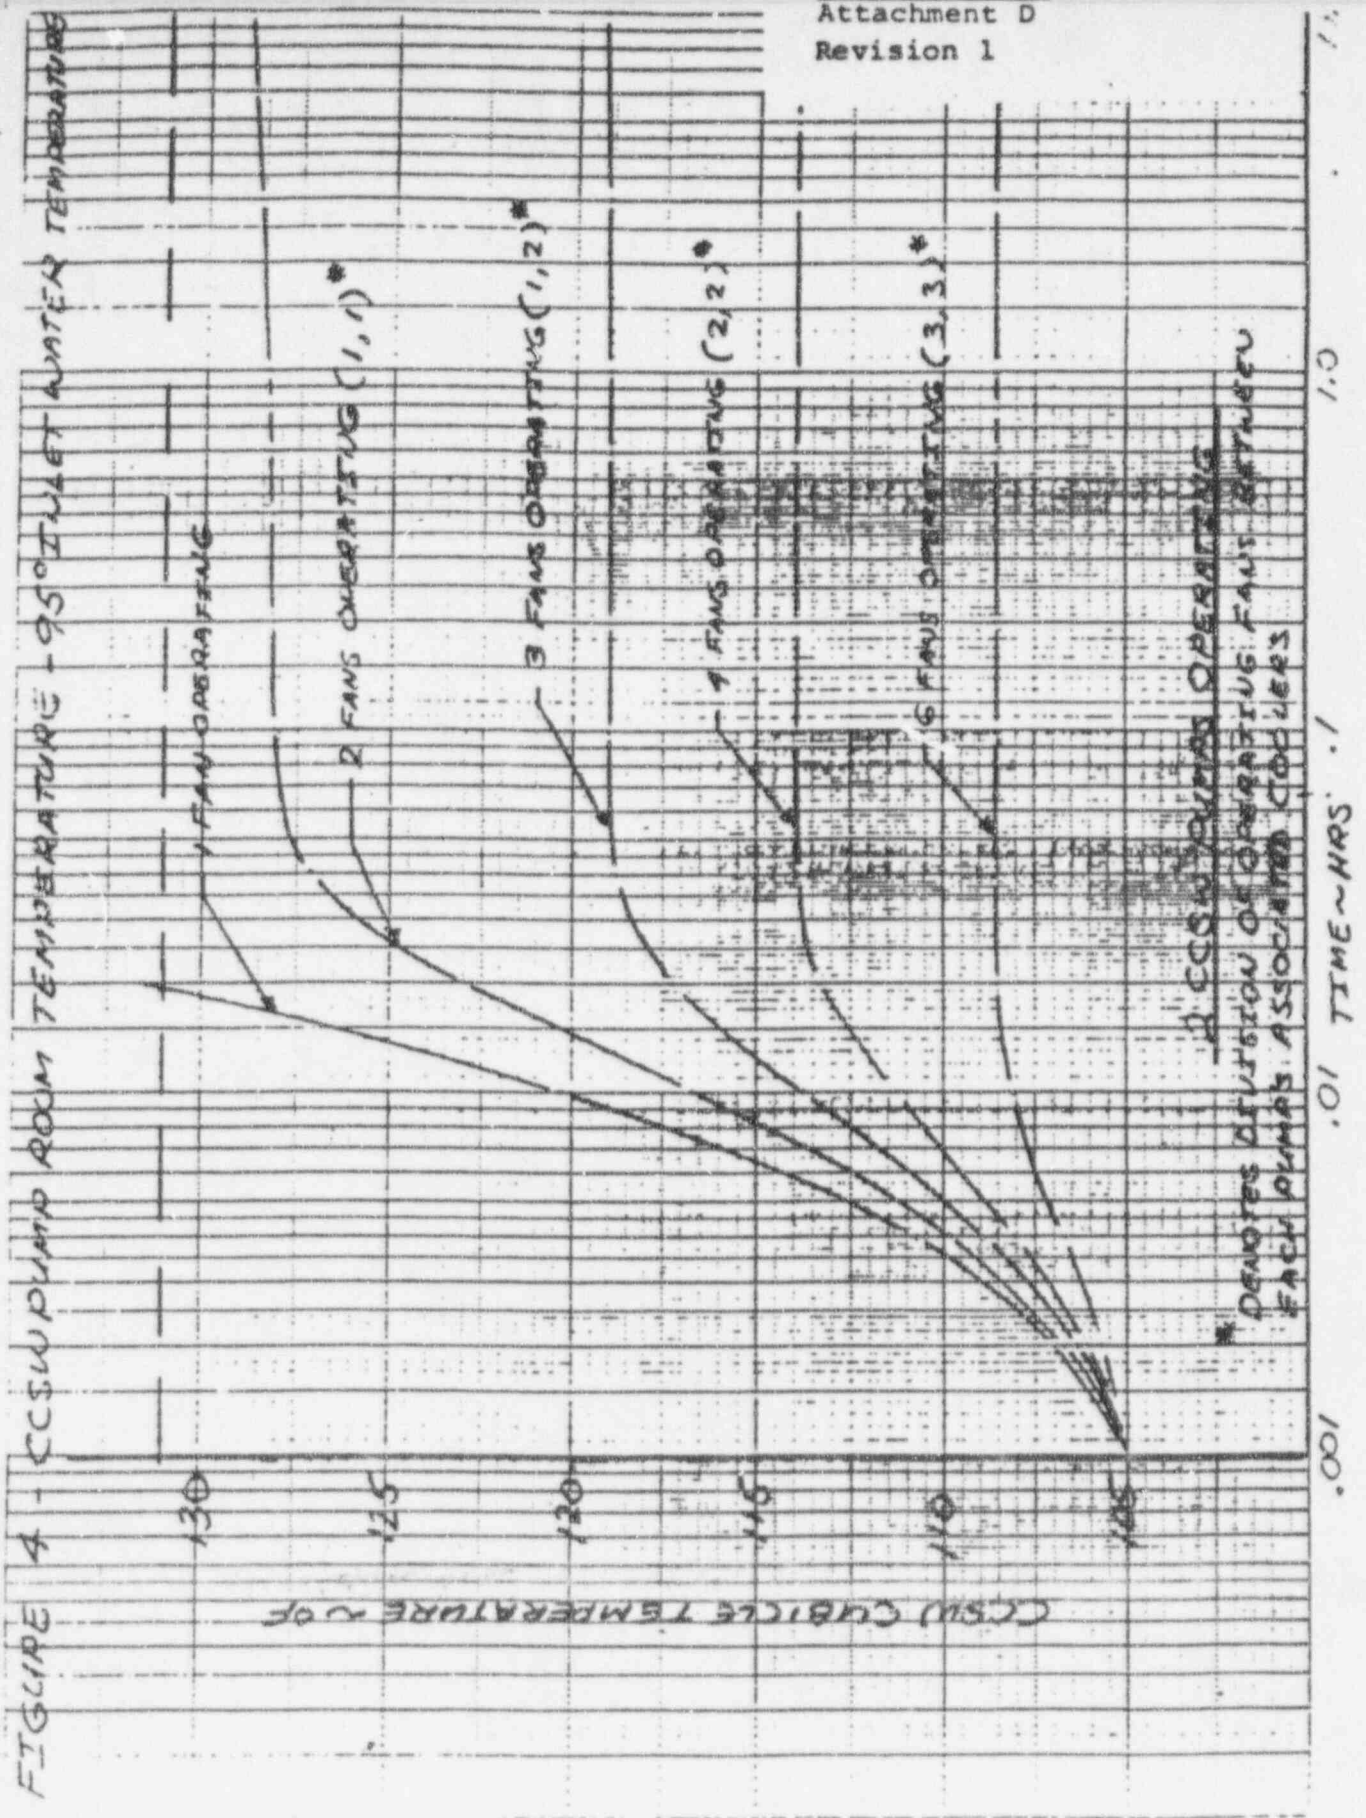
FIGURE 4 - CCSU PUMP ROOM TEMPERATURE - 95° INLET WATER TEMPERATURE

Figures 4, 5 and 6 present CCSW cubicle temperature transients for 95°F, 85°F and 75°F entering cooling water temperature with two CCSW pumps operating. Figure 4 presents five curves describing transient temperature as a function of time with 1, 2, 3, 4 or 6 fans operating. From this figure it is seen that the CCSW cubicle will reach a temperature of 131°F in less than 2 minutes when only 1 fan operates. When 2 fans operate, the temperature at 10 hours as shown in the figure is approximately 129°F. At 100 hours the additional temperature increase in the cubicle is less than 1 degree above the 10-hour value. For the condition of 3, 4 or 6

fans operating, the cubicle remains below 120°F for a 10-hour period and the temperature rate of increase after 10-hours is minimal.

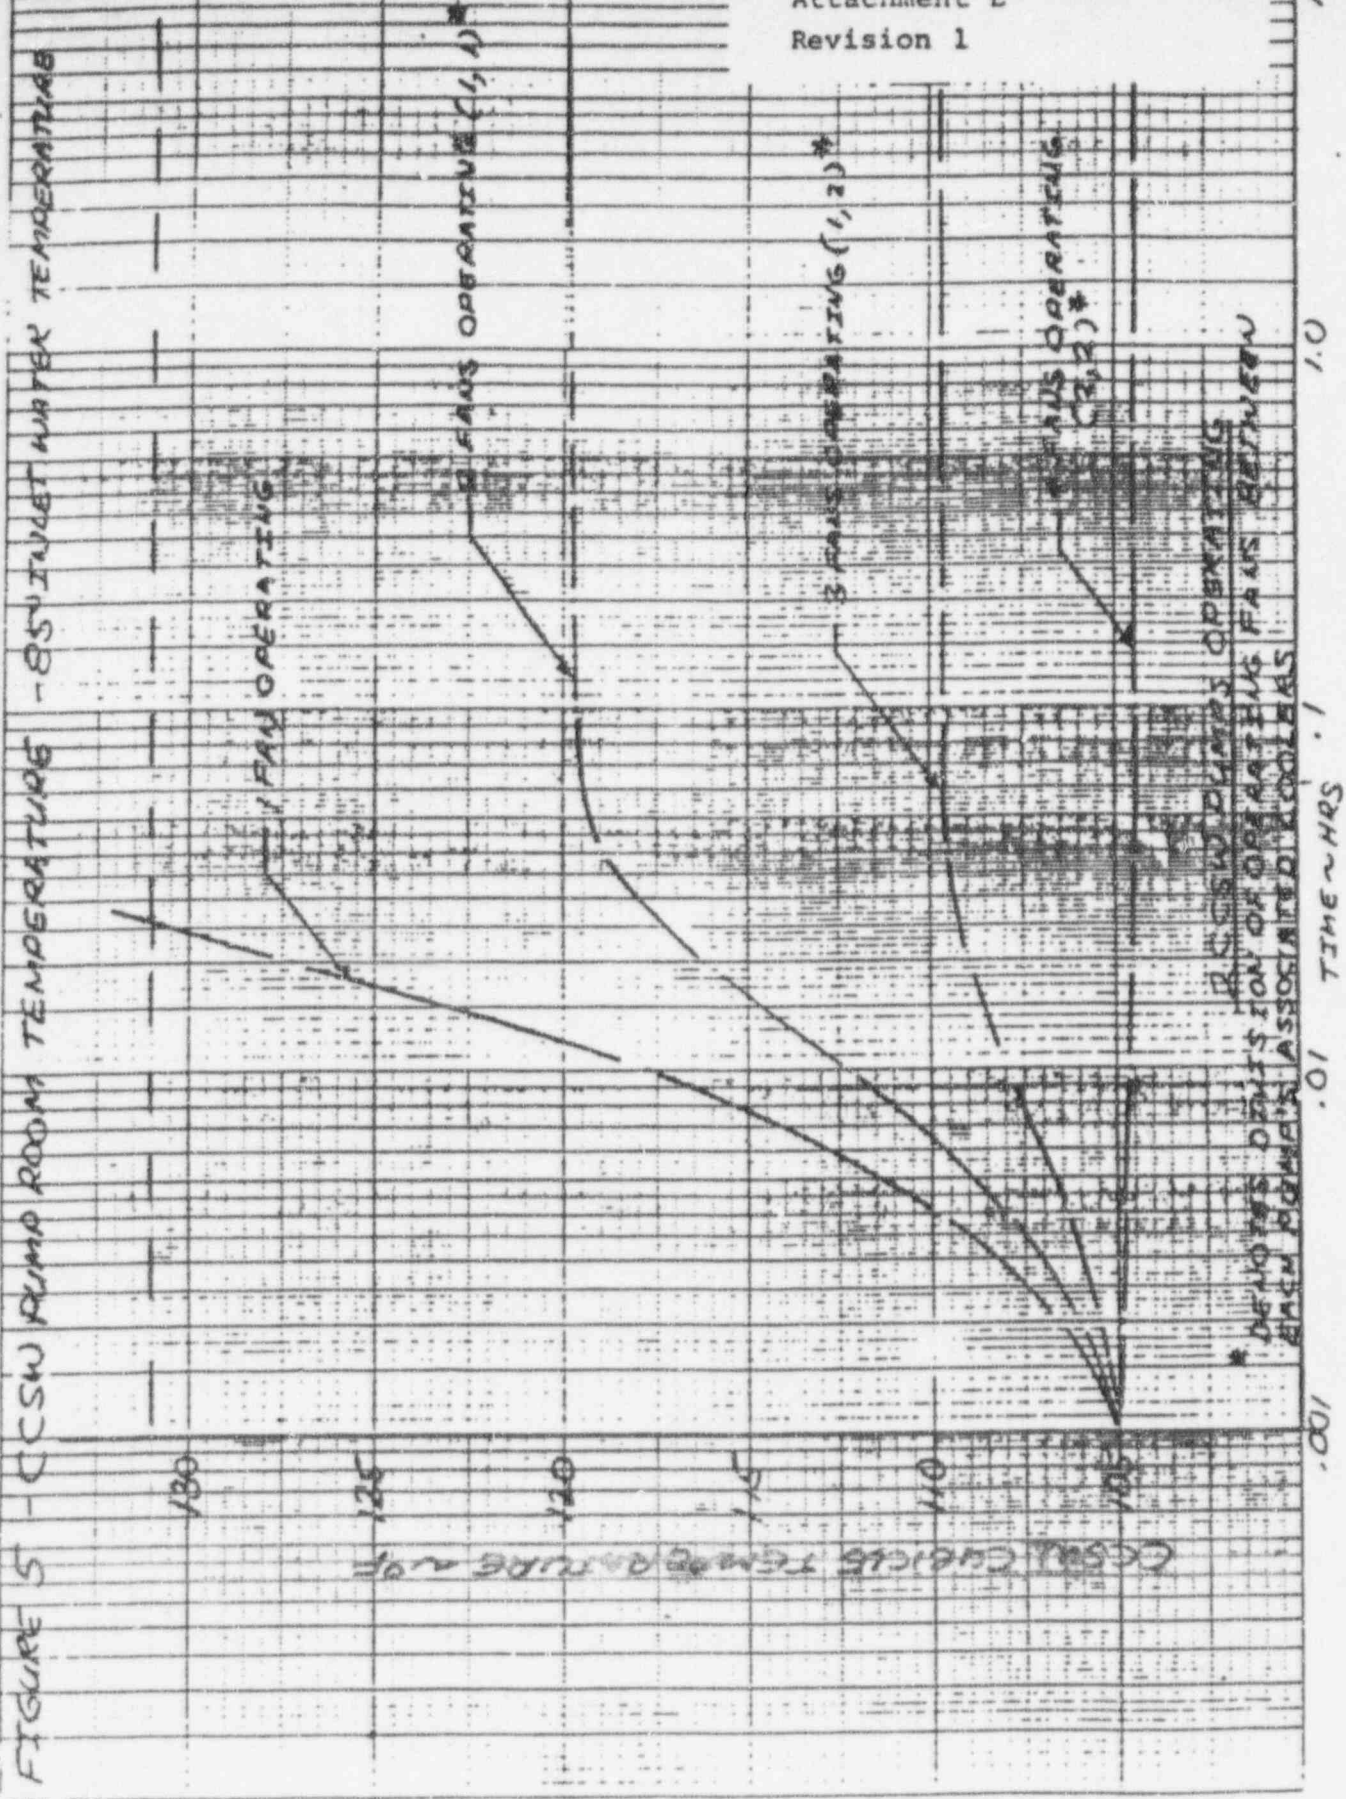
FIGURE 5 - CCSW RUMP ROOM TEMPERATURE - SS INLET WATER TEMPERATURE

The 85°F inlet water results are presented in Figure 5 and they indicate with only one fan operating the cubicle temperature will also exceed 131°F in less than 2 minutes. With 2 fans operating the cubicle temperature will reach 120°F in approximately 10 hours. With 3 fans operating, the cubicle temperature remains below 110°F. The heat removal rate slightly exceeds the heat load with 4 fans operating.

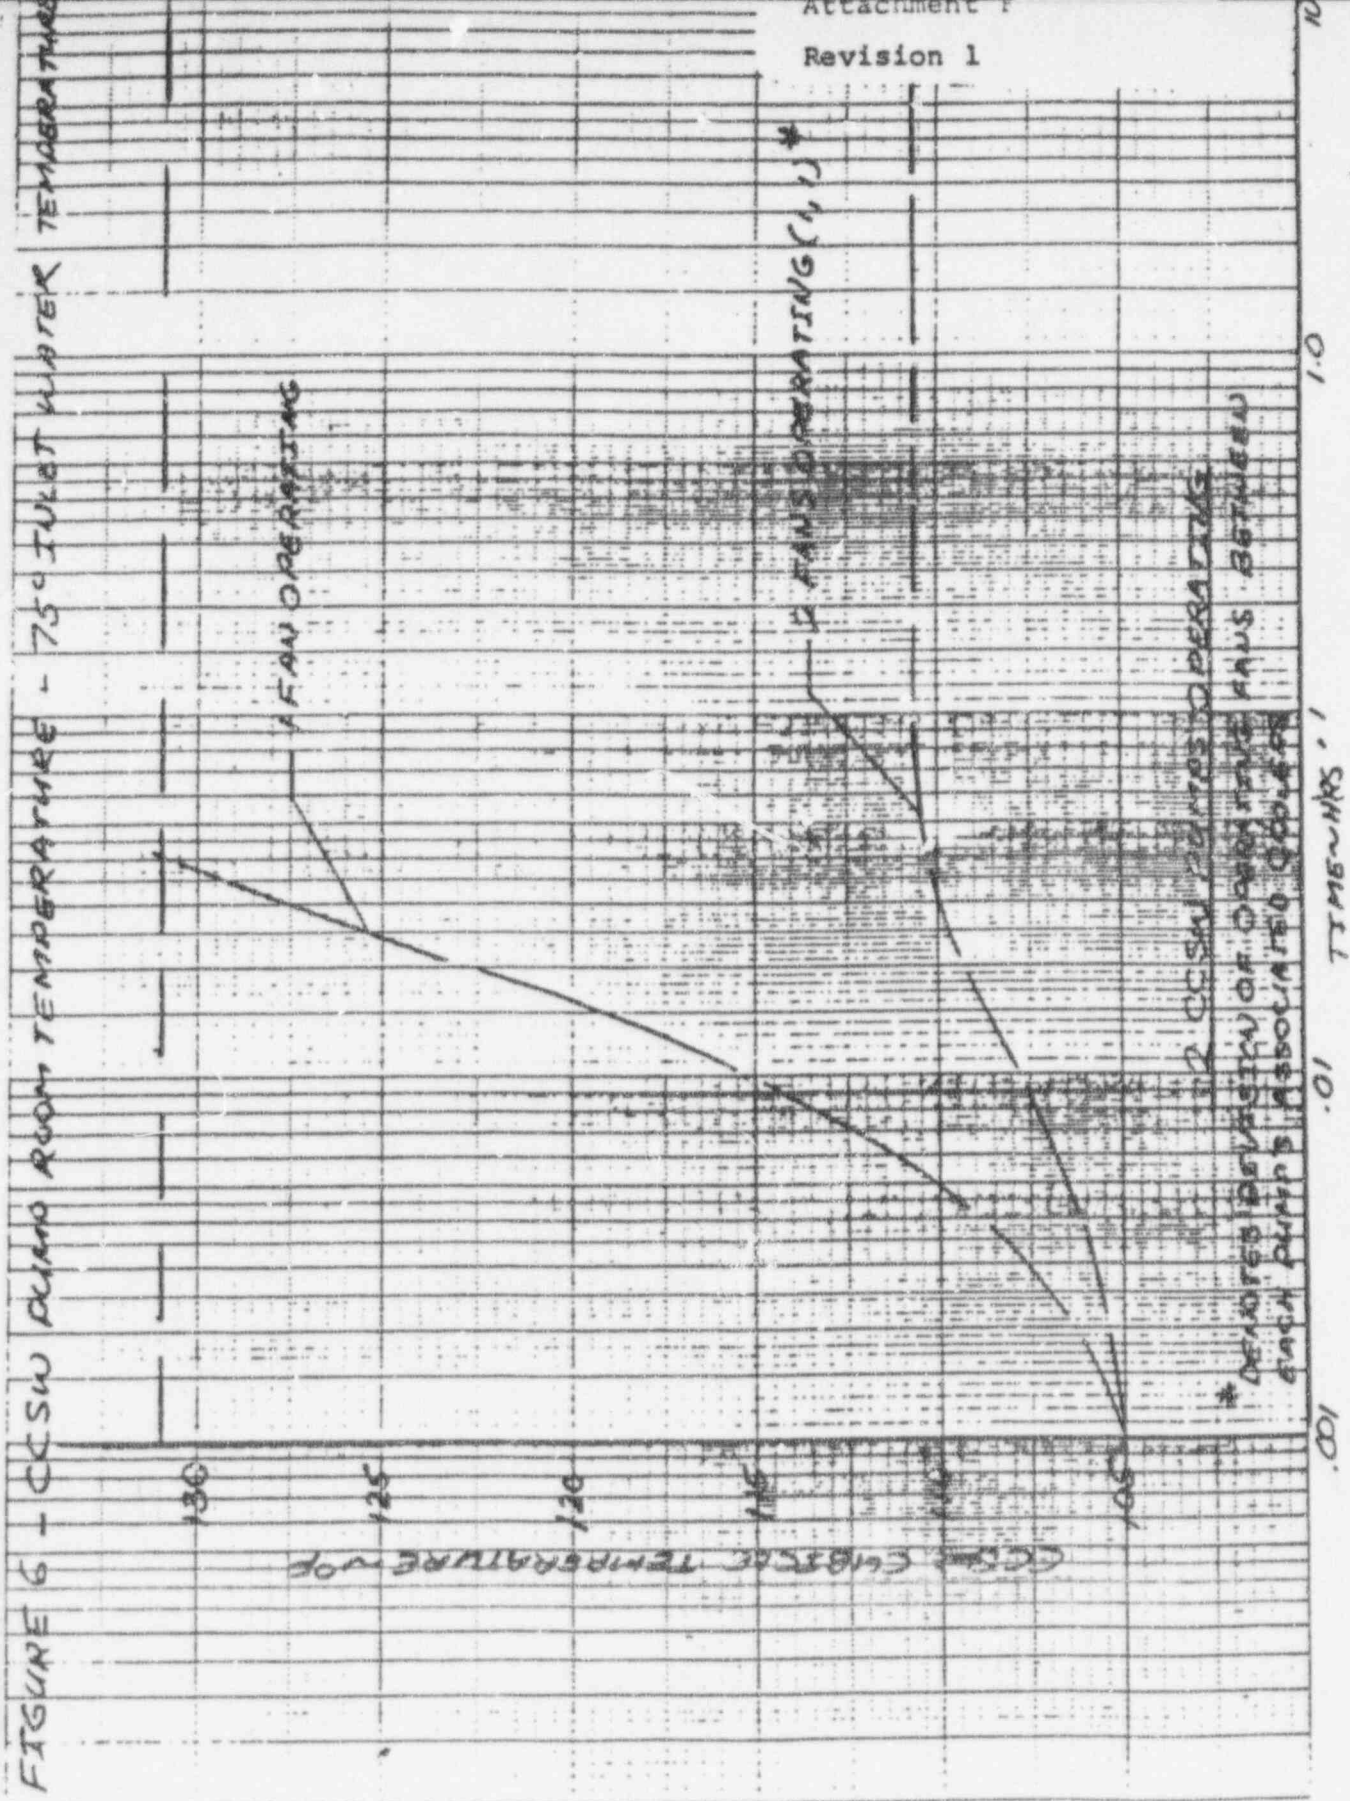
Figure 6 indicates that even with 75°F entering water temperature and 1 fan operating the qualification temperature for the CCSW pump motors is exceeded in less than 3 minutes. With 2 fans operating the temperature in the cubicle is less than 111°F after 10 hours.
