### LICENSEE EVENT REPORT

- I. LER NUMBER: LER/RO 83-21/01T-5
- II. LICENSEE NAME: Commonwealth Edison Company  
Quad Cities Nuclear Power Station
- III. FACILITY NAME: Unit Two
- IV. DOCKET NUMBER: 050-265
- V. EVENT DESCRIPTION:

LER/RO 83-21/01T  
 Quad-Cities Station  
 Indication Description & Repair

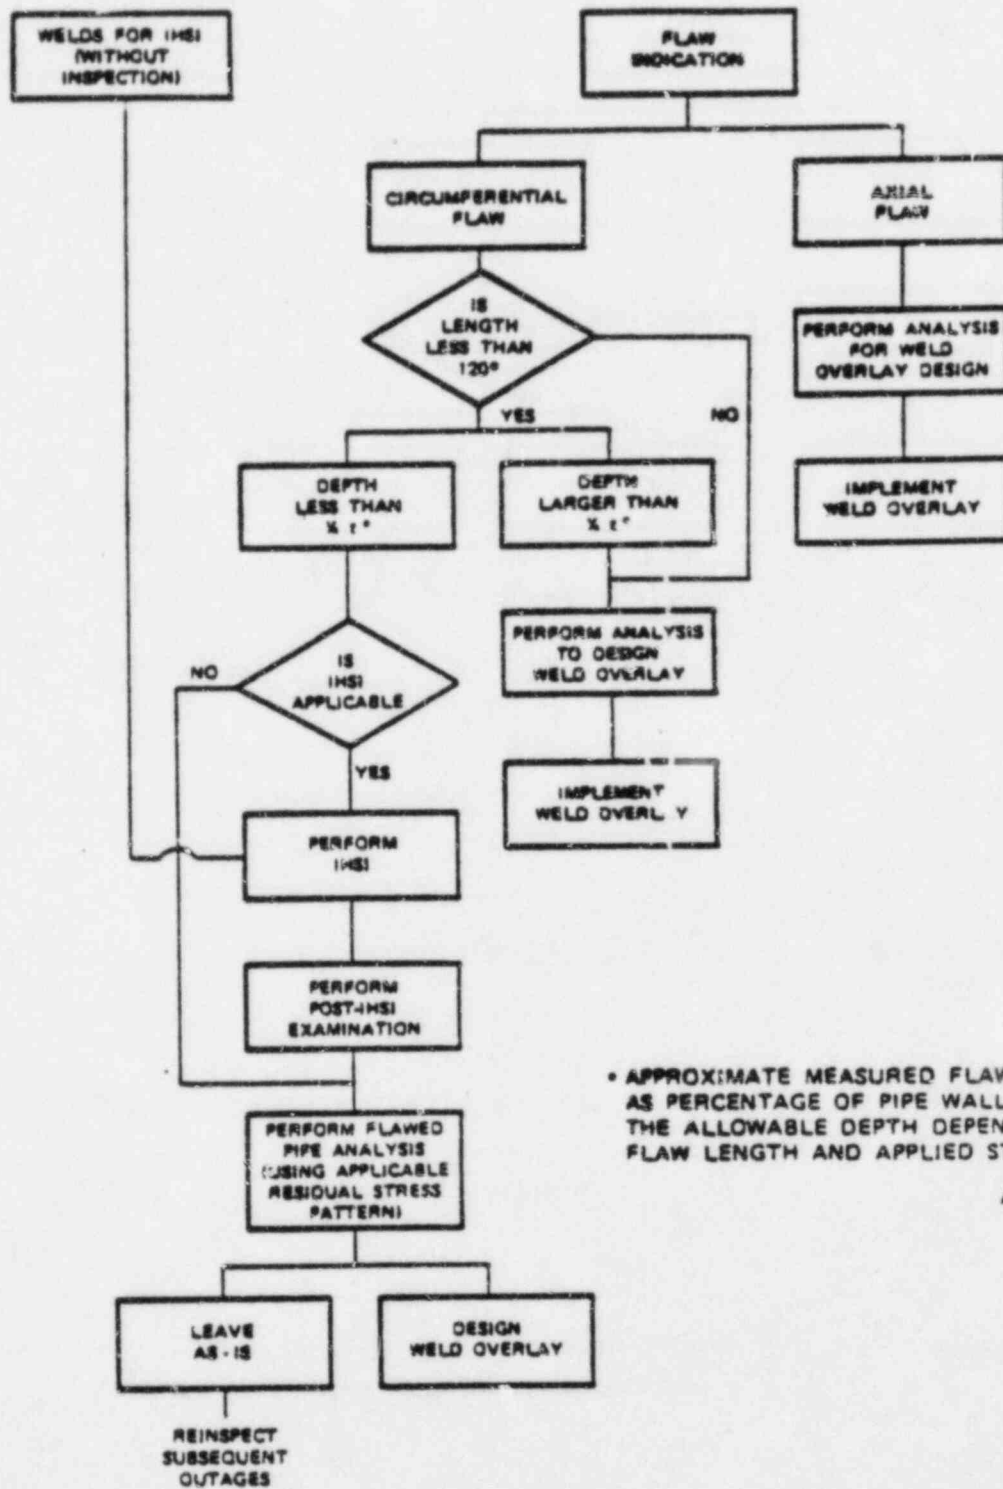
TYPICAL FLAW DISPOSITION SEQUENCE

\* APPROXIMATE MEASURED FLAW DEPTH AS PERCENTAGE OF PIPE WALL THICKNESS. THE ALLOWABLE DEPTH DEPENDS ON THE FLAW LENGTH AND APPLIED STRESS.

The crack indication evaluation and repair criteria determination was performed by NUTECH Engineers, Inc. Indications were evaluated based upon indication depth, length, direction, and applied stresses. Induction Heat Stress Improvement (IHSI) was performed on many welds, both with and without crack indications in order to reduce weld residual stress. As a general rule, circumferential indications with a length greater than 120 degrees of the pipe circumference and/or a depth of greater than 25% of the pipe wall thickness were repaired by applying a weld overlay. All axial indications were repaired by weld overlay. All analyses were performed to the guidelines specified in the ASME Boiler and Pressure Vessel Code, Section XI, Paragraph IWB-3640, "Acceptance Criteria for Austenitic Steel Piping." See Attachment 2 for a typical evaluation sequence.
