LER SUPPLEMENTAL INFORMATION

BFRO-50- 259 / 83066 RI Technical Specification Involved 3.10.A.1

TENNESSEE VALLEY AUTHORITY - BROWNS FERRY NUCLEAR PLANT UNIT 1 - DOCKET
NO. 50-259 - FACILITY OPERATING LICENSE DPR-33 - REPORTABLE OCCURRENCE
REPORT BFRO-50-259/E3C66 R1

The enclosed report provides followup information concerning interlock that prevents bridge travel over the core with one rod withdrawn and fuel grapple extended failed to operate. This report is submitted in accordance with Browns Ferry Unit 1 Technical Specification 6.7.2.b.(2).

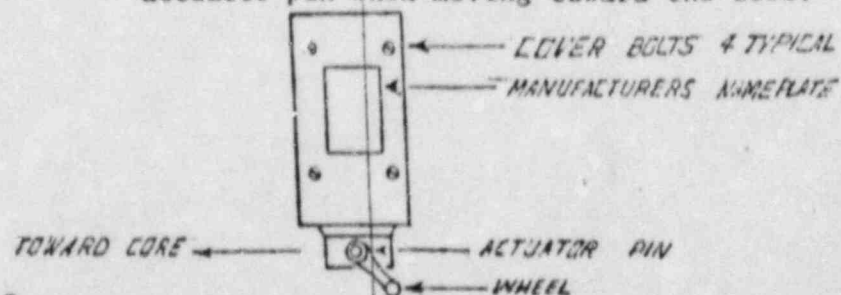
CAUTION: Verify that the refueling platform interlock limit switches actuate for both clock-wise and counter clock-wise operation. (If not, then adjust actuator to do so.)

Verify that the wheel on the actuator arm trails the actuator pin when moving toward the core.

Verify that the actuator arm is adjusted so that the contacts are in (1) the normal position when the cam is not under the limit switch and (2) the non-normal position when the cam is under the switch.

Prior to the performance of any further steps, verify that refuel floor maintenance electricians have checked the refueling platform interlock limit switches for condition and tightness of set screw on the actuating arm of both limit switches.
