Subject: Three Mile Island Nuclear Station, Unit 1 (TMI-1)  
Operating License No. DPR-50  
Docket No. 50-289  
Additional Information in Response to Generic Letter (GL) 95-03  
"Circumferential Cracking of Steam Generator Tubes"

GPU Nuclear Response to Generic Letter 95-03 Request for Additional Information

Three Mile Island Nuclear Station, Unit 1 (TMI-1)  
Operating License No. DPR-50  
Docket No. 50-289

Additional Information in Response to NRC Generic Letter 95-03

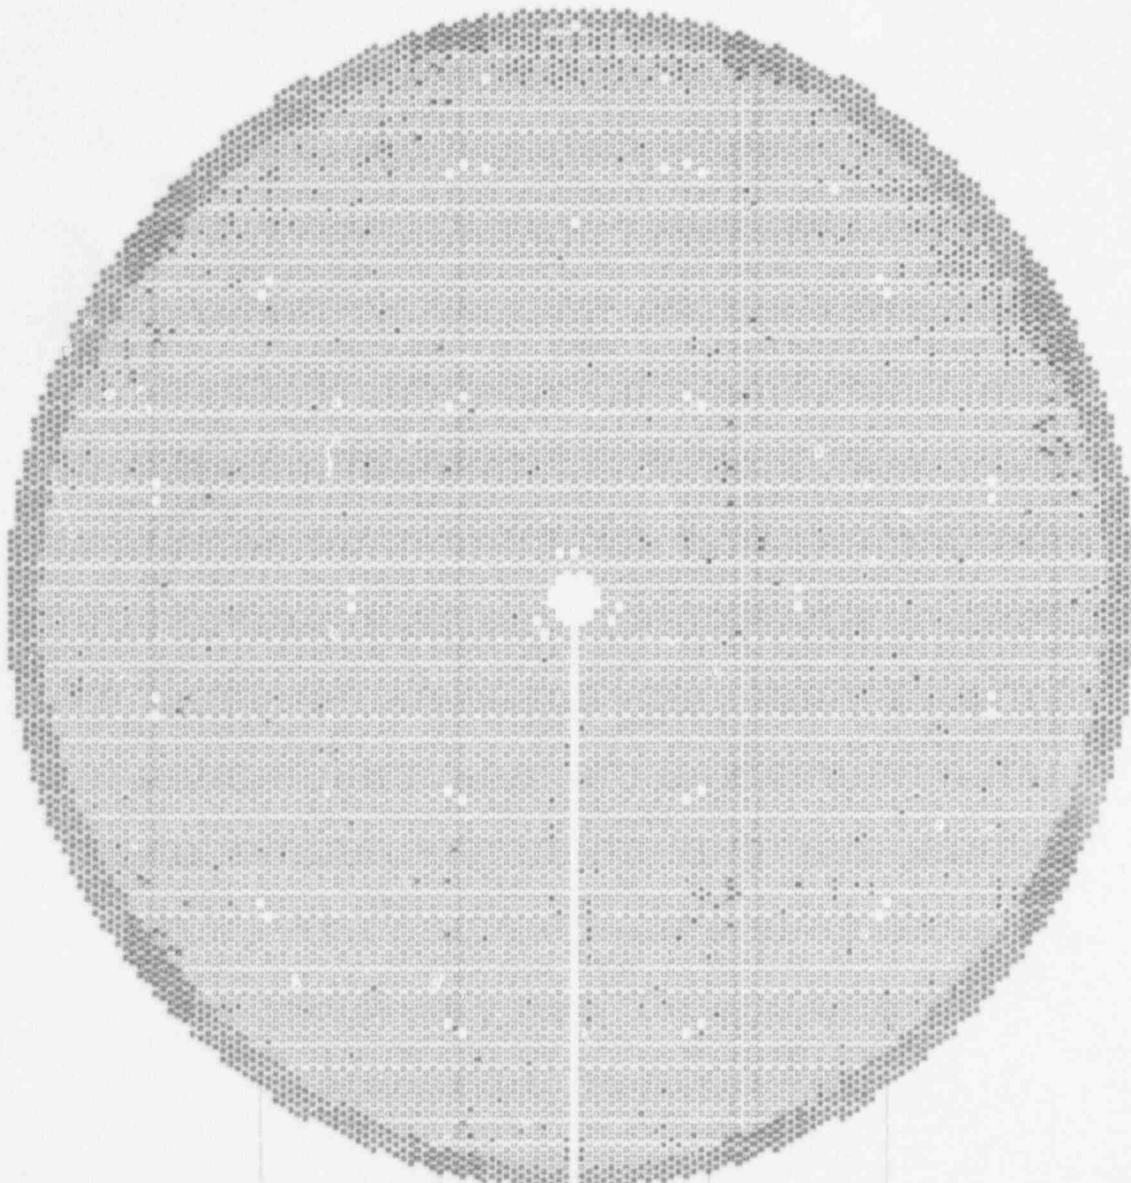
FIGURE 1

The outer tube locations in the 15th tube support plate (TSP) at all units are drilled to a .637" minimum / .646" maximum diameter. Approximately 1621 locations are typically drilled. At TMI-1 1626 locations are drilled in the 15th TSP as shown on Figure 1. All remaining locations at this support plate, and all locations at the other support plates, are broached as described in the GL 95-03 response.

As stated above in response to question #1, at TMI-1 all support plate holes are broached except for 1626 holes in the peripheral holes of the 15th TSP where the holes have been drilled only (See Figure 1).

1826: locations where 15th tep is drilled

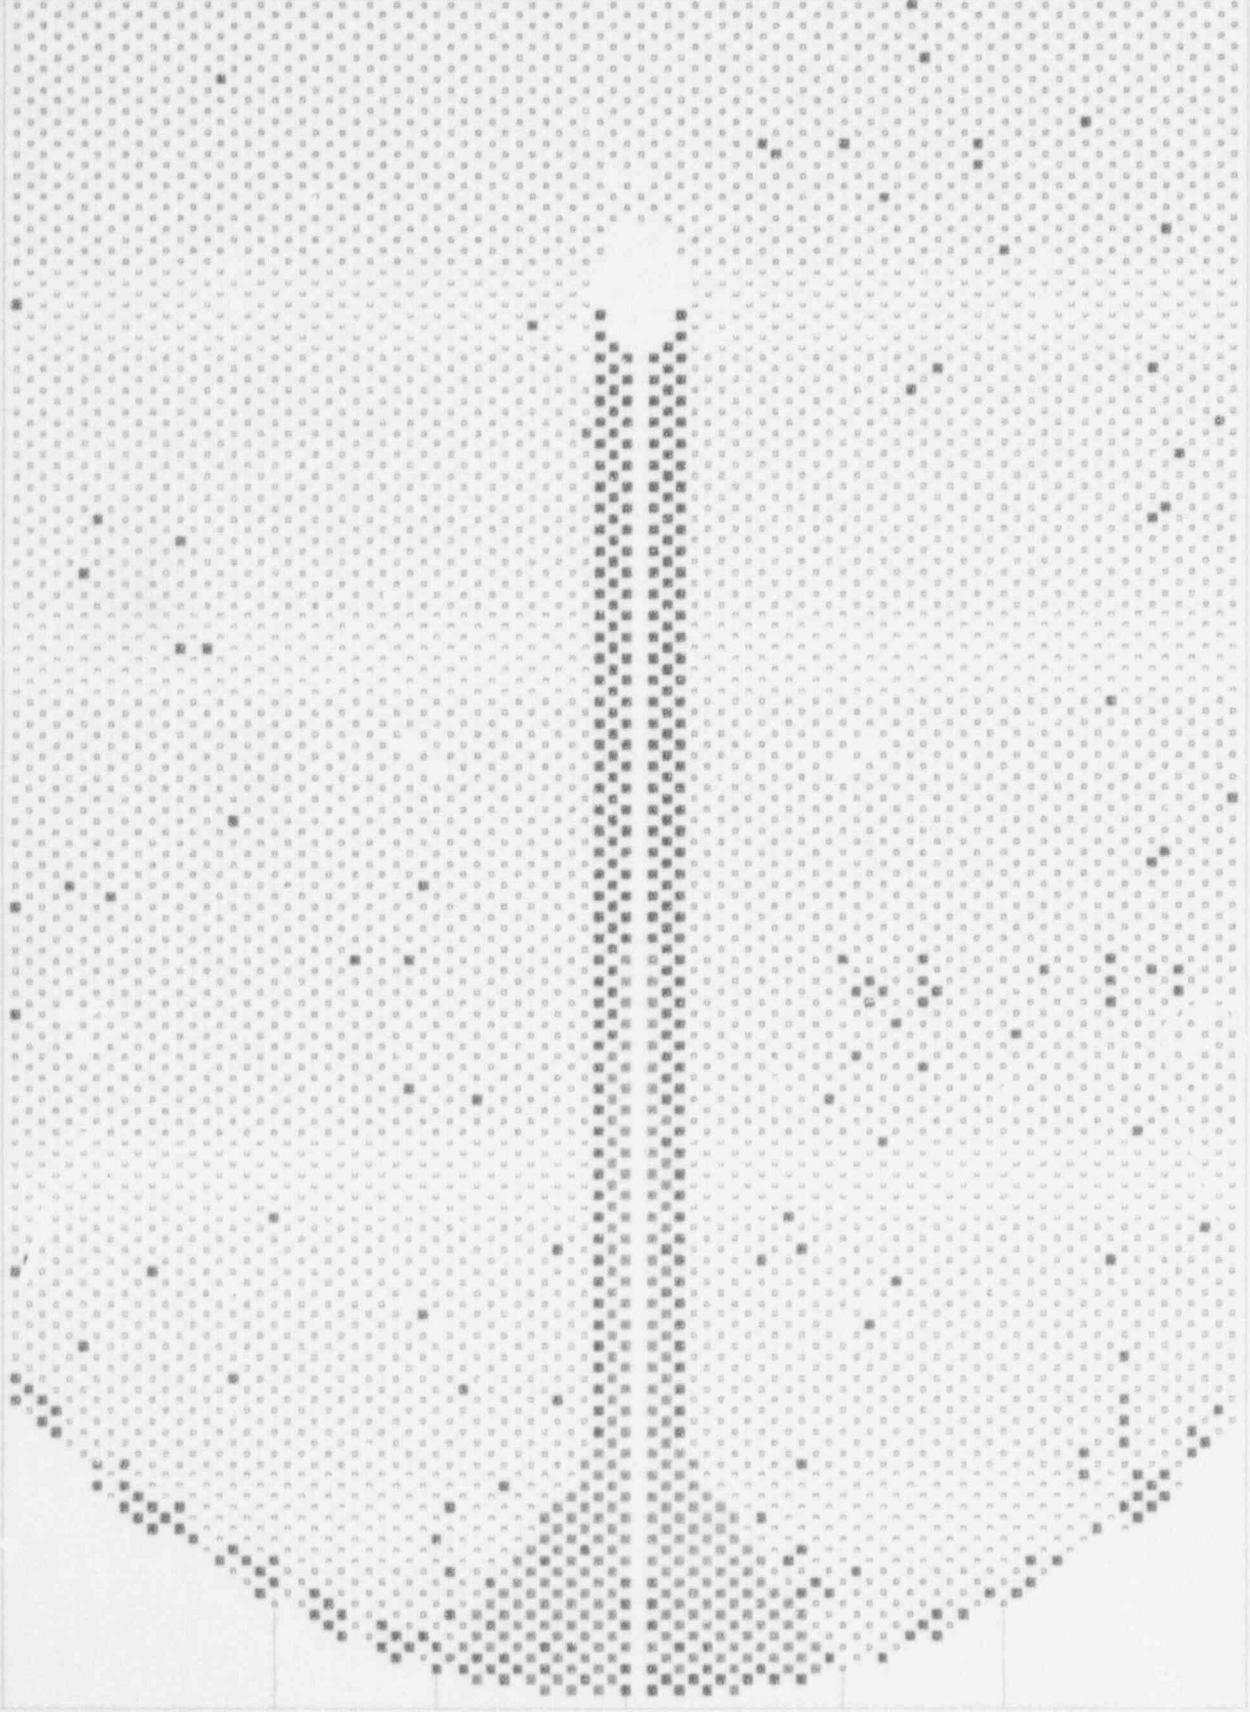
FIGURE 2A

Tubes along the inspection lane, including an area that fans out at the periphery, are referred to as the lane/wedge region. TMI-1 Tech Spec §4.19.2.a.4(1) defines a group of tubes in the lane/wedge region as "Group A-1," which, along with another group of tubes, may be excluded from the first random sample if all tubes in that group in both steam generators are inspected. Group A-1 is sometimes referred to as the "Tech Spec defined lane/wedge." Un-sleeved tubes in the TMI-1 Tech Spec defined lane/wedge areas of OTSG "A" and "B" are shown in red on Figures 2A and 2B respectively.

The "TMI-1 defined repair lane/wedge" is a region where engineering analysis and OTSG history review has determined that high cycle fatigue cracking is most likely to occur. All in service tubes in the "TMI-1 defined repair lane/wedge" have been sleeved. These tubes are shown in green on Figures 2A and 2B respectively.

216: unsleeved inspection lane/wedge  
 248: sleeved tubes inservice  
 228: currently plugged tubes

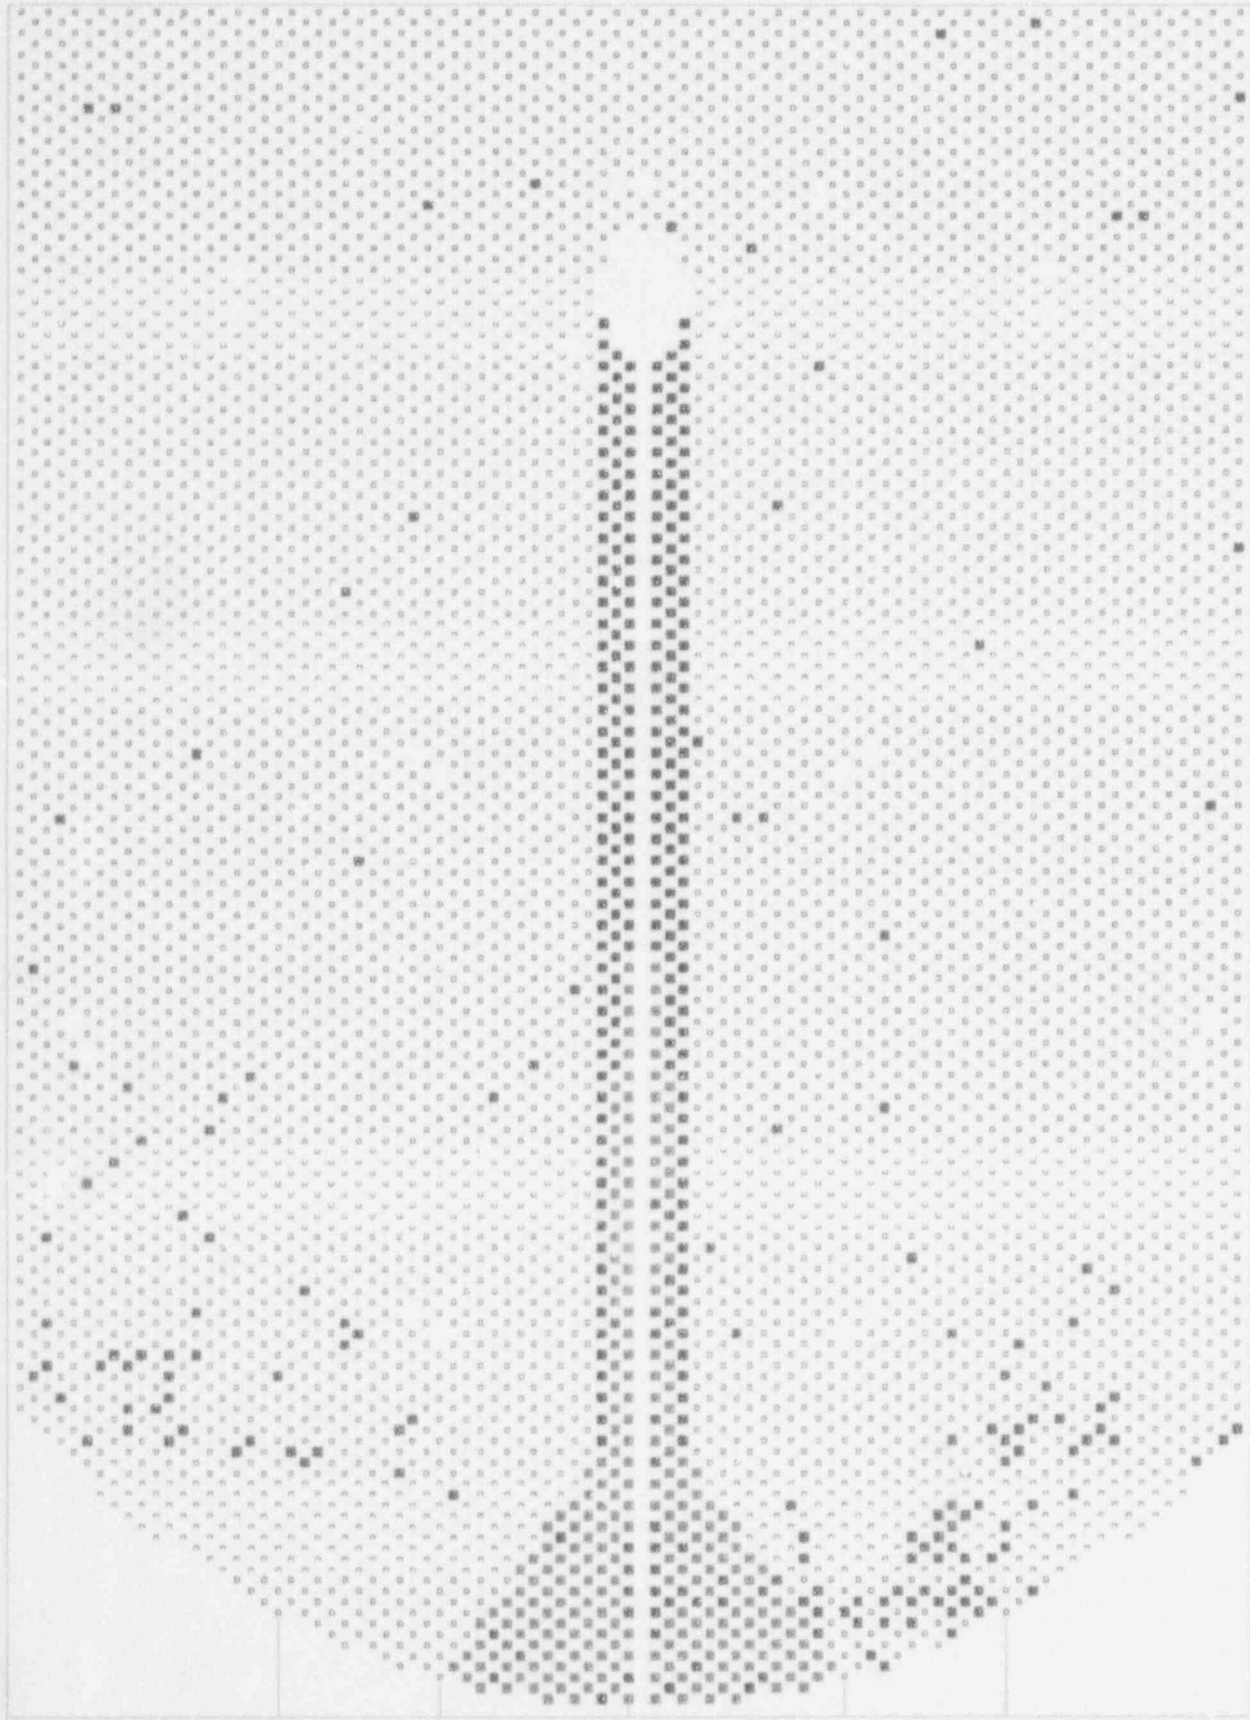
FIGURE 2B

217: unsleeved inspection lane/wedge tubes

253: sleeved tubes in service

197: currently plugged tubes

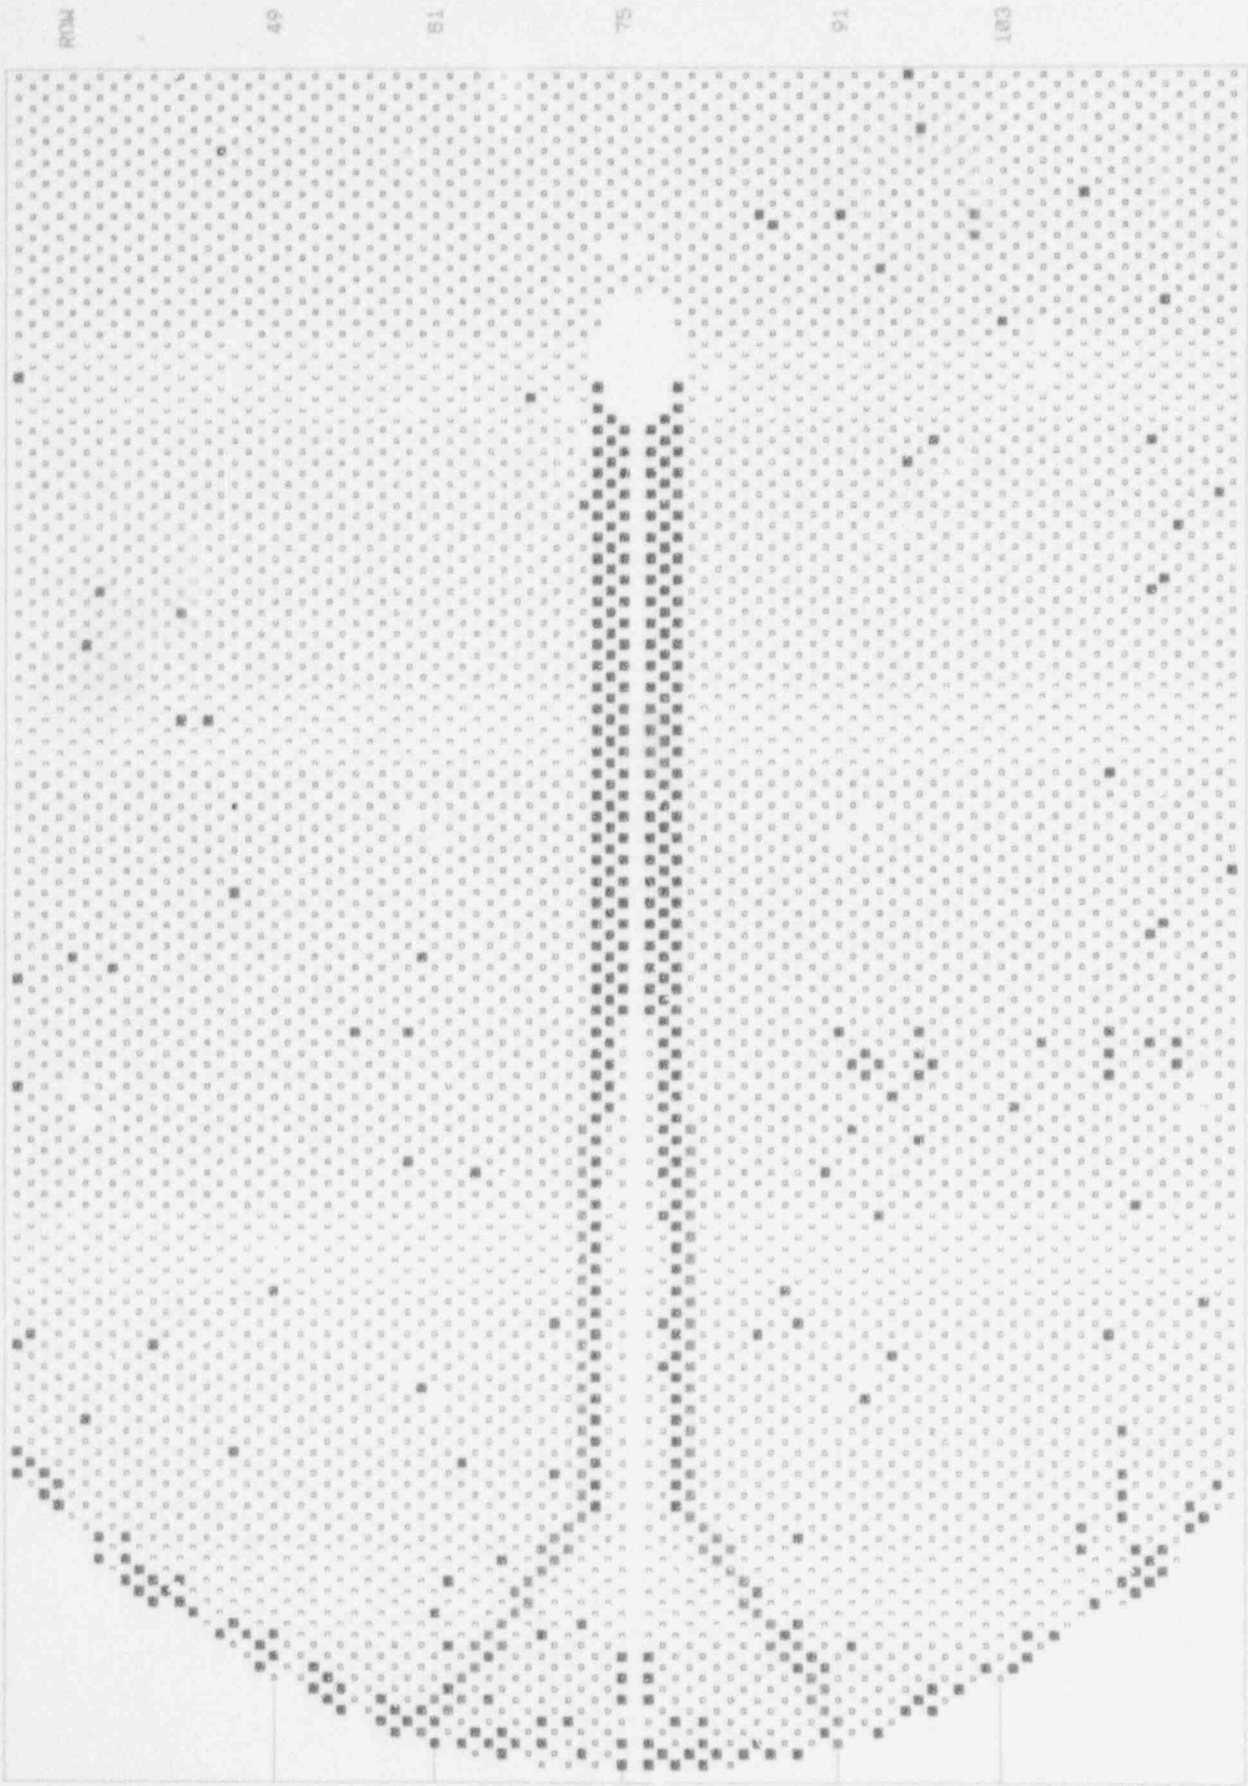
FIGURE 3A

Figures 3A and 3B show the 589 tubes where 3-coil MRPC examination of the kinetic expansion was performed during 11R. These tubes were chosen because they should be the first to exhibit high cycle fatigue cracking based on highest main steam cross flows and proximity to the previous historical OTSG high cycle fatigue failure locations.

Figures 3A and 3B show the lane/wedge tubes which were examined with the 3-coil MRPC technique during 11R. The 3-coil head contained 0.115" pancake, axial and circumferentially wound coils.

216: lane/wedge tubes examined with arpc  
 77: sleeve border tubes examined with arpc  
 220: currently plugged tubes

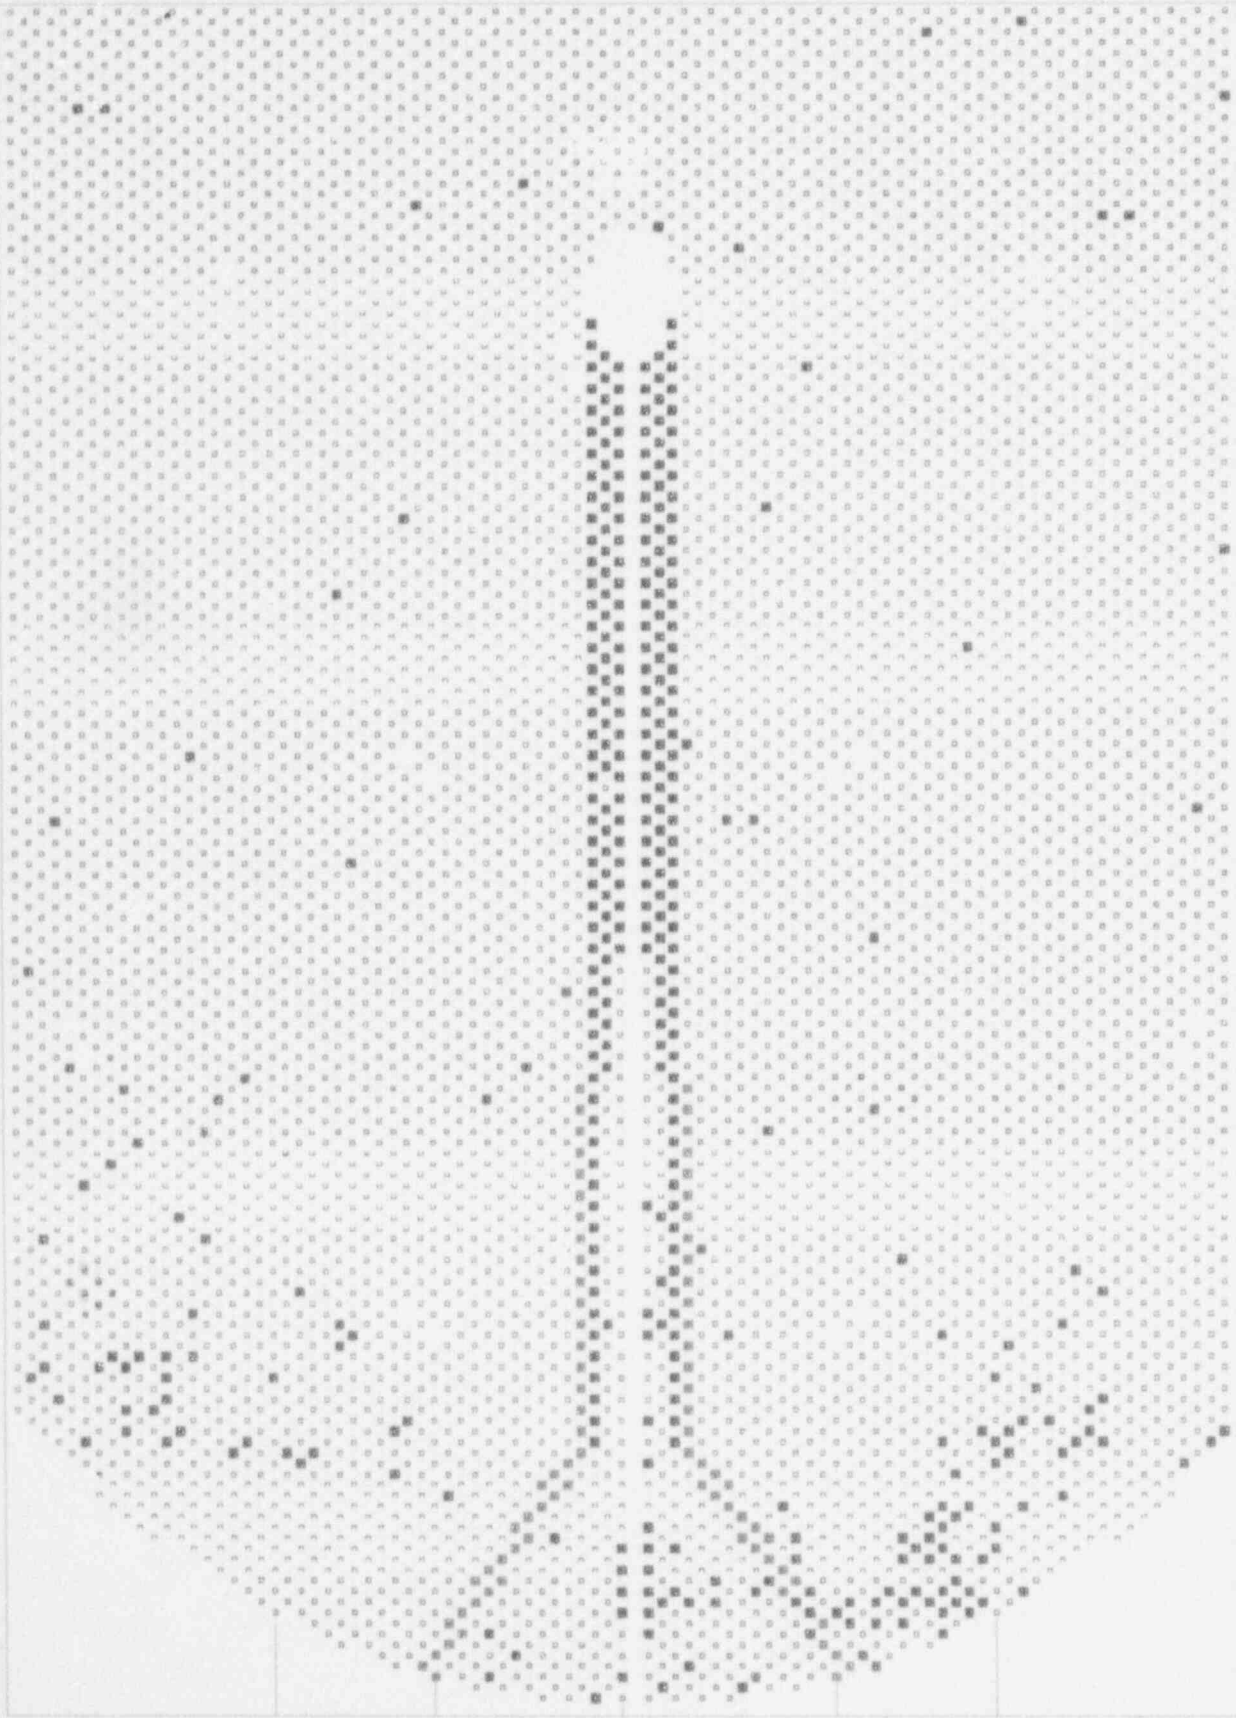
FIGURE 3B

217: lane/wedge tubes examined with mrpc

79: sleeve border tubes examined with mrpc

197: currently plugged tubes
