In the Matter of)
)
METROPOLITAN EDISON COMPANY, ET AL.) Docket No. 50-289-OLA
) (Steam Generator Repair)
(Three Mile Island Nuclear Station,)
Unit No. 1))

AFFIDAVIT OF F. SCOTT GIACOBBE

TMI-1 OTSG REPAIRS

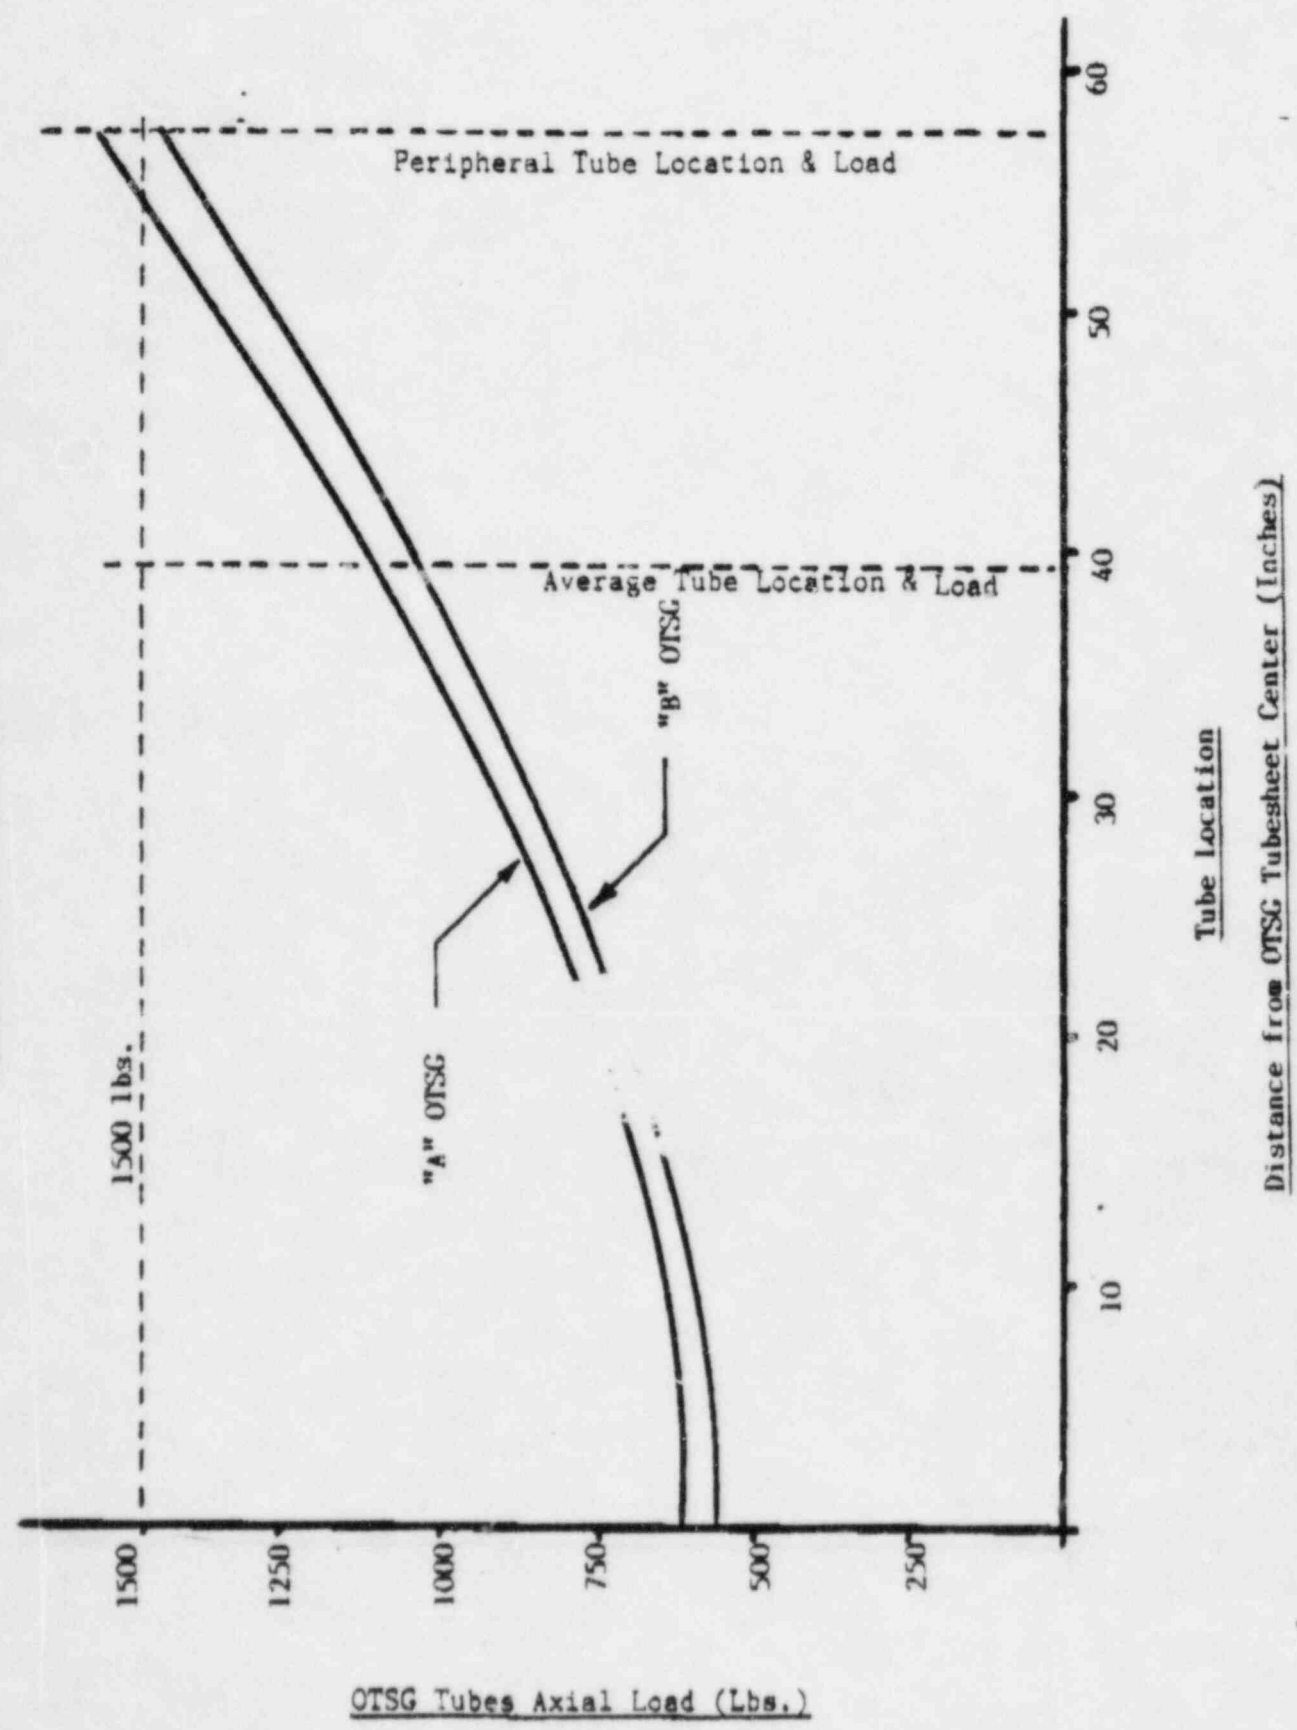
Figure 1 - TMI-1 OTSG Testing 3rd Cooldown (10-2-83)

Tube Load Distribution as a Function of Tube Location
at the Peak Applied Load for "A" and "B" OTSGs

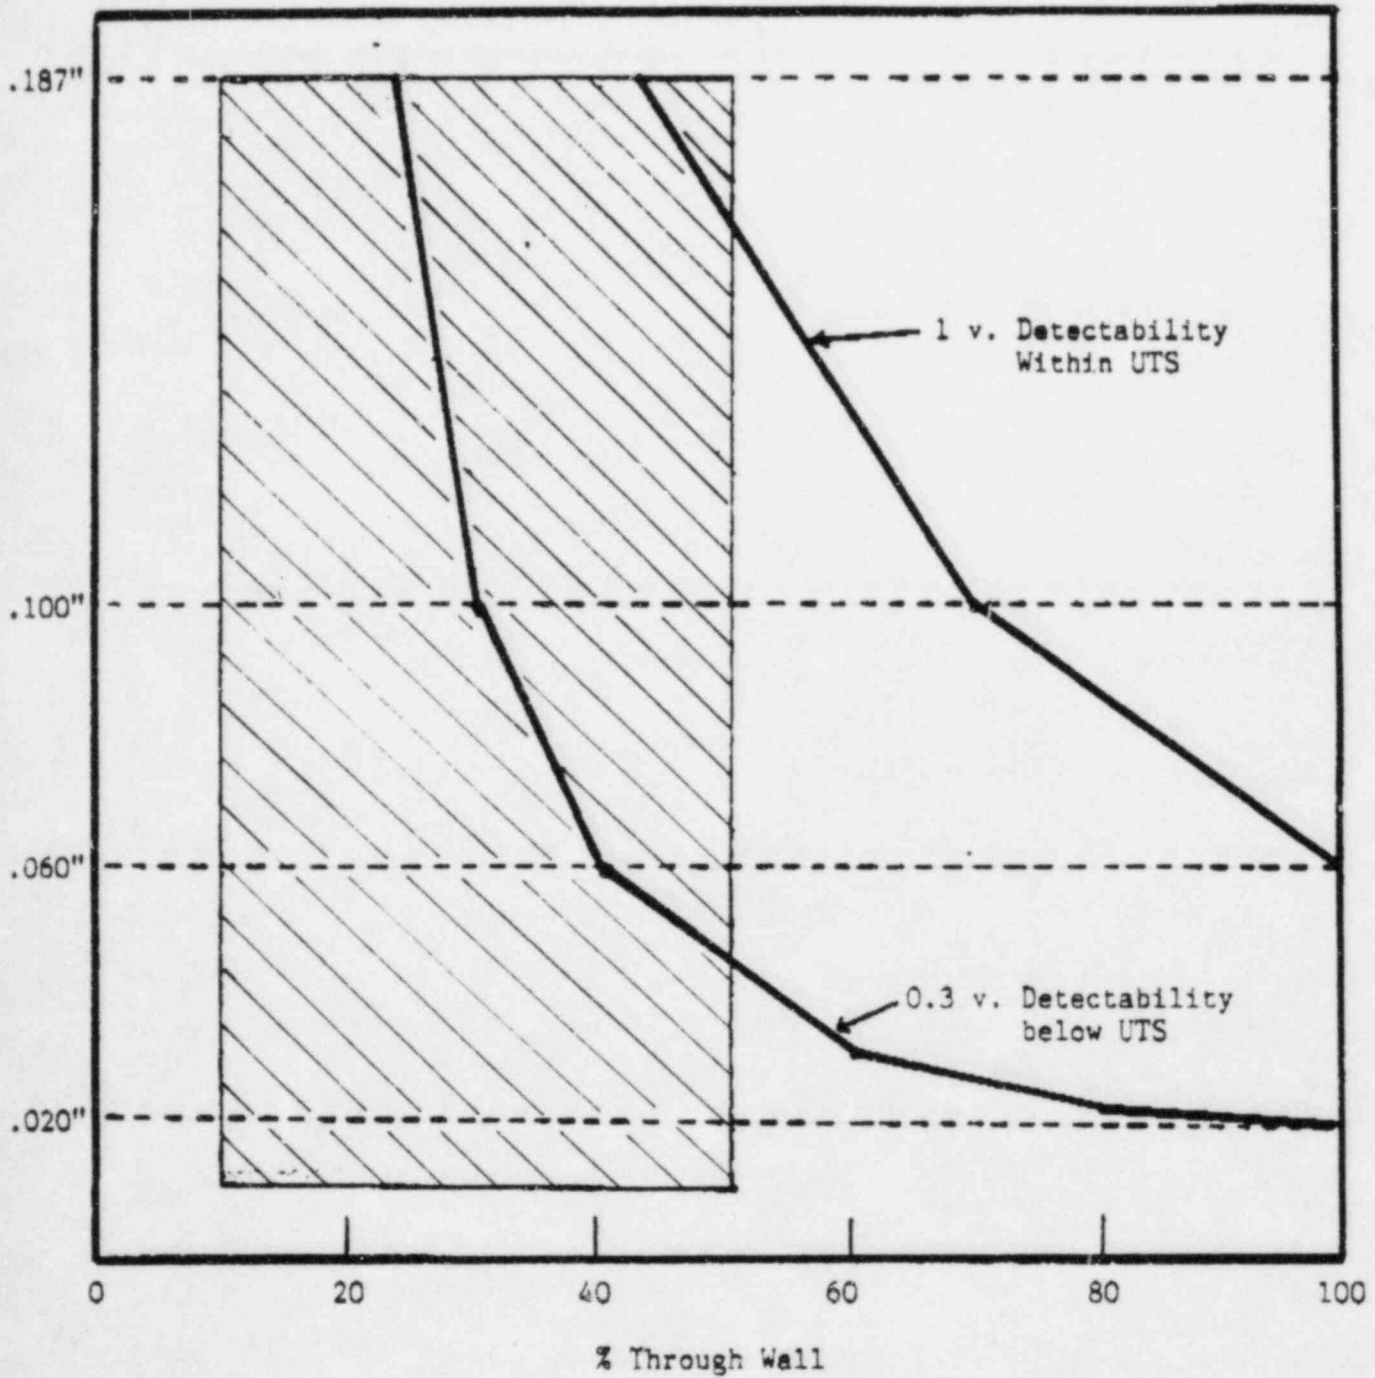
Figure 2 - 1984 Eddy Current Data
Compared to Detectability Limits

Statistical analysis of the eddy current data reveals that 90% of the observed indications fall between 10% and 50% through wall penetration, and between .020" and .190" long.

90% of 1984 Indications
Lie Within This Area

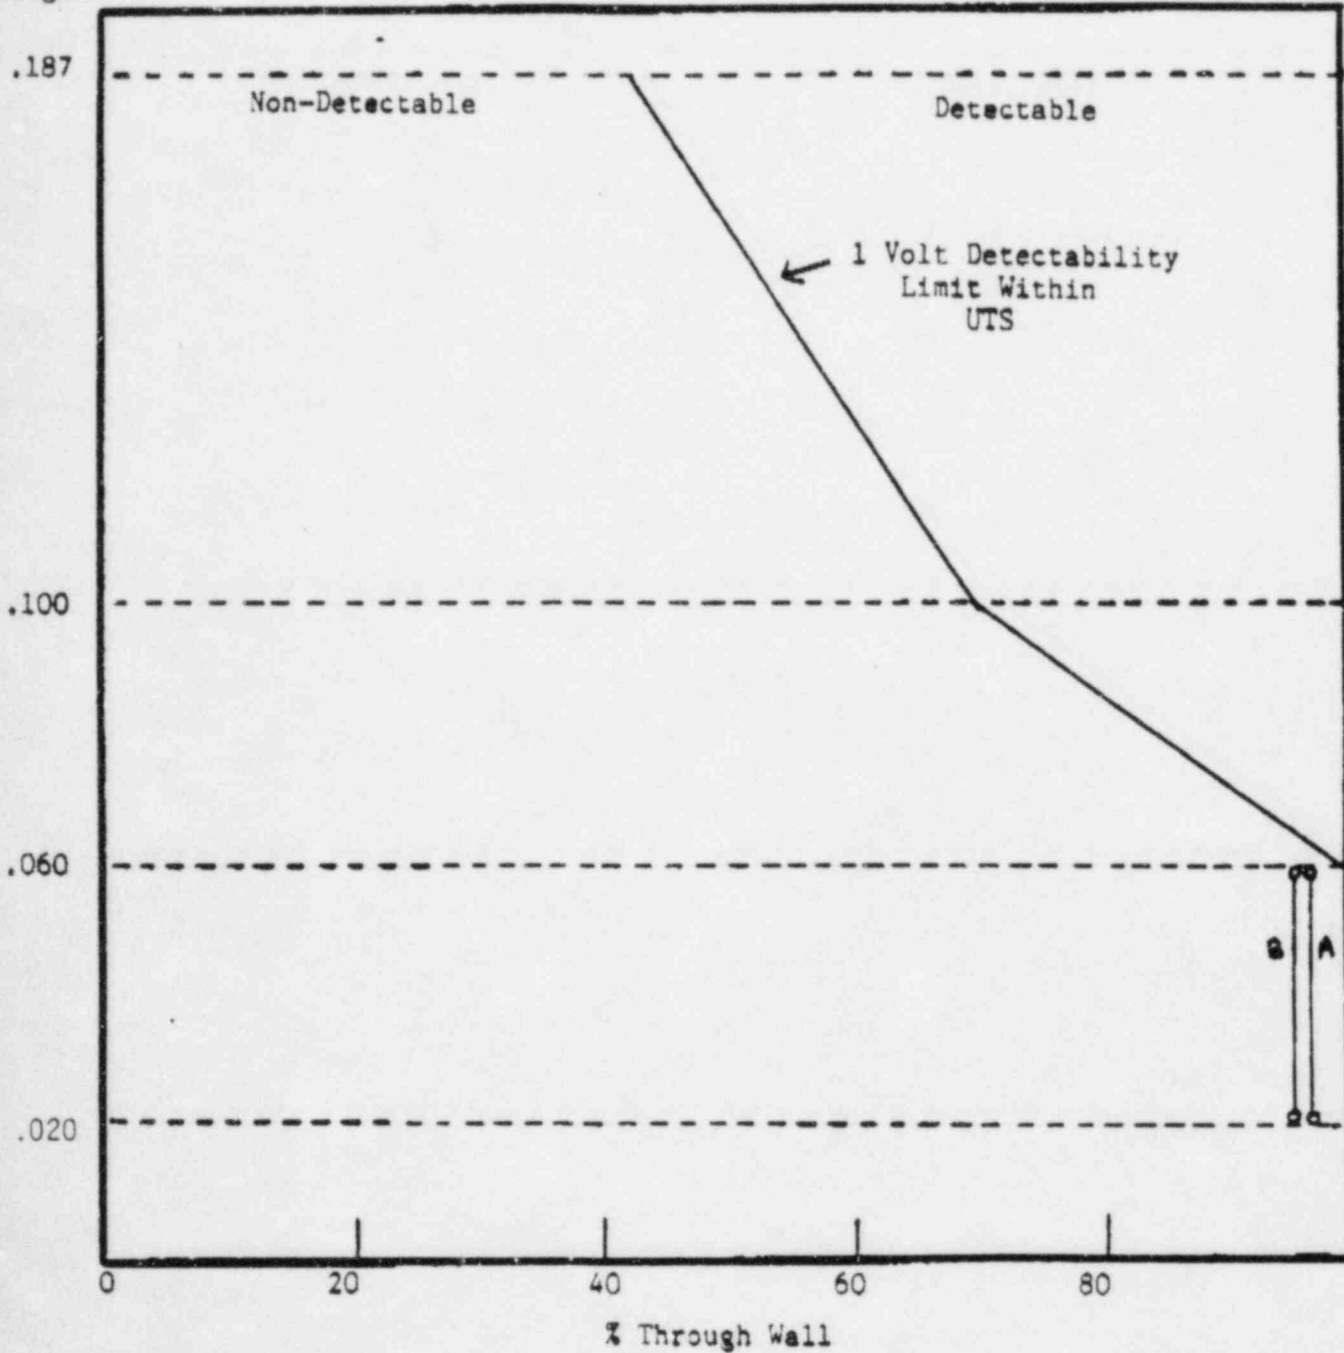
Figure 3a - Within - Tubesheet
Fiberscope Indications
Compared to Detectability Limit

Additional plant data from leak rate observations and the fiberscope examination of a sample of tubes also support the mechanical damage scenario. No leaks have been identified in the tube free span since 1983. In the region of 1984 eddy current indications, patch-like indications suggestive of IGA were seen by the fiberscope examination.
