Subject: 10CFR 21 Report

ENGINEERING REPORT

REFERENCE NUMBER 10CFR 21 - Emergency Stand By Generators

SUBJECT Inspection Procedure for Fractured Welds on Air Deflectors

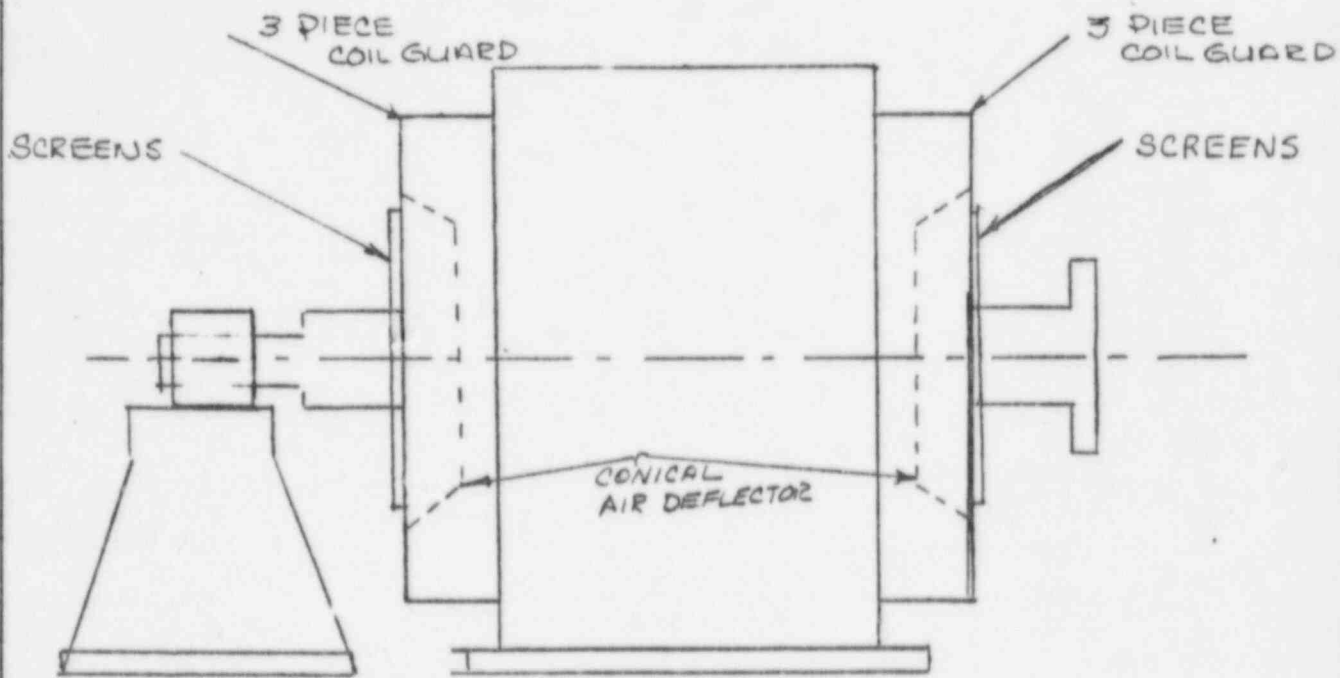
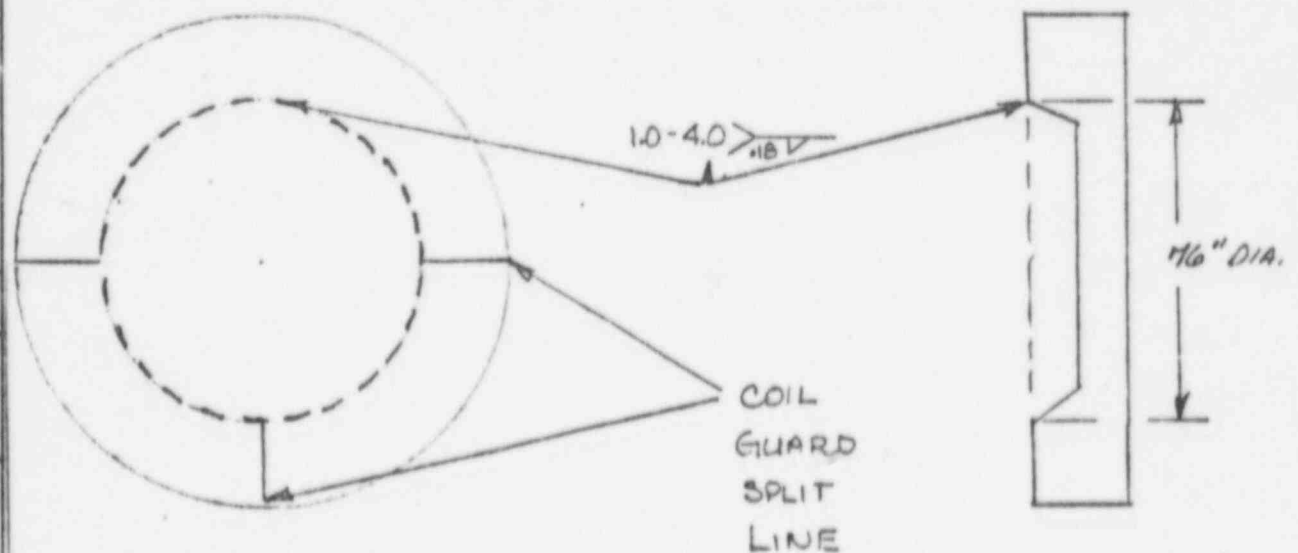
1. Remove the protective screens from each end of the generator coil guards as indicated on the attached Sketch A.
2. Inspect the fillet weld securing the conical air deflector that is welded to the three piece coil guards. The air deflector is secured to the coil guard by a 3/16" fillet weld, 1" long on centers of 4". There will be approximately sixty (60) of these welds around the circumference of this joint.
