MEMORANDUM

DATE: December 5, 1996
TO: Vermont State Nuclear Advisory Panel
FROM: Citizens Awareness Network
RE: CAN'S analysis of Vermont Yankee's July 23, 1996 presentation on RHR minimum flow valve
CC: U.S. NRC and general release

Summary of CAN's Analysis of VY's Presentation, "RHR Minimum Flow Valve Enforcement Conference," (July 23, 1996).¹

***RHR Minimum Flow Valve
Enforcement Conference***

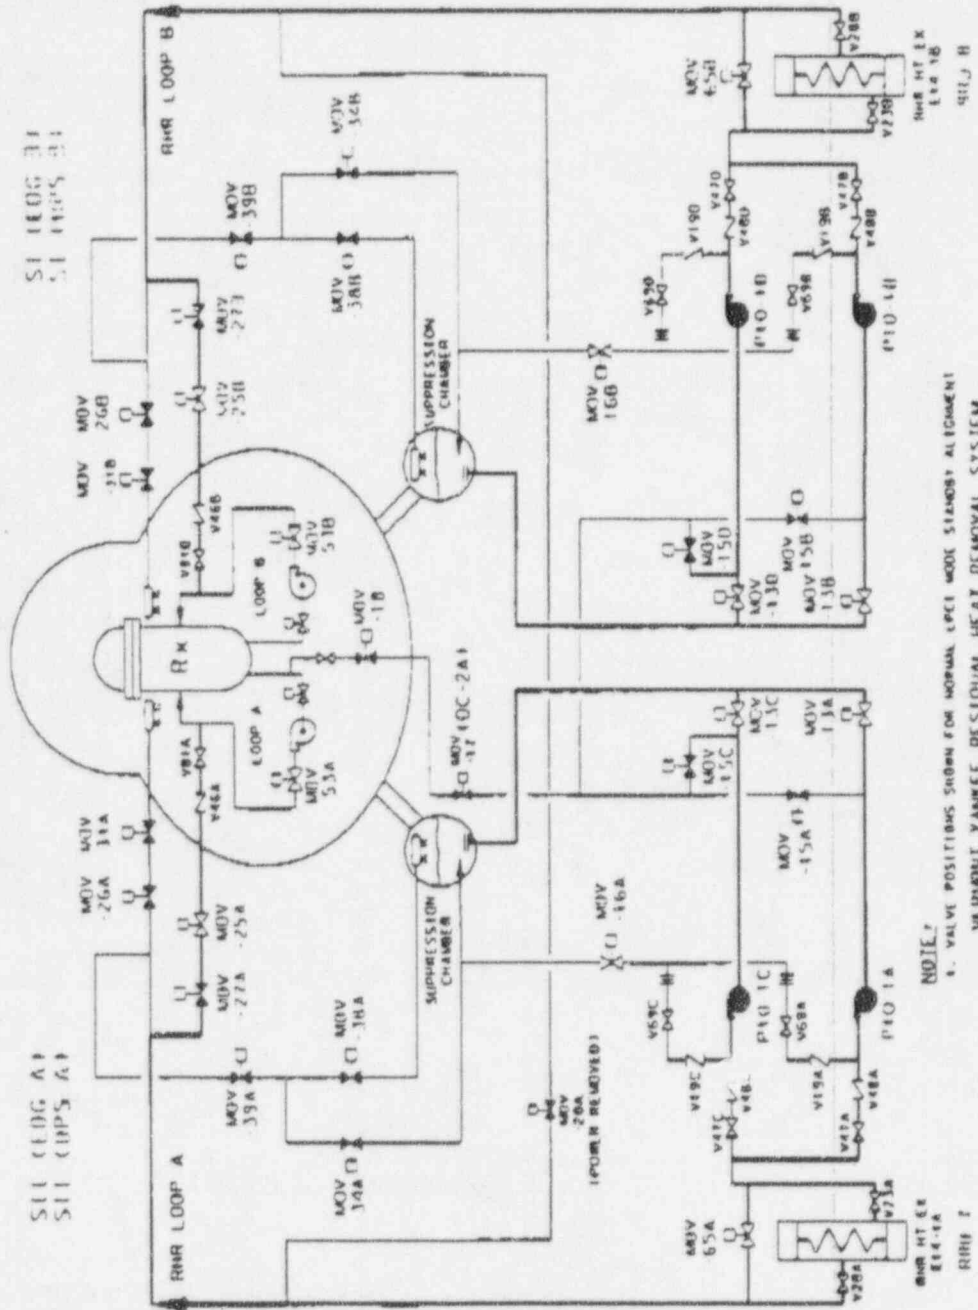
System Diagram

The RHR minimum flow valves (MOV-16A and MOV-16B) are shown on the slide "BACKGROUND SYSTEM DIAGRAM" to be the first isolation device on a line penetrating the suppression pool below the water line. Although it is not specified in the presentation slides, the RHR minimum flow valves probably have a containment isolation function. The RHR minimum flow valves at other boiling water reactor (BWR) plants of similar design (FitzPatrick, Browns Ferry, Peach Bottom, Hatch, etc.) perform a containment isolation function. Specifically, the RHR minimum flow valves must close to isolate the primary containment in the event of a pipe break outside containment.

When Vermont Yankee personnel changed the normal position of the RHR minimum flow valves from closed to open, they resolved the RHR pump protection problem. However, it is not certain that the containment isolation function of these valves was addressed. According to the slides "EXAMPLE CASE STUDY SINGLE FAILURE OF DC BUS 1 WITH LNP," the RHR minimum flow valves are normally open and fail open on loss of this power supply. With these valves now normally open, a single failure could prevent isolation of two containment penetrations.

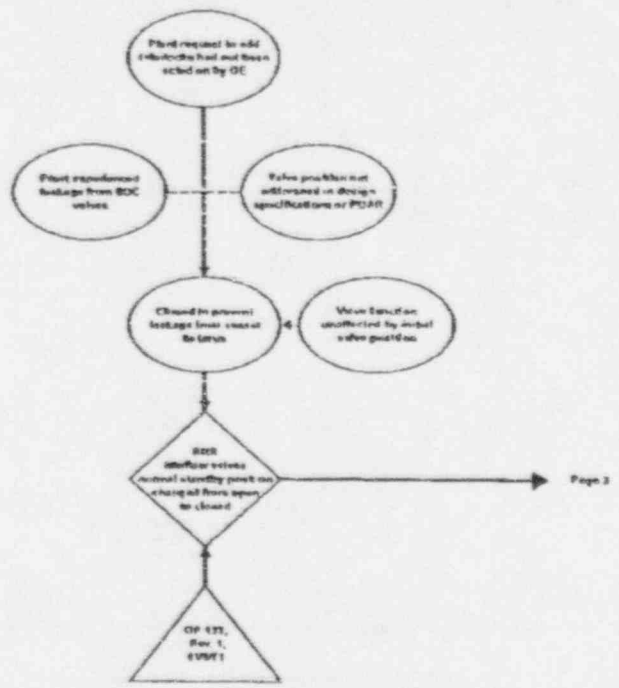
Loss of RHR Minflow Protection

- **Event Definition**
 - Failure to provide minimum flow protection for cross-powered RHR pumps
- **Primary Effects**
 - Minimum flow valves closed by procedure, but P&ID unchanged
 - RHR Pumps B and C cross-powered but not minimum flow valves

- **Root Cause**
 - Inadequate design/single failure evaluation
- **Contributing Causes**
 - Inadequate documentation of minimum flow design basis
 - ECCS design focus on large break phenomena
 - Design engineers assumed minimum flow valves were open when they were closed

- **Maintain minimum flow valves open during normal operation**
- **Revise LOCA analysis to account for failure of valve to close**
- **Review current design change process to ensure broad scope, comprehensive reviews**

- Complete single failure vulnerability review for all ECCS
- Revise FSAR description of minimum flow function
- Revise P&ID to show minimum flow valves open
- Develop policy on use of P&ID as design basis document
