U.S. NUCLEAR REGULATORY COMMISSION  
REGION I

Report No. 50-322/85-22

Facility: Shoreham Nuclear Power Station

Inspection Conducted: April 10-May 10, 1985

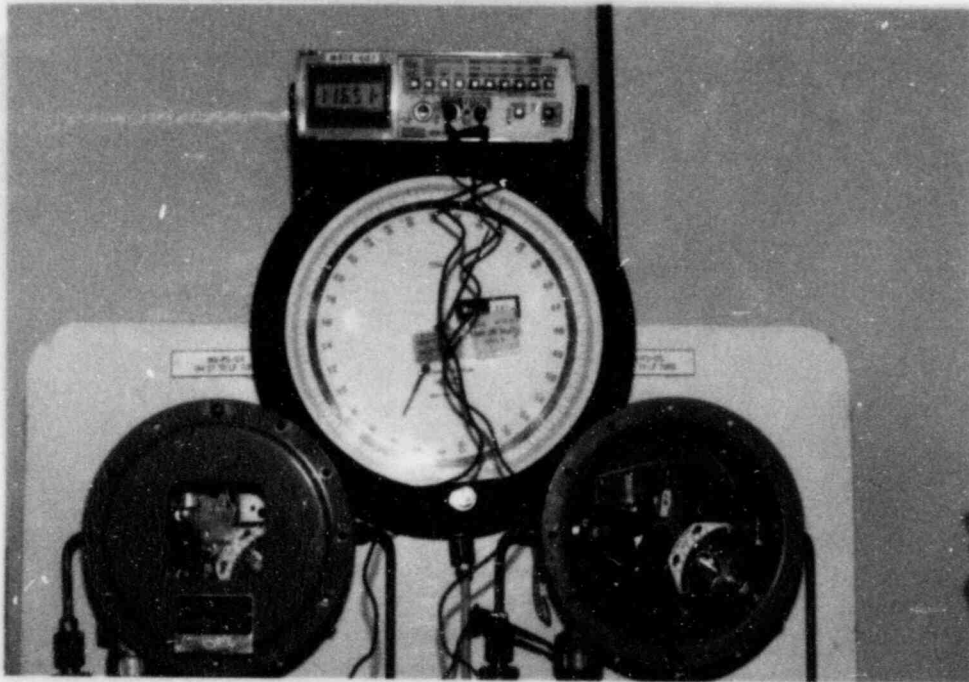
The following picture depicts a Heise gauge used to calibrate the pressure switches which are the subject of allegation number 4 (detail 4.4 of this report).

(Note: The Heise gauges are precision Bourdon tube pressure devices used as Measurement and Test Equipment (M&TE) standards to calibrate plant-installed instrumentation).

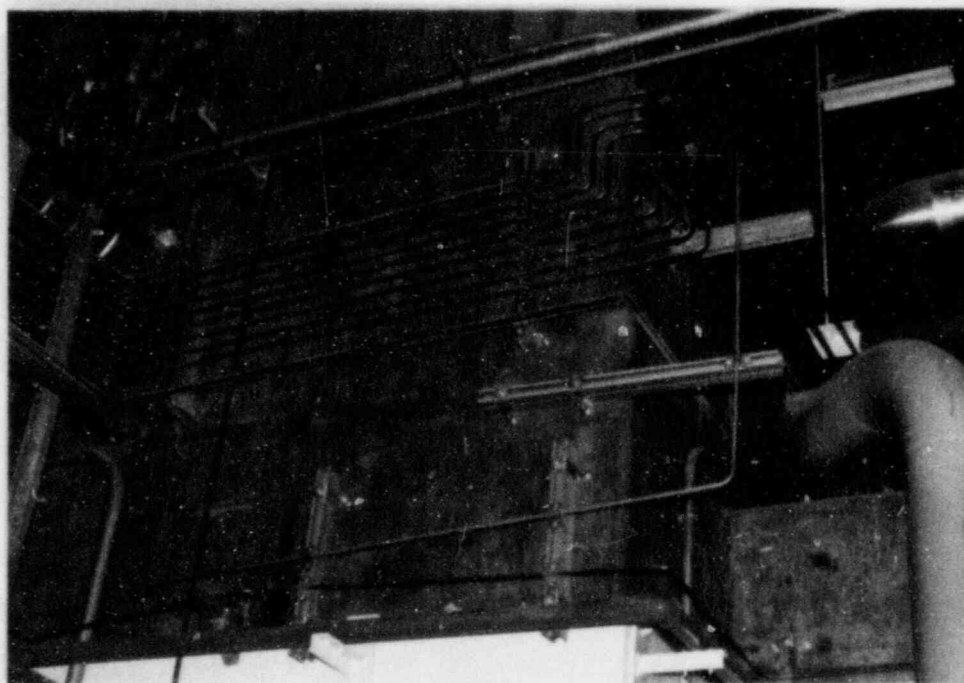
Both switches are installed approximately 307 inches below the location of the common tap, and require a static pressure head correction of 11.1 psi above their nominal control settings. (See picture below of a portion of the field-routing tubing).

During operating conditions, there would least 11.1 psi sensed because of the static column of condensed steam above the switches. However, if uncorrected, the PS-124 contacts would've constantly remained open, since the trip setting could never have been reached as long as fluid was present in the piping. The effect of this error on the MSR reheat steam supply valves MOV-031A and B would be to prevent their automatic closure for isolation of the MSRs under these conditions. Also, the MSR condensate drains would not have been opened. Dynamic calibration of these switches has not yet been performed since there has been no steam produced at process conditions in this piping to-date.

This "design error" was actually an oversight by the Startup Test Engineer who approved the previous C&IO test results but failed to note the absence of the necessary head correction. Similar pressure switches for extraction steam line drains, located adjacent to PS-124 & 125 and off of the same steam line tap, did have a proper correction of 12.5 psi for static head. Pressure transmitters N11-PT-015 A/B, which provide remote indication (0-300psi) and computer input were originally corrected in February 1981 for the difference in elevation between tap and transmitter. This suggests that the error associated with PS-124 & 125 was most probably an isolated case.

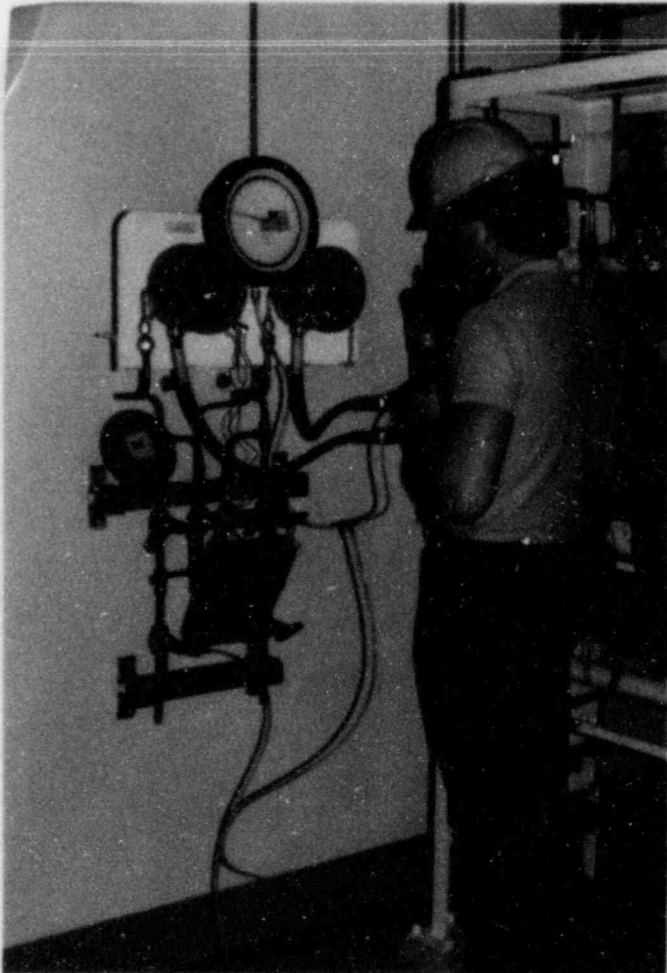
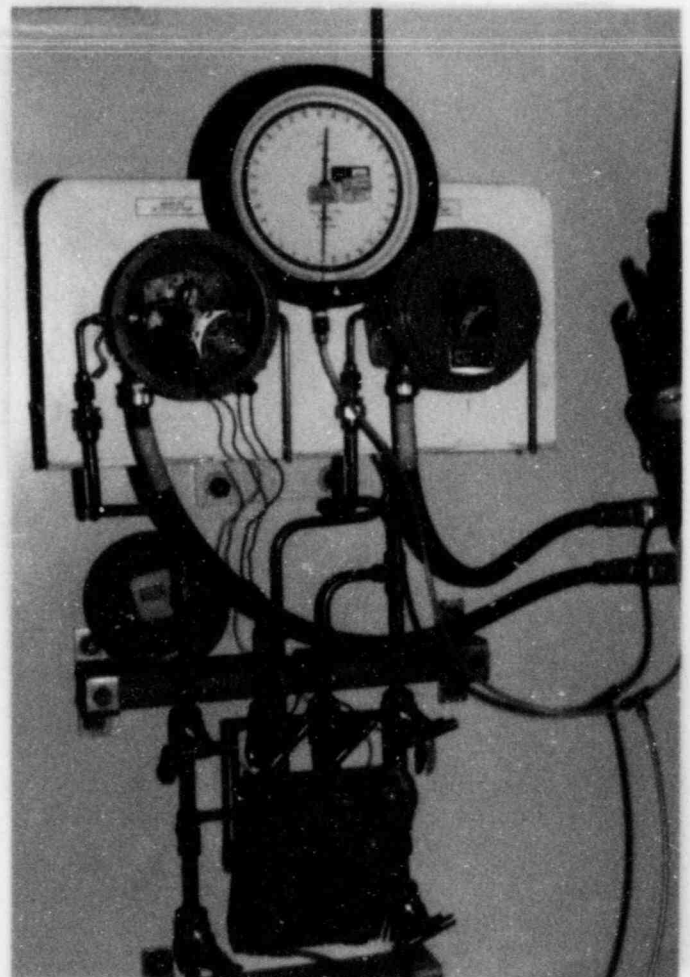
(Accuracy $\pm 2\%$ )	Setpoints (psig)		
	Increasing/Decreasing		As Left
	Nominal	As Found	
PS-124 ( $\pm 0.3$ psig)	4.0/5.5	4.2/6.0	15.0/16.7
PS-125	24.0/25.5	24.5/26.9	34.7/37.3

These switches are non-safety related and generally require calibration every two years. The nominal range while not specified on the Instrument Data Sheets, is typically 30 psig. The new corrected settings for PS-125 slightly exceed that value, although the recent calibration was successful. The required accuracy of  $\pm 2\%$  has been stringently applied to the nominal setpoint, as opposed to a percentage of full range. For example, PS-124 is intended to close and allow for isolation of reheat steam to the MSR (and open the MSR drain) when steam pressure is less than 4 psig (equivalent to below 10% load) and decreasing; the switch opens when pressure is greater than 5.5 psig (equivalent to above 15% load) and increasing. Adding the 11.1 psi correction factor results in settings of 15.1 (decreasing) and 16.6 (increasing) and a required accuracy of  $\pm 2\%$  or 0.3 psi. A successful calibration must therefore result in a trip at falling pressure within the range of 14.8-15.4 psig, and reset at rising pressure within 16.3-16.9 psig.

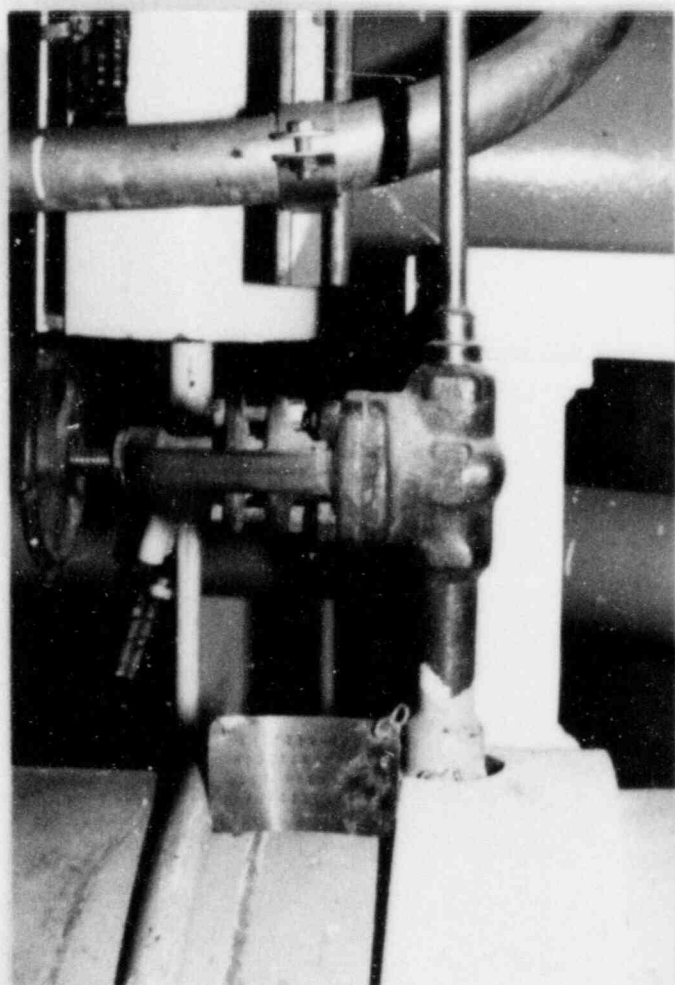
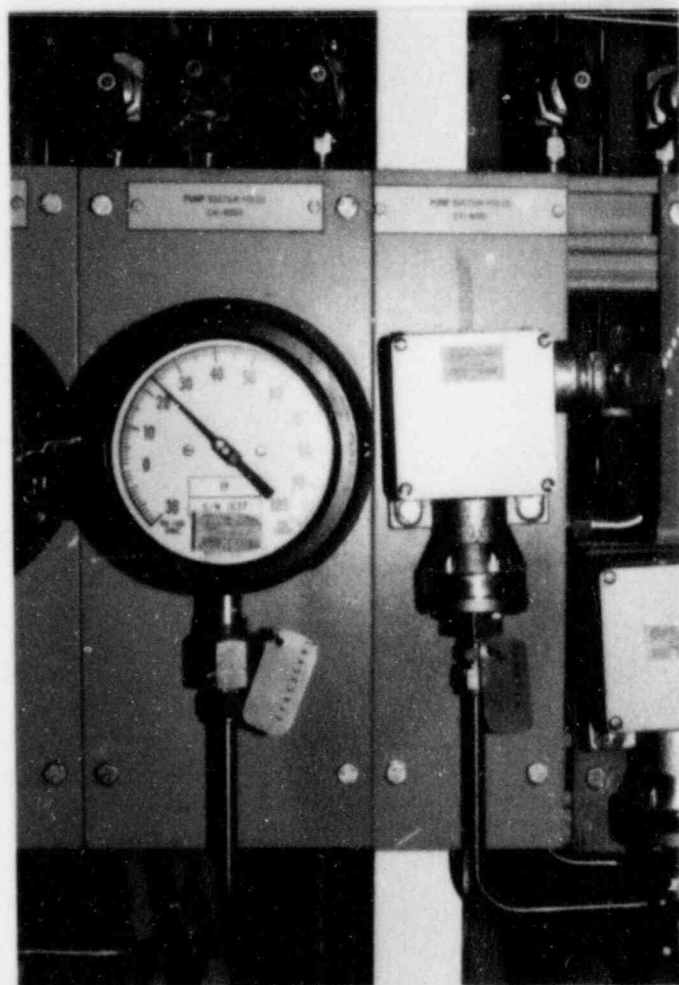
Pressure switch E41\*PS-021L senses High Pressure Coolant Injection (HPCI) system suction pressure at a location just upstream of the HPCI booster pump. The instrument sensing (impulse) line taps off of 16-inch HPCI suction piping a point approximately five feet above the pump suction and runs vertically upwards another ten feet to the ceiling. The tubing is then horizontally run across the ceiling for a span of about 20 to 25 feet, before it drops down to PS-021L located on an instrument rack near Reactor Building floor elevation-8. The switch is 23 inches vertically below the pump suction. The estimated total run of tubing is 50 feet, from tap to sensor, with approximately 10-12 installed 90-degree bends in-between. Horizontal portions were observed to contain no "negative" slopes, or potential traps, although the typically-recommended pitch of 1/2-inch per foot of tubing towards the instrument (Specification SH1-343) was difficult to assess. The actual field condition of this impulse line resembles an inverted U-tube manometer, closed on one end with unequal size legs of roughly 10 and 17 feet. The pictures below depict the tap and sensor locations of PS021L.

The as-left trip setpoint of 13.4 inches Hg. would most likely not prevent the onset of pump cavitation. Considering the required accuracy, the switch would be expected to trip in a 12.8-14.0 inch range. This corresponds to a process condition at pump suction of 17.5-16.1 feet of water; below the minimum required NPSH.

The as-left reset value of 12.5 inches falls outside of the newly-required setpoint range of  $13.3 \pm 0.6$ , technically failing the calibration by a slight amount (0.2 inches Hg.).

The field-run impulse line from the HPCI booster pump suction piping to PS-021L was in conformance with Specification 343, and was observed to have no obvious "traps" in its horizontally-run tubing. No apparent negative slope (pitched away from the sensor) was developed in the horizontal portions. The inverted U-tube configuration, while not required to have a high-point vent valve for proper operation, would have to be "solid" or completely filled with fluid from tap to sensor. Consideration should be given to a procedural step or caution which assures that this impulse line is vented and filled "solid" during and

Assuming that the impulse line is filled solid (an assumption that must be verified periodically) then there are no traps created by the instrument tubing which could conceivably affect the operation of PS-021L. This failure of the switch's contacts to close would not prevent the HPCI pumps from running. Rather, this would allow the pumps to keep running, below their limit of minimum NPSH, causing potential damage due to cavitation. The previous preoperational calibration, if unchanged, would have tripped the pumps at a short time after they had theoretically begun to cavitate.

A new replacement Static-O-Ring Inc. switch was installed as PS-021L on September 28, 1984. A proper head correction of 23 inches was applied, in the correct sense (subtracted), to the 15 inch Hg. setpoint. However, that nominal setpoint should be 14 inches Hg. if its to correspond to the required NPSH. Considering the switch's accuracy, and correcting for static head, a setting of less than 12 will ensure a trip at or before minimum NPSH. The difference in time to reach a decreasing pressure of 18 ft. of water as opposed to 11 ft. of water would predictably be about one second under rated conditions due to the large flow rates involved. Nevertheless, justification for the nominal setpoint, as well as for the as-left reset pressure which is slightly outside of the required set-range, is required.

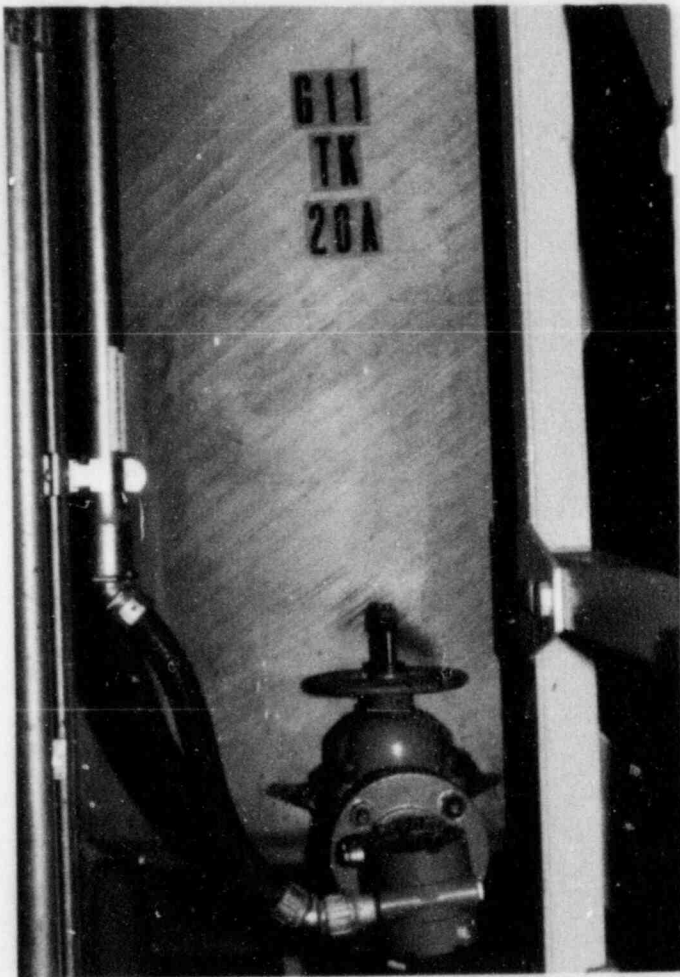
Level Transmitter LT-272

instrument loop consisting of a level transmitter LT-272 A/B which drives an indicator LI-272 A/B in the Radwaste control room and feeds a low level switch LS-272 A/B. The transmitter is located off of a horizontal tap whose centerline is  $1\frac{1}{2}$ -inches above the tank's bend line. There is an estimated 90 gallons of capacity below the instrument's tap. The transmitter is a Rosemount Model 115 with a range of 0-125 inches and a 4-20 mA output. The indicator is a GE/Reliance Model 185 with a range of 0-2000 gallons. The low level switch is set to actuate at a level 4-inches (above the transmitter's zero reference) and will stop the laundry drain tank pump.

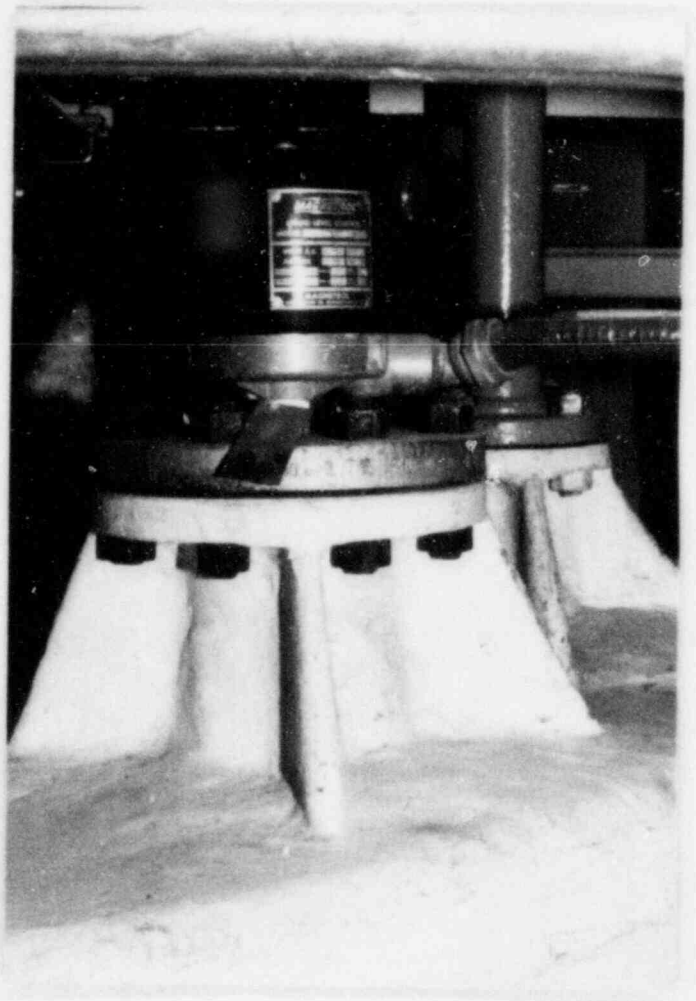
High Level Switch LS-274

Each tank has a high level switch LS-274 A/B, preset at 8'-6" above the tank's bend line, which alarms in the Radwaste control room. The alarm is initiated at an actual tank level of approximately 1320 gallons (80% capacity), which is 12 inches (and 150 gallons) below the centerline of the overflow connection. The overflow is a horizontal flanged connection at the 90% capacity level. Each tank also has a separate level sensing

Initial loop calibrations were performed as part of the pre-operational C&IO testing during December 1979-August 1981. The high level switches LS-274 A/B were calibrated on June 19, 1981 to alarm at an indicated level of 1628 gallons. No record of
