U.S. NUCLEAR REGULATORY COMMISSION  
REGION I

Report No. 50-322/85-21

Facility Name: Shoreham Nuclear Power Station

Inspection Conducted: April 9 - May 10, 1985

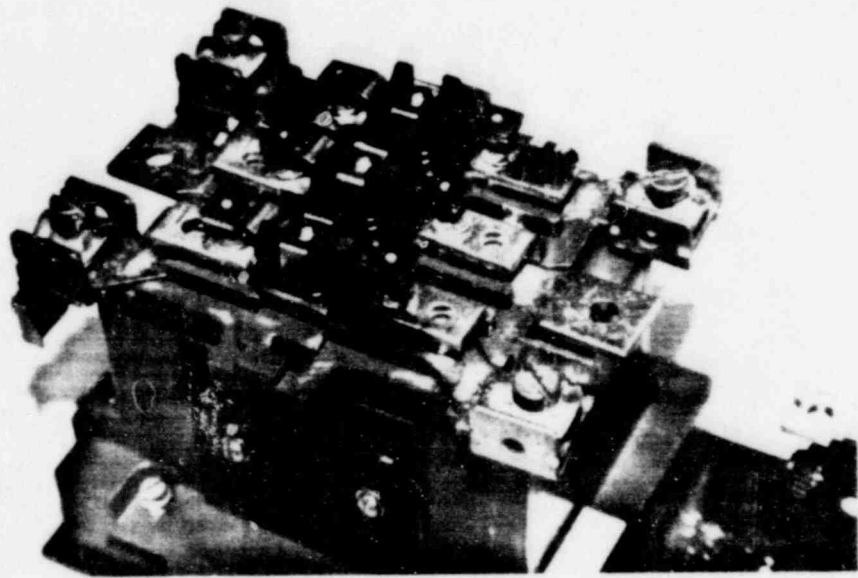
During routine maintenance and test by LILCo Overhead Lines personnel in October-November 1984, four sirens were found to have contacts that were pitted. The licensee surmised that this problem was due to the momentary "bump" of the motor during regular growl testing, which prematurely interrupts the start current across the motor contacts. The pitting is expected to be eliminated by replacement with larger NEMA size 3 contacts which have a greater continuous full load current rating of 90 Amps, and therefore a larger capacity for surge currents on the order of 500 Amps.

The original (still installed) contacts are NEMA size 2, manufactured by Siemens-Allis (catalog No. AN21P) and nominally rated for 45 continuous amps and a maximum  $7\frac{1}{2}$  HP. While the motor/sirens experience an infrequent short-duty cycle (4 starts, total of 4 minutes operation annually), the existing NEMA 2 contacts are considered to be slightly undersized and this is exhibited by the observed pitting. A siren randomly selected and inspected during the course of this inspection also was found to have pitted contacts (see Figure 1 at end of report).

The pitting is in large part due to the practice of "bumping" the motor, and the subsequent opening of the contacts while the larger surge current is still present. Newer NEMA size 3 contacts manufactured by Furnas (Cat. No. 14 HP108745U) with larger current-carrying capacity have been ordered and are planned to be installed within the next year in conjunction with new ground line indication. The practice of "bumping" a motor is being re-evaluated and will most probably be discontinued. No failures have been experienced with these sirens because of contact problems. Further pitting would not result in a siren failure to sound; rather, the contact would fuse and fail closed, "freezing" the motor on until a 3-minute timer would shut off the siren.

Figure 1: Emergency siren contacts that have experienced pitting.

The existing motor contacts are apparently slightly undersized, and most are expected to have already experienced some pitting due to momentarily "bumping" the motor to test electrical continuity (without actually subjecting nearby populations to siren sounding). The pitting was substantiated during examination of a siren as part of this inspection, as well as from the four failures observed in October-November 1984. The licensee identified this problem, and has proposed a solution of discontinuing motor "bumping" and eventual replacement of all motor contacts with larger size contacts. The observed problem would not have prevented siren operation at any time, and would have been eventually detected by the licensee's regular maintenance and test program. The contacts were only slightly under-rated, and not by "twice their capacity", as alleged. The larger contacts should be installed prior to the as-yet unscheduled full-scale emergency exercise.

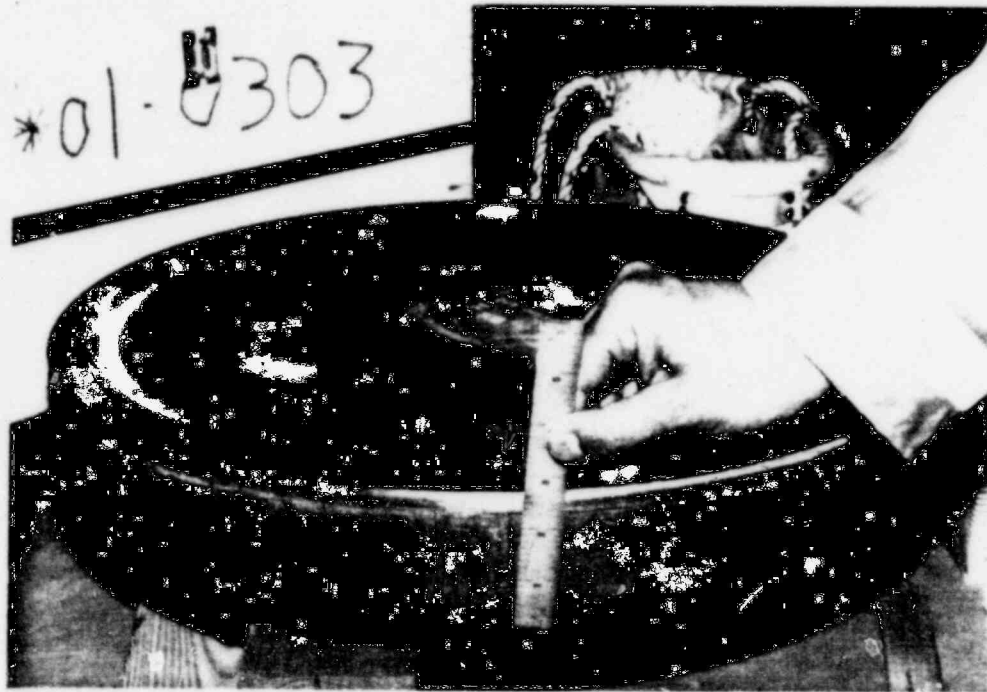
Valve disc serial number 2208 was liquid penetrant (LP)-tested on March 11, 1985 in the presence of an NRC inspector (See Figures 3 and 4 at end of report). LP was performed at the two locations of interest, with no relevant indications found. Attached is a copy of a LILCo LP Examination Report, including a sketch of the valve disc. The subject disc is a 24-inch diameter carbon steel base material with a stellite seating surface overlay.

Figure 3: Low pressure coolant injection 24 inch diameter check valve disc (serial number 2208).

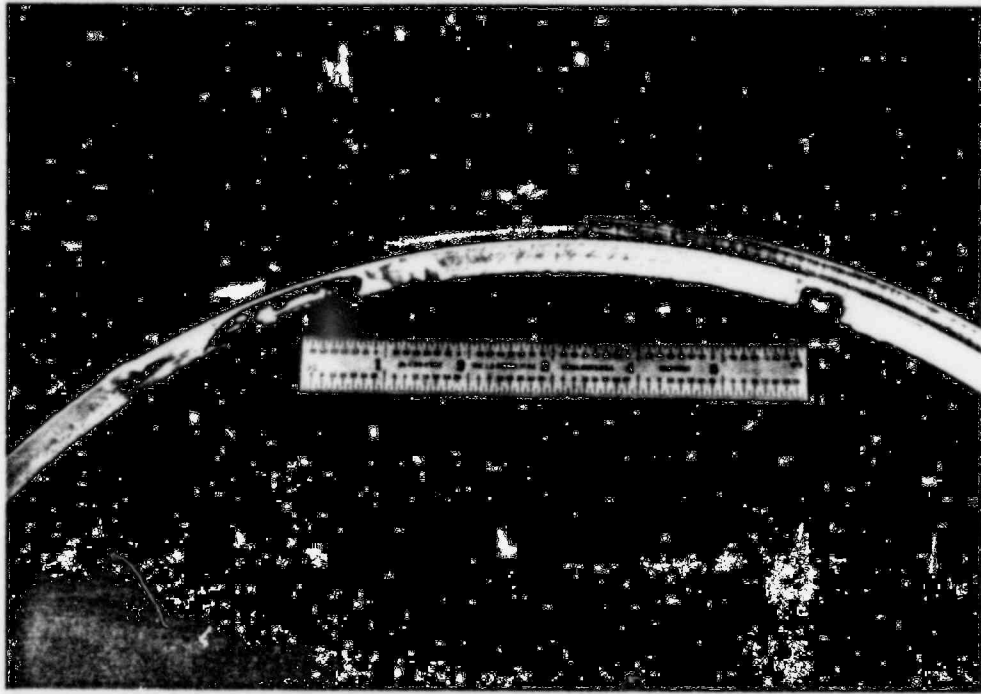
The acceptable LP re-affirmed previous engineering evaluations by both Velan and LILCo of the two minor groundouts located just inside (and off) of the raised stellite seating surface. The original Velan inspection traveller was dispositioned accepted 'as-is' on August 4, 1982. The two grind outs were originally measured as: (1) 0.155 inches deep, 0.450 inches round; and (2) 0.150 inches deep, 0.400 inches wide and 1.75 inches long (see Figure 5 at end of report).

Acceptable LP testing confirmed no surface indications of cracks, following the hard facing repair of this testable check valve flapper by GE in July 1982. The allegor's rejection of the repaired disc on August 24, 1982 (LDR-0781) was presumably based principally on ASME Code Subsection NB-2539.3, "Blending of Repaired Areas", which requires uniform blending of the repaired surface into the surrounding surface. This criterion was satisfied, although the two minor grindouts did exist. Stellite welding and repair is considered to be a difficult and tedious materials process, and is in part a reason for the existence of the surface defects.

It can be concluded from the results of the LP testing that no crack exist, associated with the two minor ground-outs on disc 2208, which would propagate and result in valve failure. The disc is currently not installed, but is a qualified spare part for the 24-inch air-operated check valves in the LPCI system which form part of the critical high-low pressure interface between reactor coolant and ECCS systems. The valve disc sat, unnecessarily, on the MPL for eight months until OQA dispositioned the grindouts, as acceptable On April 26, 1983. This conclusion was re-affirmed nearly two years later, during conduct of this inspection.

Figure 5: Grind outs in low pressure coolant injection system check valve disc.
