Prairie Island Nuclear Generating Plant

Reply to Notice of Violation (Inspection Report 97002),
Inadequate Procedural Control for Management of Heavy Loads

RESPONSE TO NOTICE OF VIOLATION

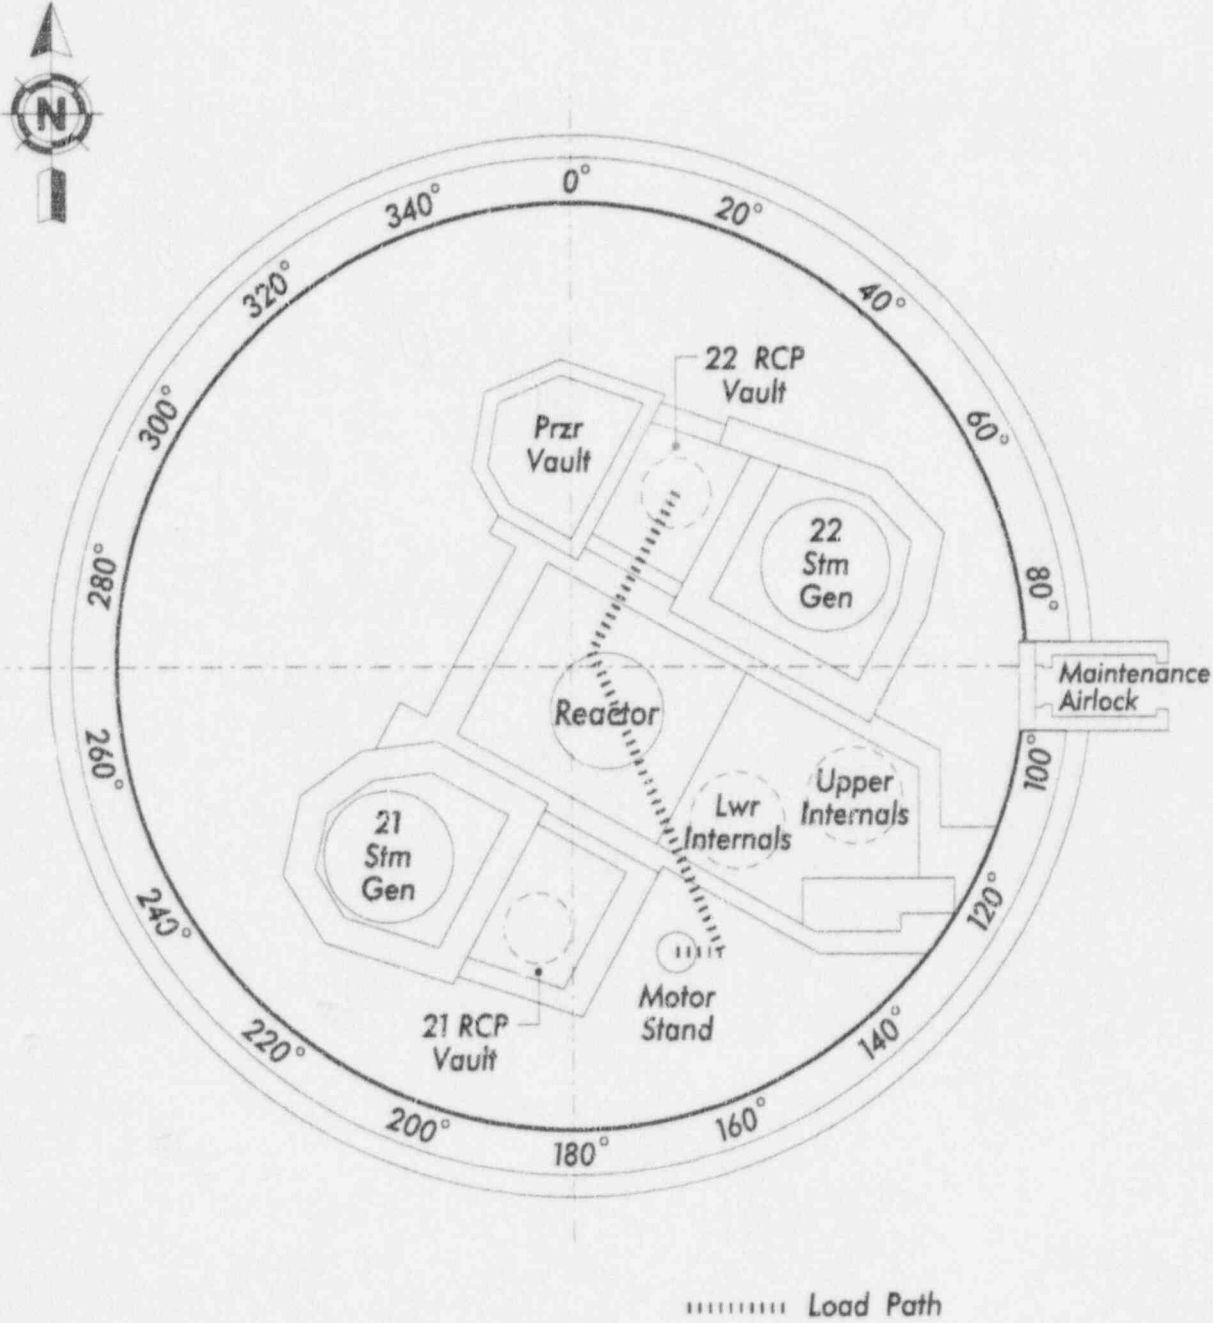
Figure 1

First Heavy Load Lift in Violation of D58 Requirements: (Figure 1)

On 2/4/97, it was determined that 22 Reactor Coolant Pump (RCP) upper bracket and rotor (heavy load - 21 tons) was moved over irradiated fuel on 2/3/97, without a specific load handling procedure defining the safe load path and without containment isolated (Figure 1). This occurred when the RCP upper bracket and rotor, which are handled as a unit, were being moved from the RCP vault to the motor stand as part of the 10 year RCP motor inspection under WO 9608888. (Note that WO is the beginning designator for work order numbers.) The movement of this heavy load in containment did not follow the reactor building safe load path requirements stated in Operations Manual Section D58, Control of Heavy Loads. (Note that all documents referred to in this report as Dxx are Operations Manual Section procedures.) D58 states that "With the reactor head removed, loads greater than 2100 lb. SHALL NOT be moved within 15 horizontal feet of the irradiated fuel without specific written procedures per step 5.3.5" and containment isolation requirements satisfied.

Sometime around 1130, 22 RCP motor upper bracket and rotor were lifted from the pump vault and moved to the RCP motor stand. The path taken to the motor stand was as follows (refer to Figure 1): the RCP upper bracket and rotor lifted vertically out of the motor stator and vault until it was above the CRDM piping on the pool side of the vault, the load was then moved horizontally to approximately a third of the way out over the refueling pool, the polar crane bridge was then rotated to a position that would allow the trolley to move the load to the stand, the load was then moved horizontally across the pool to the RCP motor stand. The RCP motor stand is located on top of the removed pressurizer missile shield sitting on the 755' level of containment near 21 RCP vault. According to the lead rigger the heavy load was within the 15' area of the core for approximately 2 minutes. For a part of this 2 minutes the heavy load crossed over a portion of the core.

1450 - The determination was made that Prairie Island Unit 2 was in a condition outside of the design basis of the plant on 2/3/97 when 22 RCP upper bracket and rotor was moved over the core and the requirements of D58 were not met.

1. Movement of 22 RCP upper bracket and rotor back to the stator placed on hold until a specific procedure could be written and approved by the OC. *completed 2/4/97*

2. Work order 9700661, "Lift 22 RCP Upper Bracket and Rotor," written and approved to cover the move of 22 RCP upper bracket and rotor in accordance with reactor building safe load path requirements per D58. *completed 2/5/97*

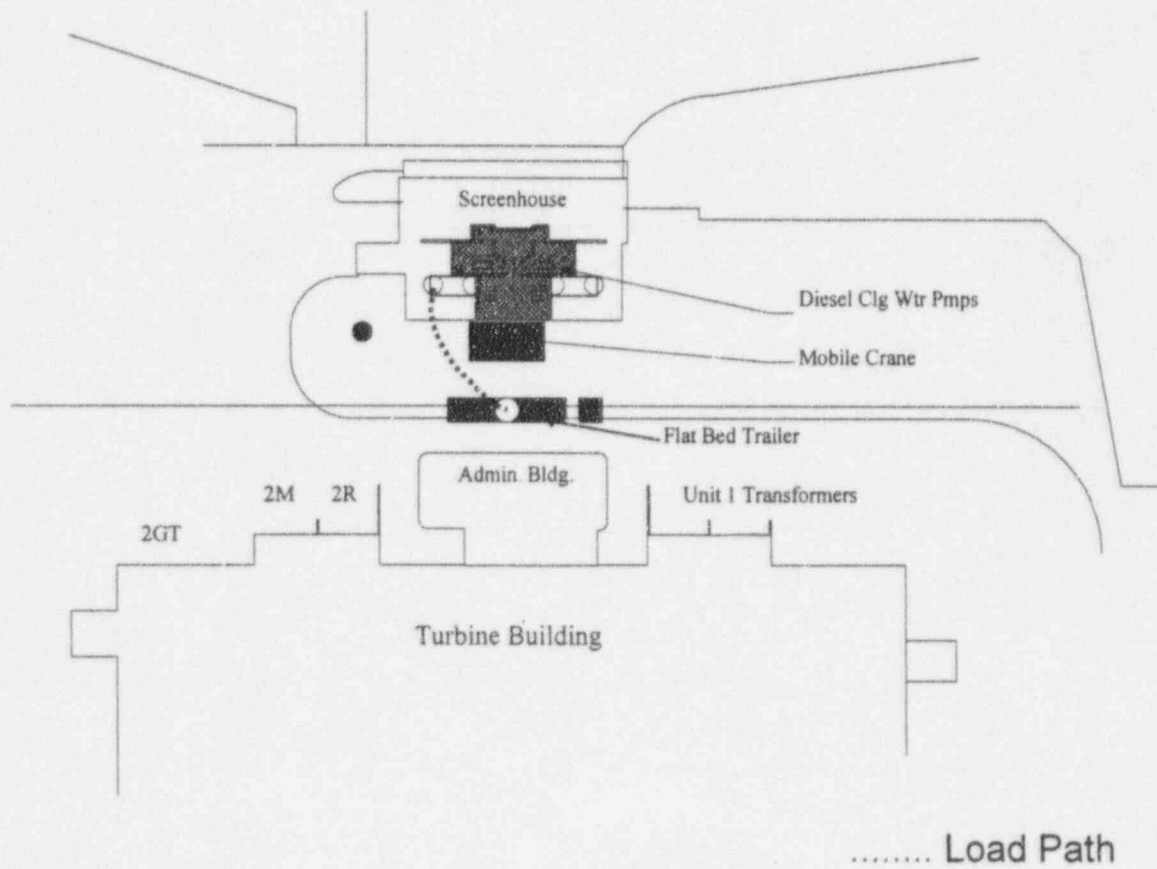
Figure 2
Plant Screenhouse

Second Heavy Load Lift Using a Mobile Crane: (Figure 2)

Circulating Water (CW) Pump motor was being reinstalled under WO 9700434. This heavy load was being moved with the use of a mobile crane near safe shutdown equipment located in the Screenhouse (Figure 2). D58 was reviewed before moving the heavy load, but D58 does not contain specific guidance pertaining to the use of mobile cranes. Before the heavy load was moved the safe load path was considered and the designated load path discussed with the mobile crane operator and riggers performing the lift. The movement of this heavy load was not over any of the safe shutdown equipment located in the Screenhouse.

The CW pump was lifted from the flat bed trailer and moved into the Screenhouse through an opening in the Screenhouse roof (refer to Figure 2). The pump was lowered to the lower level and set in place. After 22 CW pump motor was set in place, 21 CW pump was rigged and removed through the Screenhouse roof opening and placed on the flat bed trailer.

The NRC Resident inspector observed the lift of 22 CW Pump motor and the removal of 21 CW pump and had a concern with the potential impact on safe shutdown equipment in the Screenhouse because of the load paths close proximity to the area of the Screenhouse roof over the safe shutdown equipment. The NRC Resident Inspectors determined that D58 was not adequate in that it did not contain the necessary administrative controls for handling heavy loads over or near safe shutdown equipment when using a mobile crane.

Before reinstalling 21 CW pump a specific procedure, WO 9614600 Attachment 1, was prepared and approved by the Operations Committee to lift and move the Unit 2 Screenhouse hatch cover and to lift and move 21 CW pump from the turbine building to the Screenhouse. This procedure defined special considerations and defined a safe load path which avoided identified safe shutdown equipment and the Unit 2 transformers.

6. WO 9614600 attachment 1, for lifting and moving 21 CW Pump, prepared and approved by the OC. *completed 2/21/97*
7. The General Superintendent of Plant Maintenance, Supt. Mechanical Systems, General Superintendent of Engineering, and system engineers are assisting with heavy load reviews for the interim until corrective actions #16 & 17 are implemented. *completed 2/26/97*

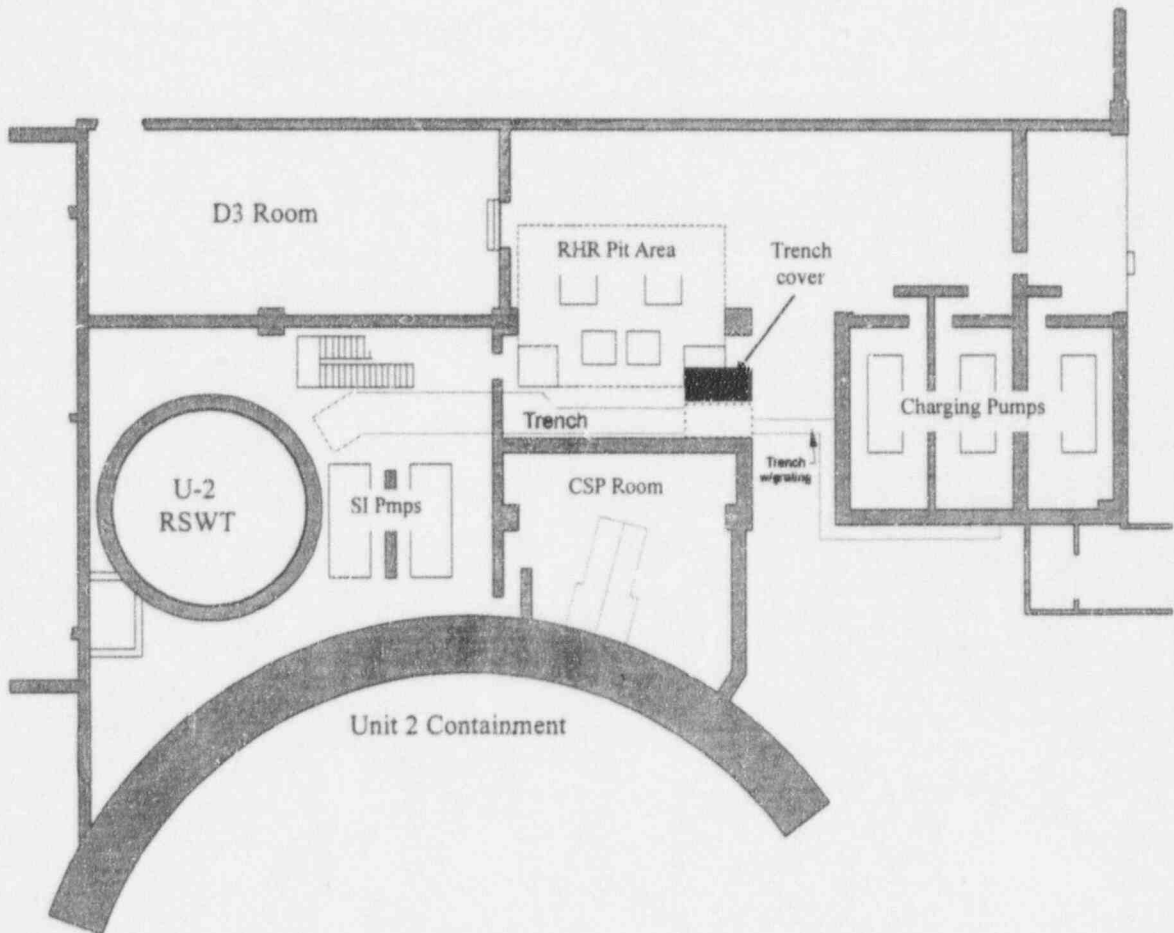
Figure 3

Third Heavy Load Lift Using a Fork Lift: (Figure 3)

The third event involving the control of heavy loads occurred on 2/25/97, when a concrete trench cover was removed from the Unit 2 Auxiliary Building trench under WO 9614795. The trench cover was removed to allow ASME XI Inservice Inspection (ISI) of pipes in the trench from the Refueling Water Storage Tank (RWST) to the Containment Spray Pump (CSP) room. The concrete trench cover, which weighed approximately 6000 pounds and measured 107"L, 53"W, 12"T, was lifted and moved with a fork lift. The trench cover was lifted to a height that was approximately 1" above the surrounding floor and then set off to the side of the trench. This heavy load lift was made over the Train A Residual Heat Removal (RHR) discharge piping to the Safety Injection (SI) pump suction and the RWST to charging pump piping. The movement of this heavy load was not over any safe shutdown equipment.

Using a fork lift, eye bolts, shackles and lifting beam maintenance personnel attached these to the trench cover. The equipment was inspected per NSP rigging requirements. The trench cover was then lifted and moved back and set on the edge of the trench opening (refer to Figure 3).

Later a QC inspector arrived to witness the inspection of the RWST to charging pump piping. When in the area of the trench, he noticed the concrete trench cover, that had been removed earlier, sitting along side the trench. Because of its apparent size and weight and the increased awareness on site concerning the movement of heavy loads, the inspector questioned if the removal of this trench cover fell under the requirements of D58 because of its weight and the RHR piping located in the trench. This concern was passed on to another QC inspector who determined that the weight of the cover met the definition of a heavy load (>1799 pounds), but the guidance in D58 did not specifically address the lifting and movement of the trench cover. Before moving the cover back the conservative approach was taken and a specific procedure prepared and approved for replacing the cover.

WO 9701169, Replace SI/RHR Trench Cover, was prepared and approved by the Operations Committee for replacing the trench cover. The WO applied the requirements of D58 Appendix B and section 5.7 for moving a heavy load over equipment that is required to be operable.

The Unit 2 Auxiliary Building trench cover was replaced per the instructions of WO 9701169.

9. MSIP 6003, Control of Heavy Loads, written and issued. *completed 2/27/97*
10. WO 9701169, "Replace SI/RHR Trench Cover", for moving the trench cover prepared and approved by the OC. *completed 2/28/97*
