U.S. NUCLEAR REGULATORY COMMISSION
REGION I

Report No. 50-293/85-29

Facility Name: Pilgrim Nuclear Power Station

Inspection Summary: Inspection on September 28, 1985 - October 2, 1985
(Report No. 50-293/85-29)

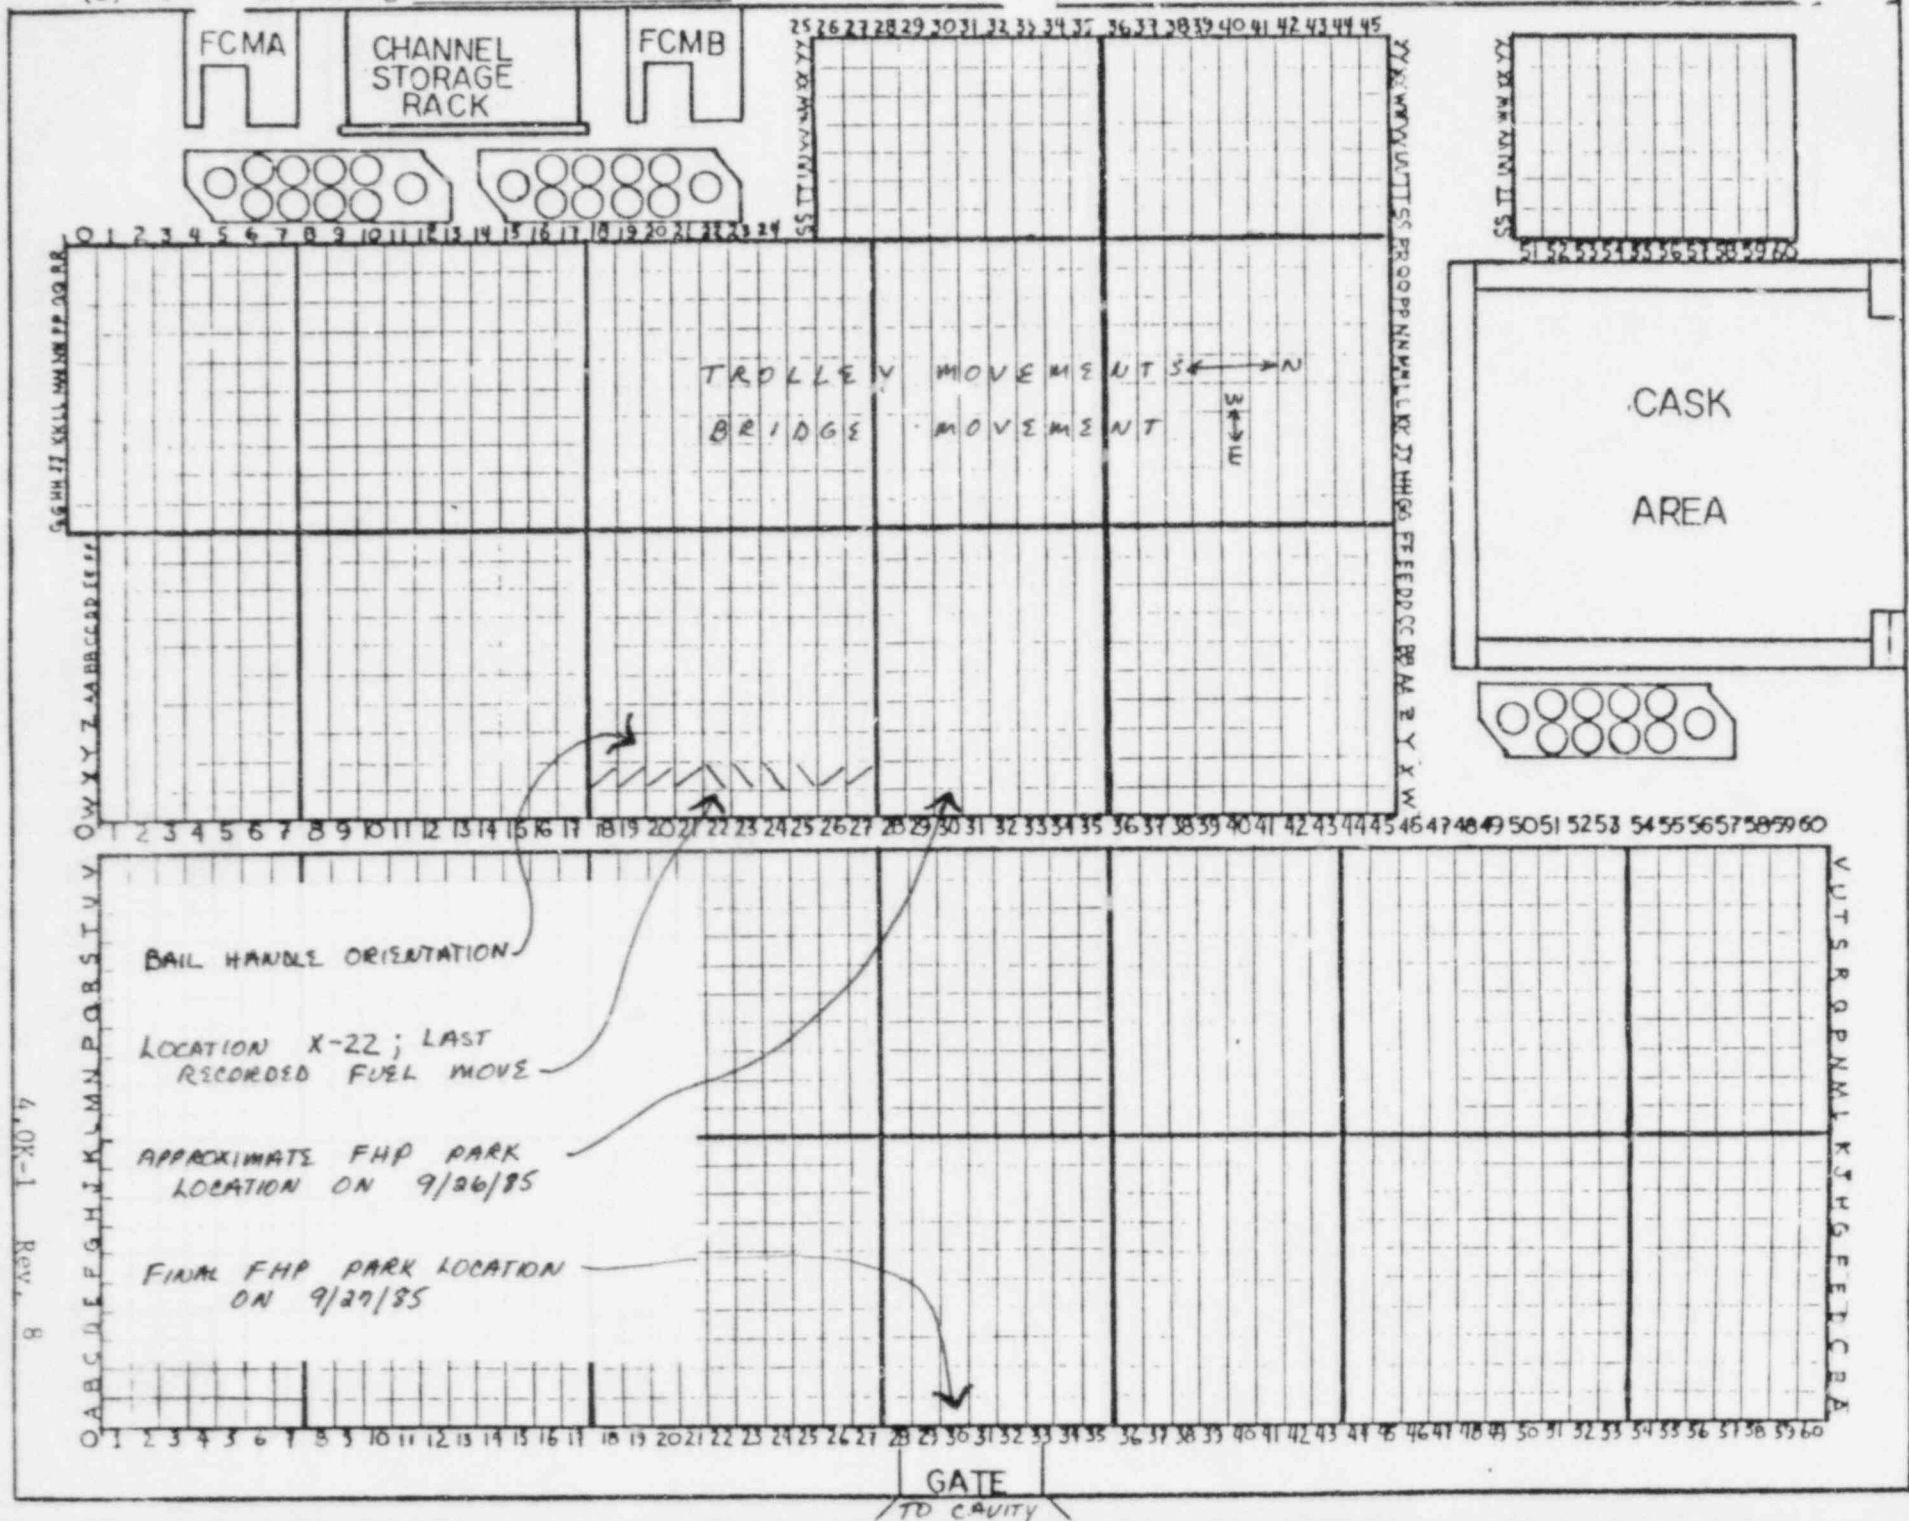
SPENT FUEL POOL LOCATION GRID DIAGRAM - (50-293/85-29)

As reported by the licensee, the FHP was located at approximately the X-30 location (see Attachment B) on Friday, September 27, 1985. This appeared to be the same location that it was left on September 26 at 2:50 p.m. when authorized fuel movement was terminated for the day. The mast was down and grappled to the bail handle of a fuel bundle located approximately 4 to 5 feet to the left of the trolley location. The Senior Reactor Operator (SRO) moved the trolley over the fuel bundle, upgrappled and raised the mast as much as the bend would allow and then moved the bridge and trolley to about location A-30 (see Attachment B) in preparation for the approaching hurricane Gloria. The SRO did not note which fuel bundle the grapple had been attached to.
