Prairie Island Nuclear Generating Plant

Reply to Notice of Violation (Inspection Report 97006),
Inadvertent Excessive Draining of the RCS Pressurizer While at Cold Shutdown

RESPONSE TO NOTICE OF VIOLATION

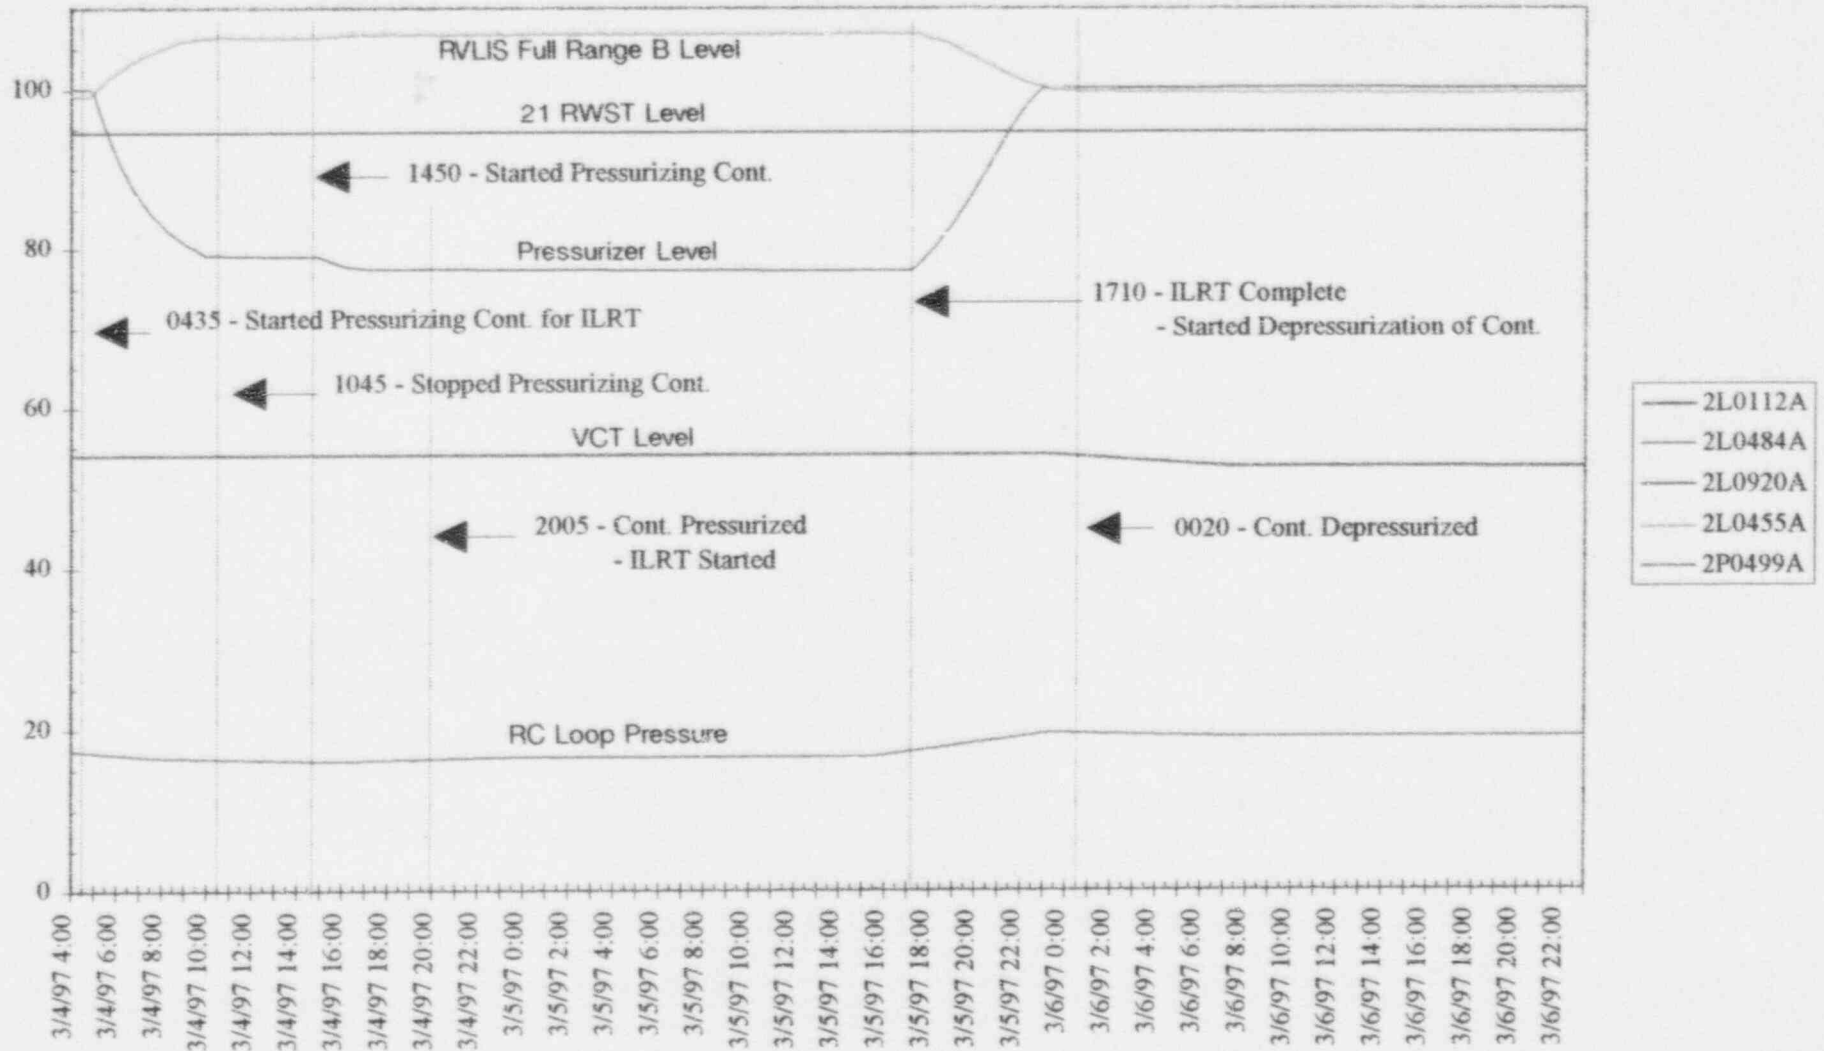
Chart 1

0435 - (Chart 1) ILRT preparations completed per SP-2071.4. Started pressurizing Unit 2 containment to 46 psig per WO 9613273, SP-2071.5 Procedure For The Containment Vessel ILRT. A precaution and limitation in SP-2071.5 states the following: "The volume of fluid in the RCS will be compressed during the I.L.T.

2005 - (Chart 1) Closed the Unit 2 containment pressurization valve per the ILRT Lead. Containment pressurized to test pressure of 46 psig and pressure test started per SP-2071.5. PI computer data: PZR Lvl - 77.35%, RVLIS Upper Range B - 105.64%, RVLIS Full Range B - 106.95%, RHR Inlet Temp - 91.2 F, RC Loop Press - 16.35 psig. The change in pressurizer level from start of the ILRT test until this time was 23%. Based on this change and the precaution at the beginning of the ILRT procedure, it can be assumed that approximately 3.3% of the RCS volume was air.

0020 - (Chart 1) Completed depressurization of Unit 2 containment per SP-2071.5. PI computer data (initial parameters before pressurization enclosed in []): PZR Lvl - 100.08% [100.02%], RVLIS Upper Range B - 103.07% [102.36%], RVLIS Full Range B - 99.88% [99.29%], RHR Inlet Temp - 91.0 F [91.3 F], RC Loop Press - 19.5 psig [17.28 psig].

1800 - (Chart 1) Shift change took place and the off-going crew turned over that they were aligned to drain the pressurizer and that the draining was being delayed until SV-37096 was replaced because there was no RCS vent path. SV-37096 is part of the 2D8 vent path and allows the vent path to be isolated from the control room. After shift change the decision was made to identify and establish an alternate

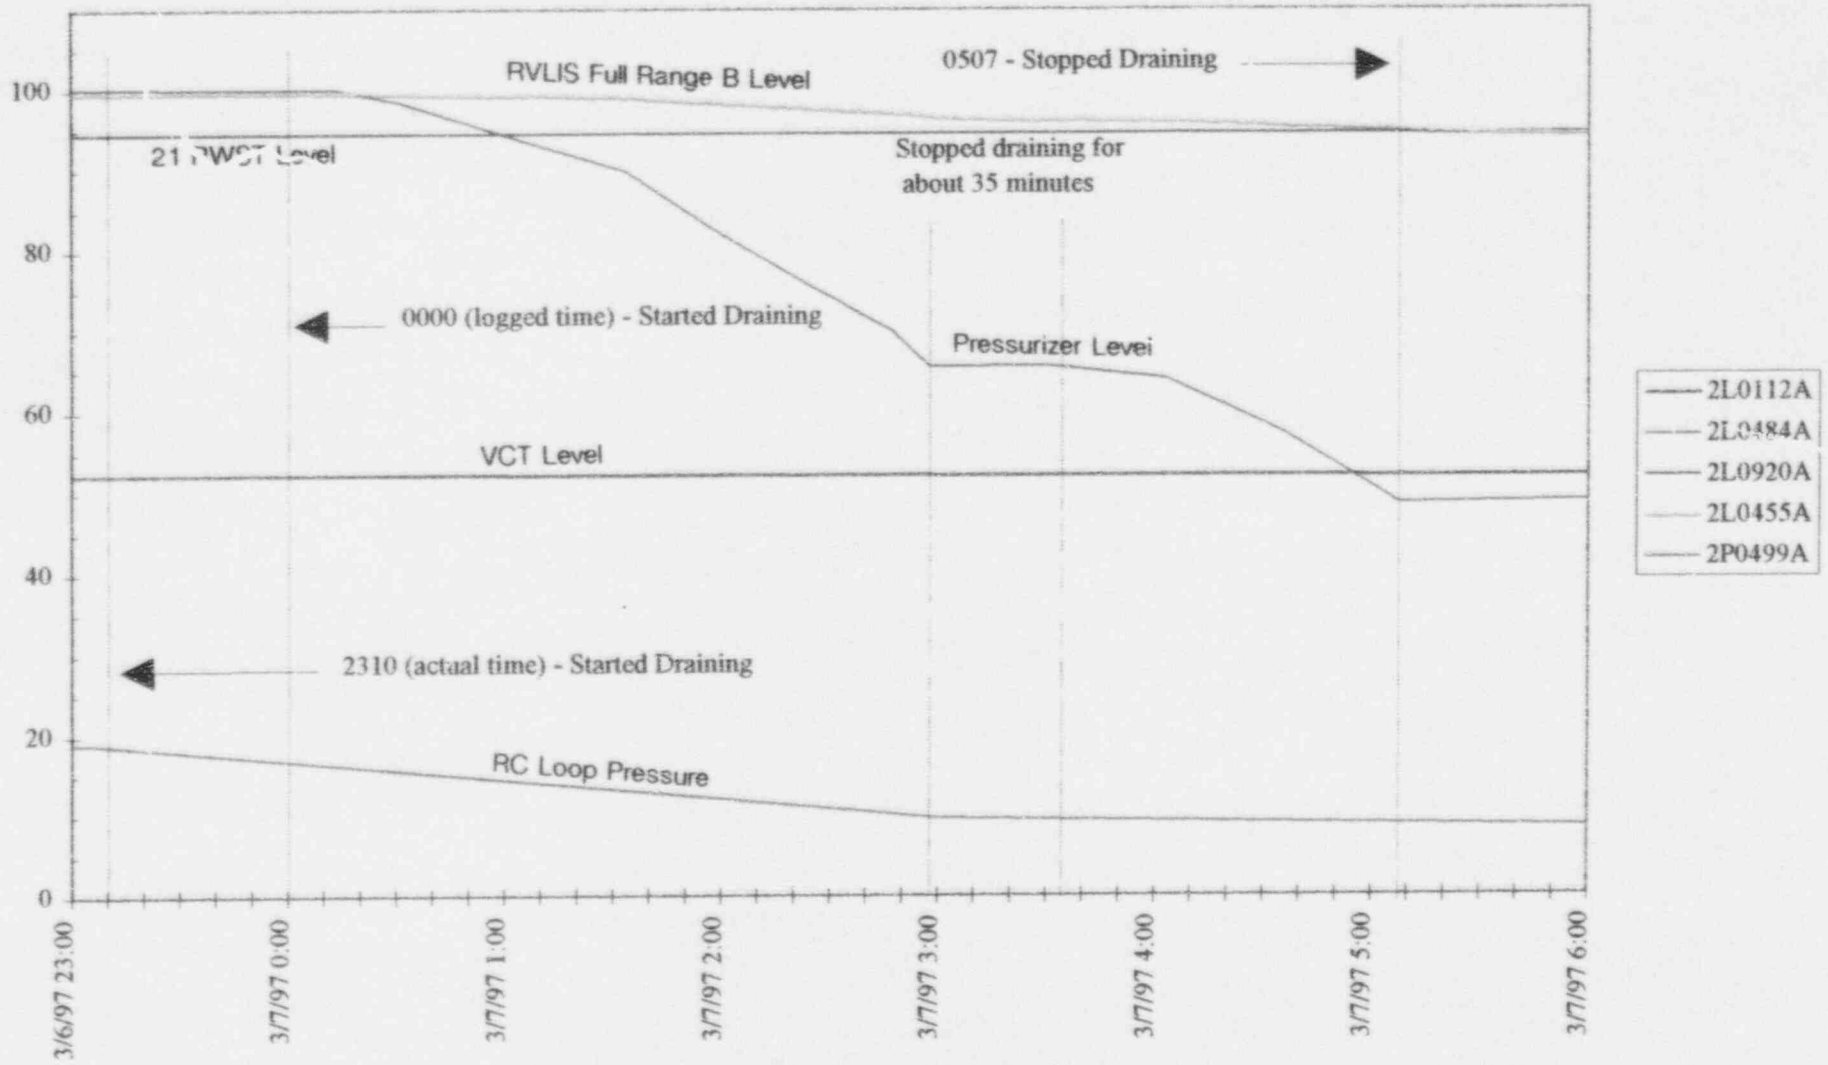
Chart 2

2330 - (*Chart 2*) While performing the isolation for WO 9701175, 2RC-8-16, Head Vent To PRT, was mistakenly left in the as found position of CLOSED, instead of positioning it to the OPEN position as required by the I&R and Hold Card. The Hold Card for 2RC-8-16, with an indicated isolated position of OPEN, was then hung on the valve. The failure to properly position this valve in the OPEN position maintained the alternate vent path to the containment atmosphere isolated. Around 2345 isolation 9701175 for replacing the valve and establishing the alternate RCS vent path was completed. PI computer data: PZR Lvl - 99.99%, RVLIS Upper Range B - 102.51%, RVLIS Full Range B - 99.73%, RWST Lvl - 94.44%, RHR Inlet Temp - 90.9 F, RC Loop Press - 17.44 psig.

0000 - (*Chart 2*) Control room operator started draining the RCS to lower pressurizer level per 2D8 step 5.2.57 B. The Purification Jumper line up with CV-31251, Letdown Divert to HUT in the "DIVERT" position was being used to drain the RCS to 21 CVCS HUT. The drain rate was being regulated by adjusting the position of CV-31228, 21 RCP Loop A PRZR Spray CV and was being monitored using control board indications along with an emergency response computer system (ERCS) quick plot that included PZR, VCT & RCDT levels. PI computer data: PZR Lvl - 99.97%, RVLIS Upper Range B - 102.48%, RVLIS Full Range B - 99.67%, RWST Lvl - 94.44%, RHR Inlet Temp - 90.9 F, RC Loop Press - 16.84 psig, 21 CVCS HUT Lvl (log reading) - 70.0%.

About 0255, (*Chart 2*) three hours into the evolution, the draining was stopped for

0507 - (Chart 2) Pressurizer cold cal level reached 49% and draining of the RCS was stopped. The indicated amount drained by the 51% change in pressurizer level was 3295 gallons. Because of the inadequate vent path the actual amount drained, which was determined later, was greater than the amount indicated by the change in pressurizer level. It was later determined that the actual amount drained, by using the 21.5% increase in 21 CVCS HUT level, was 7245 gallons. RCS pressure was approximately 8 psig and was recognized to be lower than what was expected (13-15 psig) at this time. However, pressure was thought to be slowly increasing and was assumed it would return to the 13-15 psig range once the RCS returned to atmospheric pressure. The control room operators thought the lower pressure was caused by a drain rate that exceeded the vent path capability. This was turned over to the on-coming crew at shift turnover. PI computer data: PZR Lvl - 48.74%, RVLIS Upper Range B - 97.38%, RVLIS Full Range B - 94.98%, RWST Lvl - 94.44%, RHR Inlet Temp - 91.0 F, RC Loop Press - 8.84 psig, 21 CVCS HUT Lvl (log reading) - 81.5%.

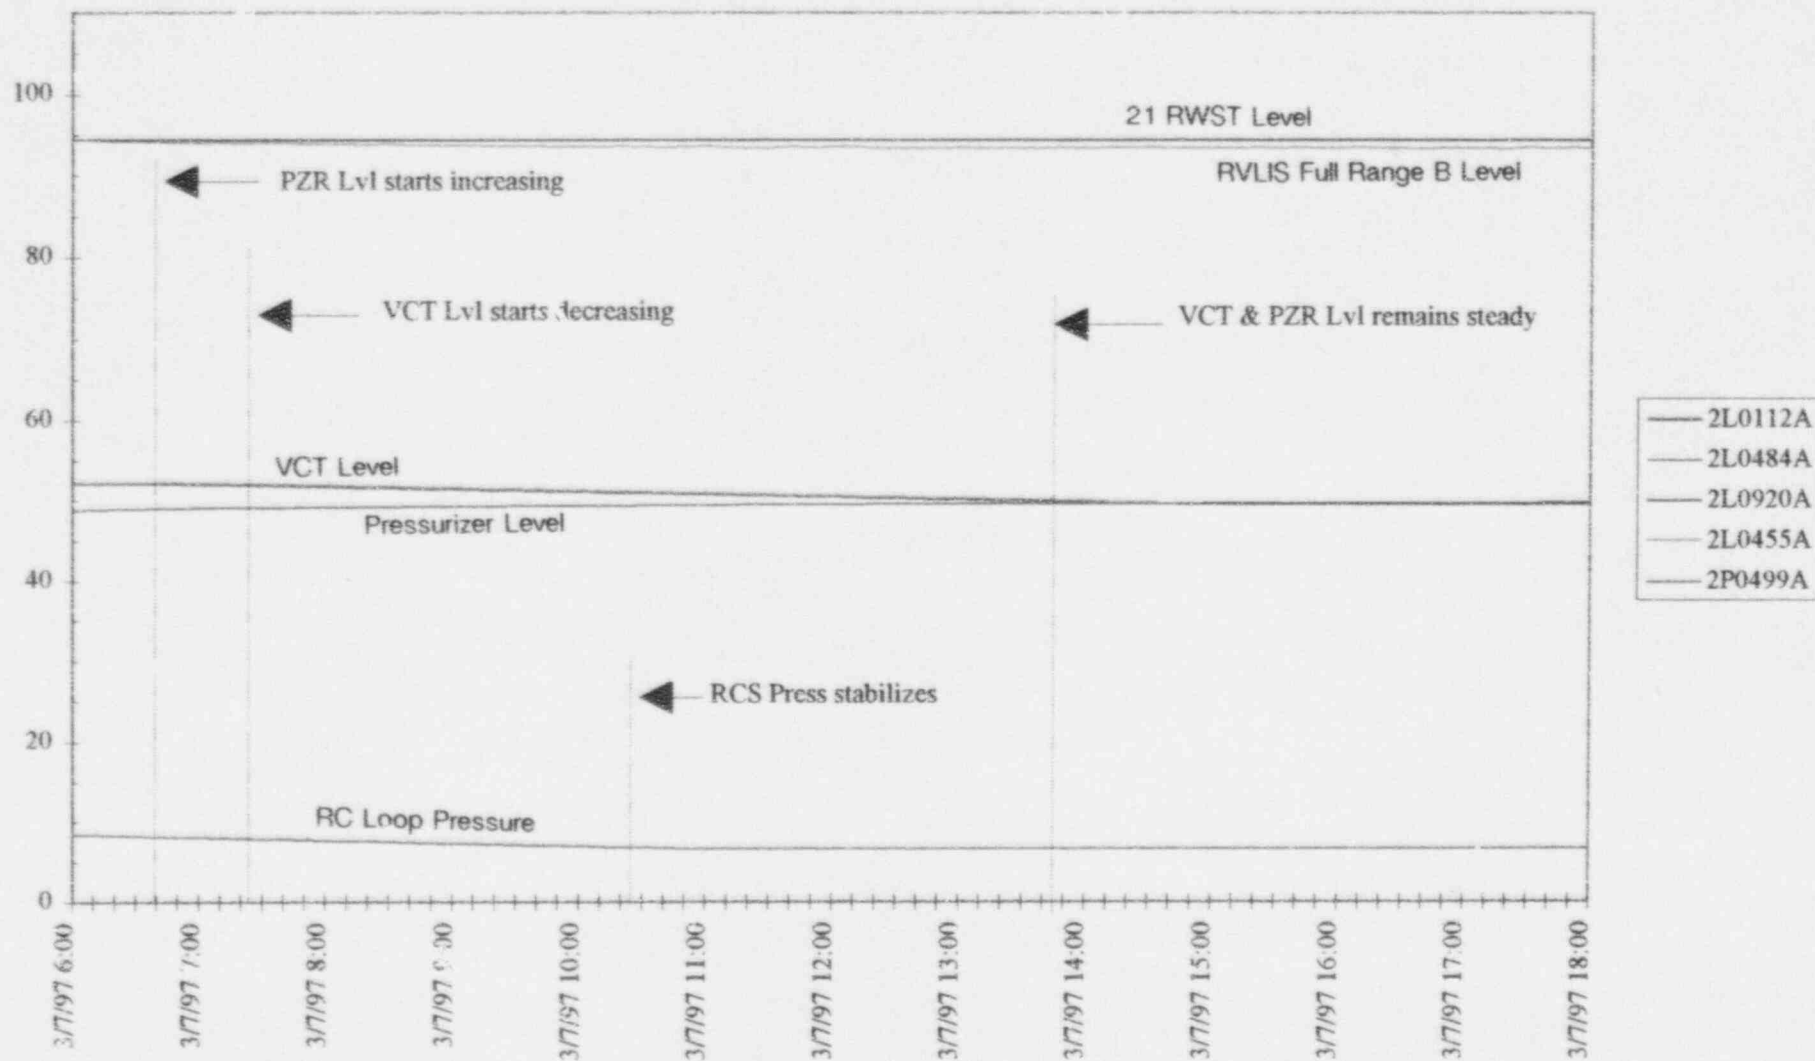
Chart 3

0600 - (Chart 3) The night shift turned over to on-coming crew. The day shift observed RVLIS Full range to be indicating around 94% (100% is full) and concluded that a possible gas void existed in the reactor vessel head. The SOC, Day Shift SM and the Outage Manager discussed this and agreed it wasn't a shutdown cooling issue. Because they did not fully understand how the void was created (they suspected an inadequate vent path but did not know the details) they decided nothing should be done until SV-32096 was repaired and the vent path could be returned to its normal lineup. Repair of SV-37096 continued under WO 9701175 through the shift. PI computer data: PZR Lvl - 48.86%, RVLIS Upper Range B - 97.01%, RVLIS Full Range B - 94.29%, RWST Lvl - 94.44%, RHR Inlet Temp - 91.1 F, RC Loop Press - 8.52 psig, 21 CVCS HUT Lvl (log reading) - 81.5%.

1800 - (Chart 3) The day shift turned over to on-coming crew. The day crew informed them that they suspected that a possible void existed in the reactor vessel head because the RVLIS indications were indicating <100%. PI computer

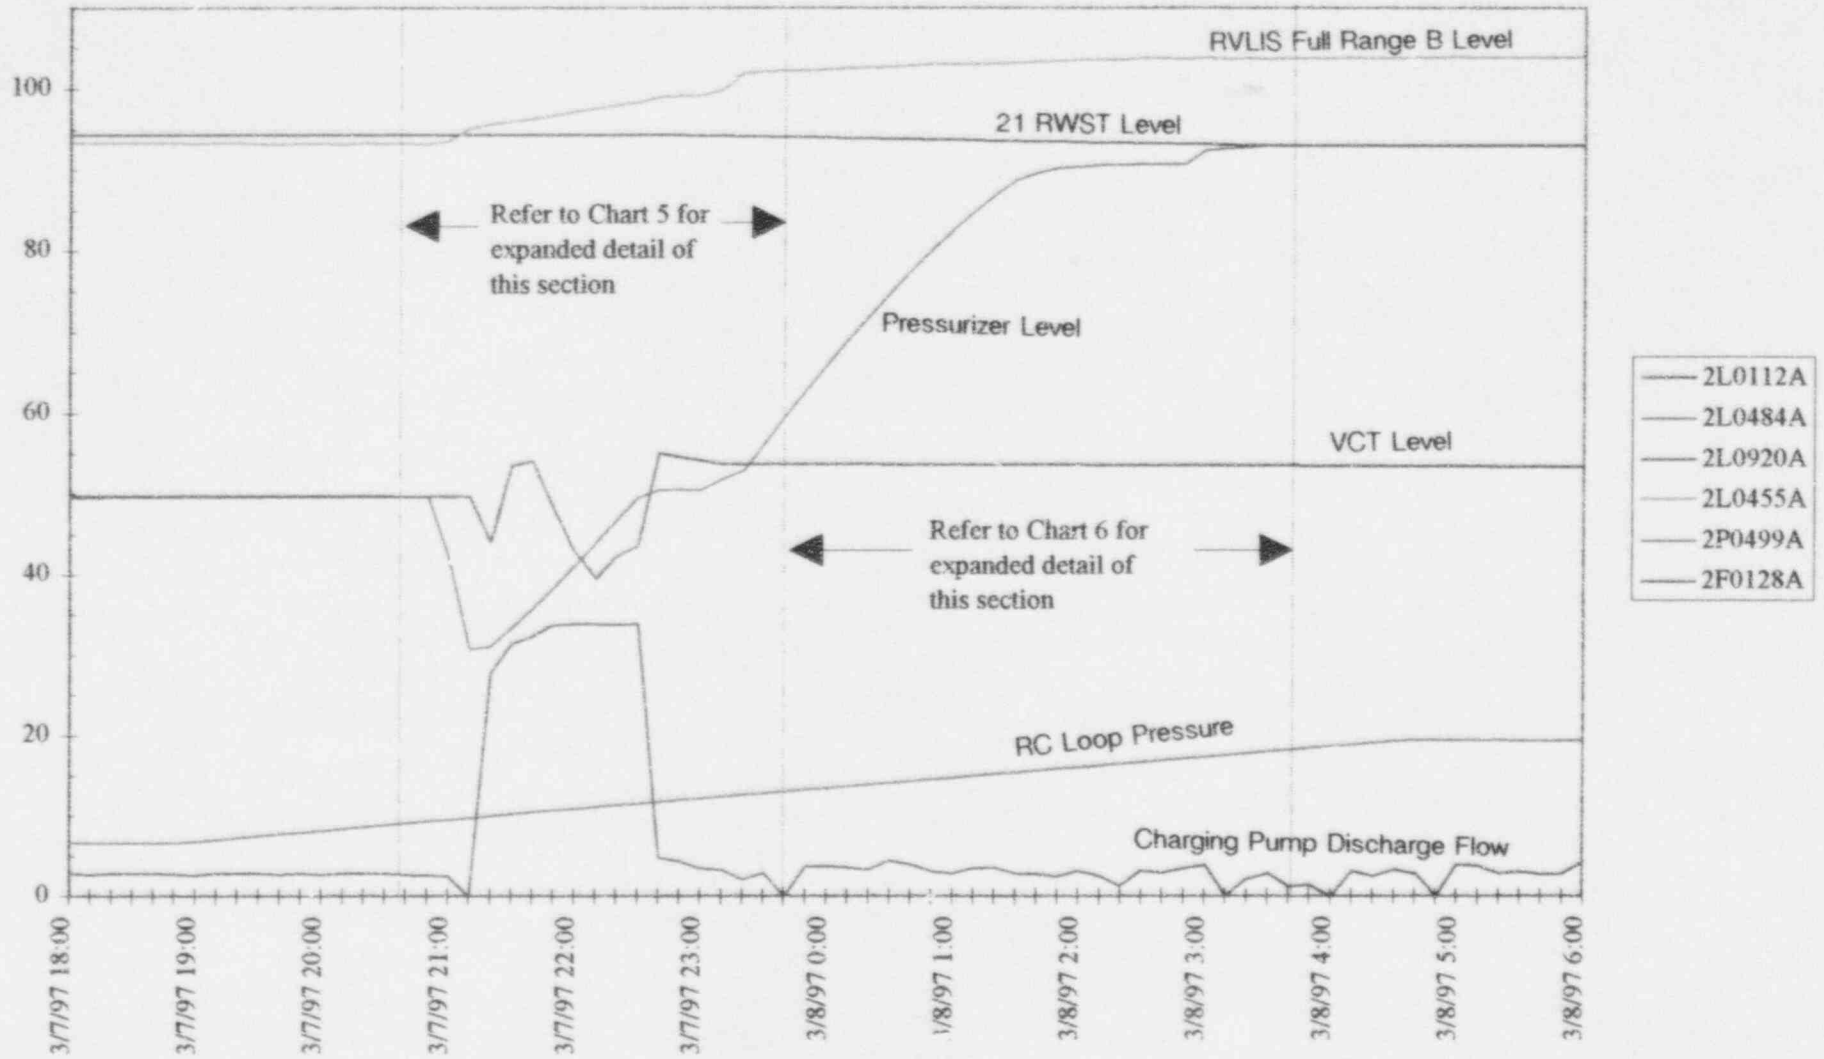
2055 - (Chart 4 & 5) When 2RC-8-16 was cracked open the containment operator could hear air being drawn in through the vent valve and line. The control room operators observed pressurizer cold cal level start to slowly decrease.

About 2110 (Chart 4 & 5) When pressurizer cold cal level reached approximately 30% the control room instructed the containment operator to close 2RC-8-16 so the pressurizer could be refilled. PI computer data: PZR Lvl - 48.24%, RVLIS Upper Range B - 96.45%, RVLIS Full Range B - 92.79%, RWST Lvl - 94.43%, RHR Inlet Temp - 91.5 F, RC Loop Press - 9.54 psig.

2112 - (Chart 4 & 5) The control room operator started blended make-up flow to the VCT and then started 22 Charging Pump to refill pressurizer in accordance with

2230 - (Chart 4 & 5) When pressurizer level reached 50% cold cal 22 Charging Pump was stopped and a few minutes later the blended make-up flow to the VCT was stopped in accordance with C12.1 & C12.5. About 2650 gallons of blended make-up water was charged into the RCS to increase pressurizer level back to 50%. PI computer data: PZR Lvl - 49.51%, RVLIS Upper Range B - 95.90%, RVLIS Full Range B - 98.28%, RWST Lvl - 94.43%, RHR Inlet Temp - 91.4 F, RC Loop Press - 11.65 psig.

About 2237 (Chart 4 & 5) the operator in containment was instructed to reopen and hang the Hold Card on 2RC-8-16 to vent the pressurizer. No air flow through the valve could be heard. The control room observed pressurizer and RVLIS levels for approximately 25 minutes with no noticeable change. The SS then decided to have the reactor head vented to the containment atmosphere by using manual head vent valves that weren't part of the isolation for repairing SV-37096. PI computer data: PZR Lvl - 50.22%, RVLIS Upper Range B - 95.81%, RVLIS Full Range B - 98.63%, RWST Lvl - 94.43%, RHR Inlet Temp - 91.4 F, RC Loop Press - 11.76 psig.

Approximately 2305 (Chart 4 & 5) the operator in containment opened 2RC-8-5, Reactor Vessel-Vent, 2RC-8-31, Reactor Head Vent Flushing Valve, and 2RC-8-33, Rx Head Vent Orifice Bypass, to vent the reactor head. The operator noted air coming from the vent and the control room observed RCS pressure and RVLIS levels increasing and a slow increase in pressurizer level. Around this same (Chart 5 & 7) time it appears (based on computer data that shows RWST level starting a slow decrease, a increase in pressurizer level and VCT level slow decrease leveling off and holding steady) that the control room operator opened MV-32062, 21 RWST To Chg Pump Suct MV, and closed MV-32063, 21 VCT Outlet To Chg Pump Suct Header MV. In order to close the VCT outlet to the charging pump suction MV-32062 has to be opened first to satisfy valve logic. The opening of the RWST to charging pump suction motor valve allowed RWST water to slowly flow through the charging system into the RCS. This was identified during the event evaluation by reviewing PI computer RWST level readings and confirmed by primary chemistry silica sample results which indicated an increase for this time period. PI computer data: PZR Lvl - 50.54%, RVLIS Upper Range B - 96.10%, RVLIS Full Range B - 99.05%, RWST Lvl - 94.40%, RHR Inlet Temp - 91.4 F, RC Loop Press - 12.30 psig.

0003 - (Chart 4 & 6) When RVLIS indicated that the reactor vessel head was full the operator in containment was instructed to close 2RC-8-31 and 2RC-8-33. PZR Lvl 69.7% and increasing, RVLIS Full Range 102%, RVLIS Upper Range 99%. PI computer data: PZR Lvl - 67.02%, RVLIS Upper Range B - 98.72%, RVLIS Full Range B - 102.46%, RWST Lvl - 94.10%, RHR Inlet Temp - 91.4 F, RC Loop Press - 13.65 psig.

0350 - (Chart 4) PI computer data (readings before drain down enclosed in []): PZR Lvl - 93.15% [93.97%], RVLIS Upper Range B - 99.51% [102.48%], RVLIS Full Range B - 103.70% [99.67%], RWST Lvl - 93.11% [94.44%], RHR Inlet Temp - 91.4 F [90.9 F], RC Loop Press - 18.50 psig [16.84 psig].

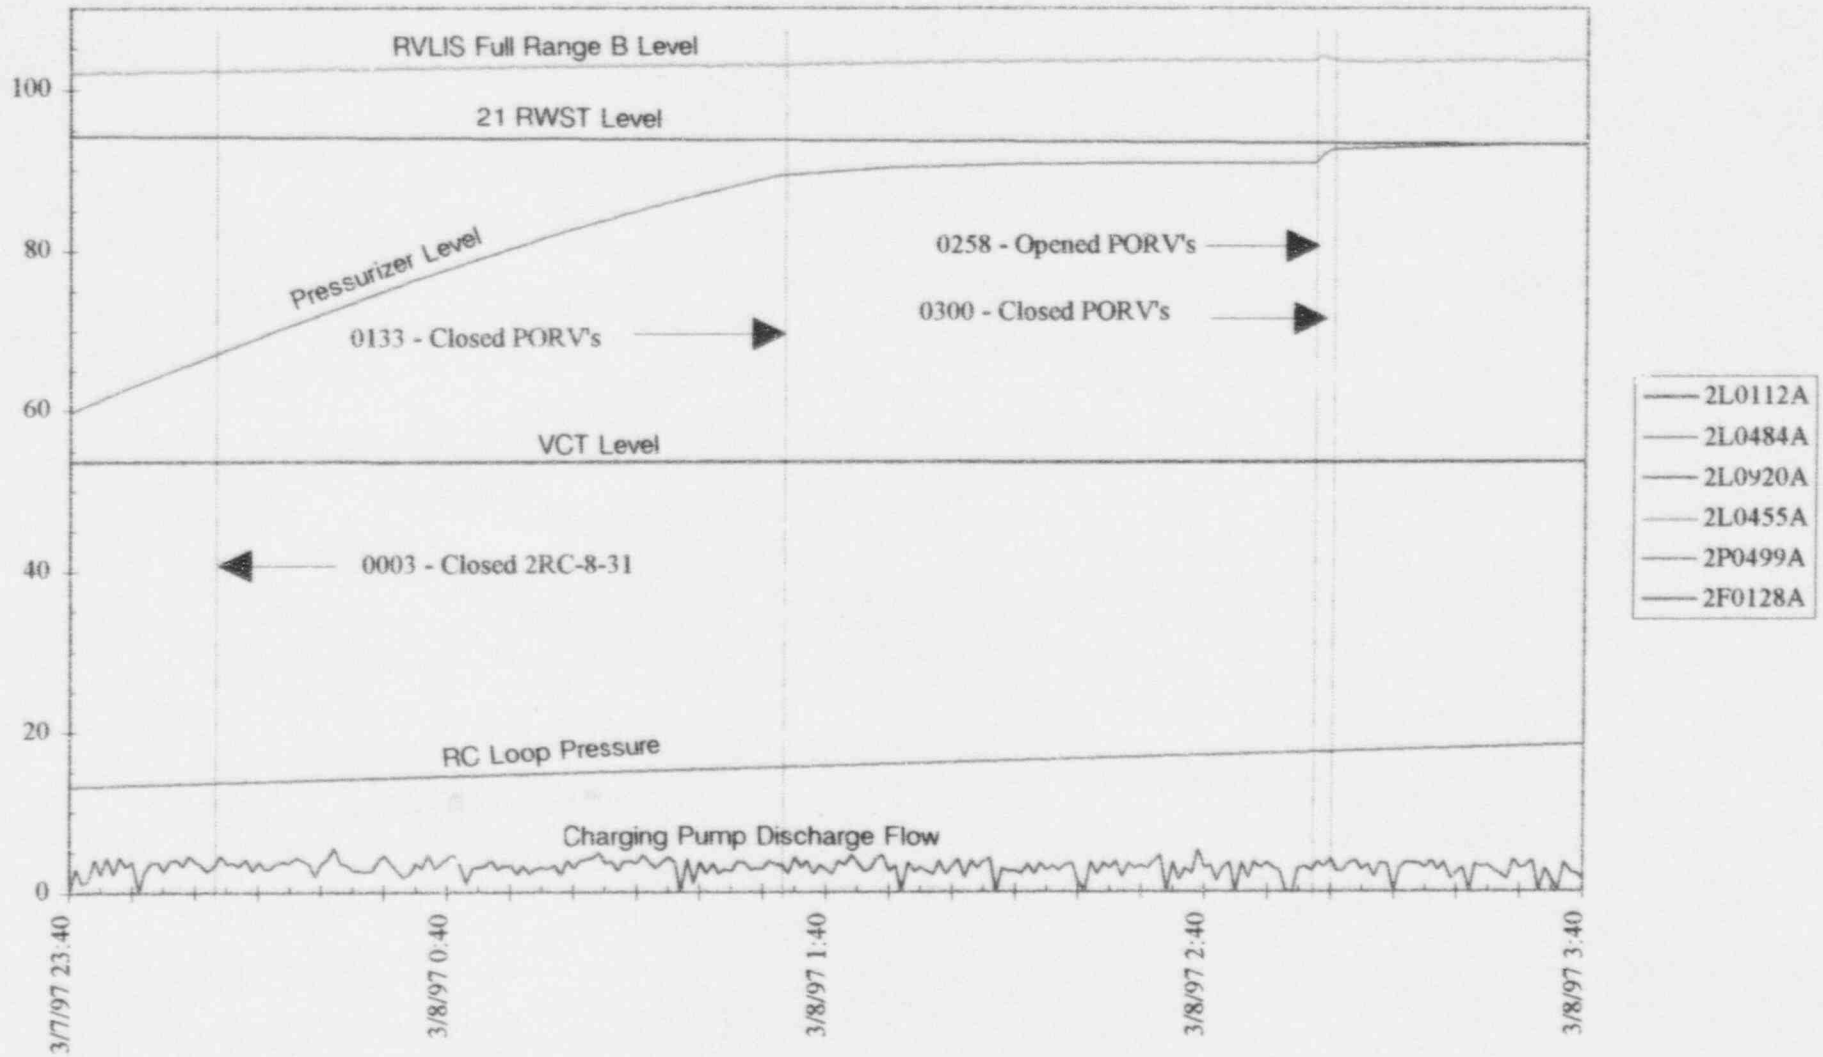
Chart 6

Pressurizer level continued to slowly increase (Chart 4 & 6) after the reactor head vent valves were closed. The control room operators discussed possible sources of water (RMU tanks, RWST, BAST, SG tubes) that could be causing pressurizer level to increase. Control board tank level indicators were checked and indicated no change. The RWST MVs to the RHR system were checked and found to be closed. From these indications control room personnel concluded that the most likely source of water causing the increase in pressurizer level was from the steam generator (SG) tubes. After the reactor head vent valves were closed the pressurizer was still vented to the containment atmosphere via the PORVs, 2RC-8-16 & 2RC-14-1.

0133 - (Chart 4 & 6) Closed both PORVs because pressurizer level continued to increase. Closing the PORVs isolated the pressurizer vent path to the containment atmosphere and slowed the level increase down until it leveled off. PI computer data: PZR Lvl - 89.29%, RVLIS Upper Range B - 98.56%, RVLIS Full Range B - 103.02%, RWST Lvl - 93.69%, RHR Inlet Temp - 91.4 F, RC Loop Press - 15.57 psig.

0258 - (Chart 4 & 6) Opened both PORVs to determine if the pressurizer level had stabilized. When the valves were opened pressurizer cold cal level started to increase. PI computer data: PZR Lvl - 91.50%, RVLIS Upper Range B - 99.62%, RVLIS Full Range B - 104.27%, RWST Lvl - 93.30%, RHR Inlet Temp - 91.4 F, RC Loop Press - 17.59 psig.

0300 - (Chart 4 & 6) Closed both PORVs to stop the pressurizer level increase. PI computer data: PZR Lvl - 92.50%, RVLIS Upper Range B - 99.98%, RVLIS Full Range B - 103.63%, RWST Lvl - 93.29%, RHR Inlet Temp - 91.4 F, RC Loop Press - 17.4 psig.
