In Reply Refer To: Docket: 50-267

This forwards a copy of a letter from Promatec, dated February 17, 1986, for your information. This letter was a 10 CFR Part 21 report concerning defective material used in fire stops and may be applicable to the installations in your facility.

Reference: 10 CFR Part 21 - Notification of Defects

Pursuant to the provisions of 10 CFR Part 21 - Reporting of Defects and Noncompliance, notification is hereby given of the existense of defective conduit seals at Waterford 3 and other nuclear generating stations as identified herein. Final information leading to this report was obtained on February 13, 1986 at 12:00 p.m. and verbal notification as required by § 21.21 (2) was given on February 14, 1986 at 8:36 p.m. to Mr. David Powell, U.S. Nuclear Regulatory Commission, Washington, D.C.

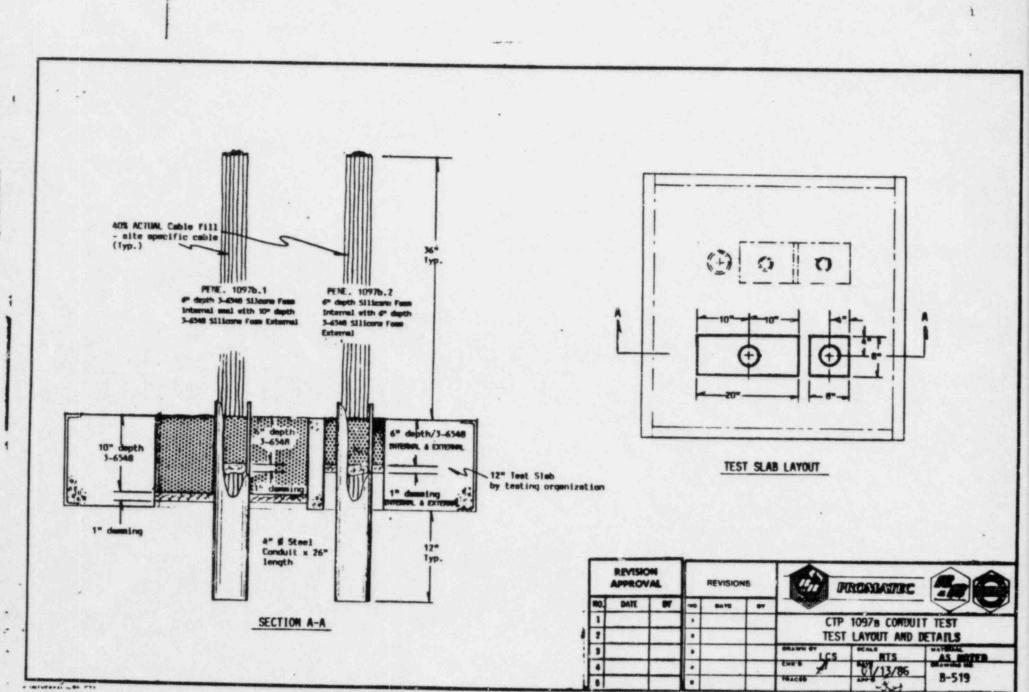
One 8" x 8" blockout and one 8" x 20" blockout in a 12" thick concrete slab with two (2) conduit penetrators as described below and detailed on drawing no. 8-519 (attachment 1).

- 1.1 4" diameter x 27" long steel conduit
- 1.2 40% actual fill of IEEE 383 rated cables. Cables were a total length of 62" and extended a minimum 36" above the slab.
- 1.3 Conduit extended a minimum 1" above the top of the slab and a minimum 12" into the furnace below the slab. Cable fill and mix within each conduit was similar to the ANI/ MAERP requirement of one-third 16 GA/2 cond (Representing instrumentation cable), one-third 12 GA/7 cond (Representing control cable), and one-third 300 MCM/1 cond (Representing power cable).
- 2.0 Penetration and Conduit Seal Characteristics
  - 2.1 Materials used in installation consisted of:

- 2.1.1 Damming and cable separation Alumina Silica Fiberous Material (Bulk and Board).
- 2.1.2 Penetration and conduit seal Dow Corning 3-6548 Silicone RTV Foam
- 2.2 Penetration and conduit seal configurations were as follows:
  - 2.2.1 Configuration 1097b.1 Conduit seal with a minimum depth of 6" plus 1" damming as measured from the top of the slab; penetration seal with a minimum depth of 10" plus 1" damming as measured from the top of the slab.
  - 2.2.2 Configuration 1097b.2 Conduit seal with a minimum depth of 6" plus 1" of damming as measured from the top of the slab; penetration seal with a 6" depth plus 1" of damming as measured from the top of the slab.

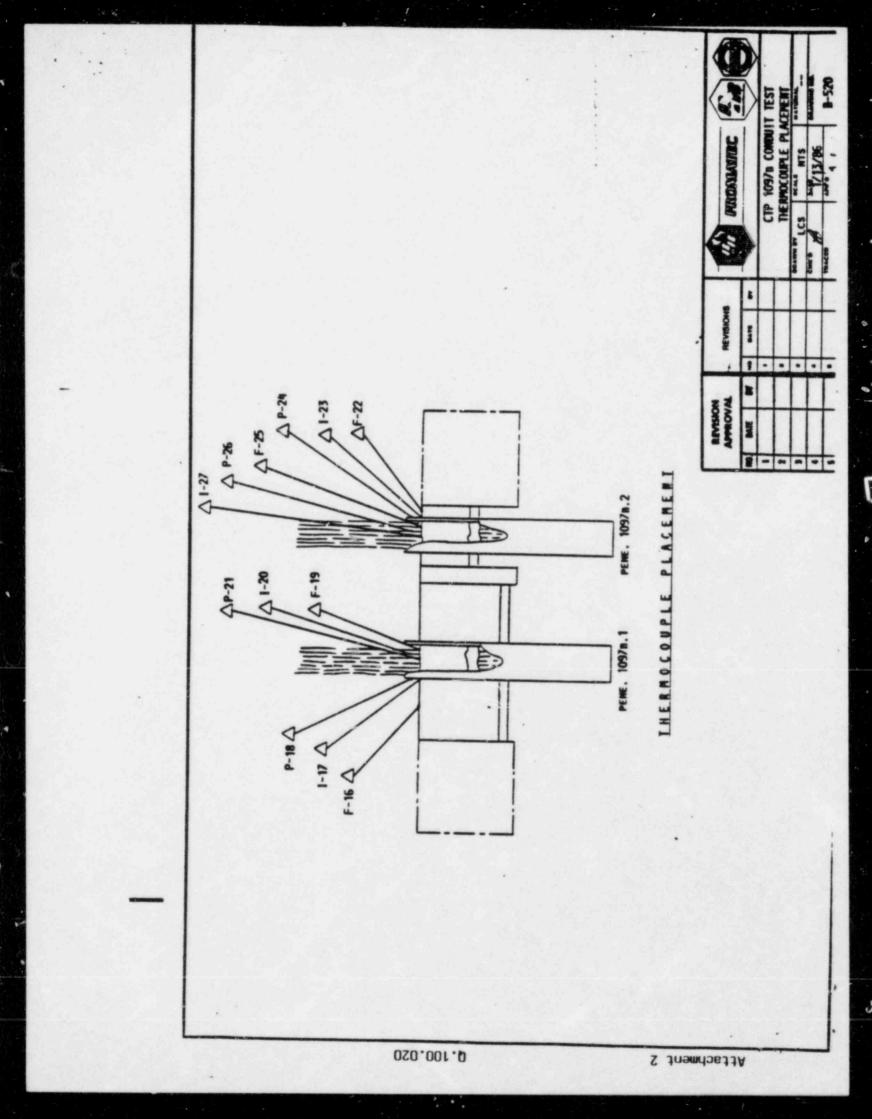
- 3.1 Thermocouples were located in accordance with the requirements of IEEE 634 and ASTM E119 as shown on drawing no. B-520 (attachment 2).
- 3.2 The prepared test slab assembly was exposed to the standard time temperature curve established by ASIM E119 for a period of three (3) hours with the following results:

- 3.2.1 Configuration 1097b.2 Thermocouple F-19 exceeded the maximum allowable with a temperature of 401° F at 1 hour, 23 minutes and a three (3) hour reading of 659° F.

- 3.2.2 Configuration 1097b.1 Thermocouple F-25 exceeded the maximum allowable with a temperature of 401° F at 2 hours, 14 minutes and a three (3) hour reading of 446° F.

- 3.3 While no flame through was noted on the unexposed side and hose stream tests did not cause openings, heat transmission as indicated by the field thermocouples exceeded the maximum temperature requirement of 325° F above ambient. An autopsy was performed and resulted in the discovery that both conduit seals were reduced to ash.
