**ATTACHMENT 1**  
Description and Assessment

Subject: Application for Revision to TS 5.5.9, "Steam Generator (SG) Program," for a One-Time Deferral of Steam Generator Tube Inspections

This proposed amendment request revises TS 5.5.9, "Steam Generator (SG) Program," for a one-time revision to the frequency for SG tube inspections. The requested TS amendments support deferral of the TS required inspections until the next Unit 2 refueling outage, which is scheduled in spring 2022 (B2R23).

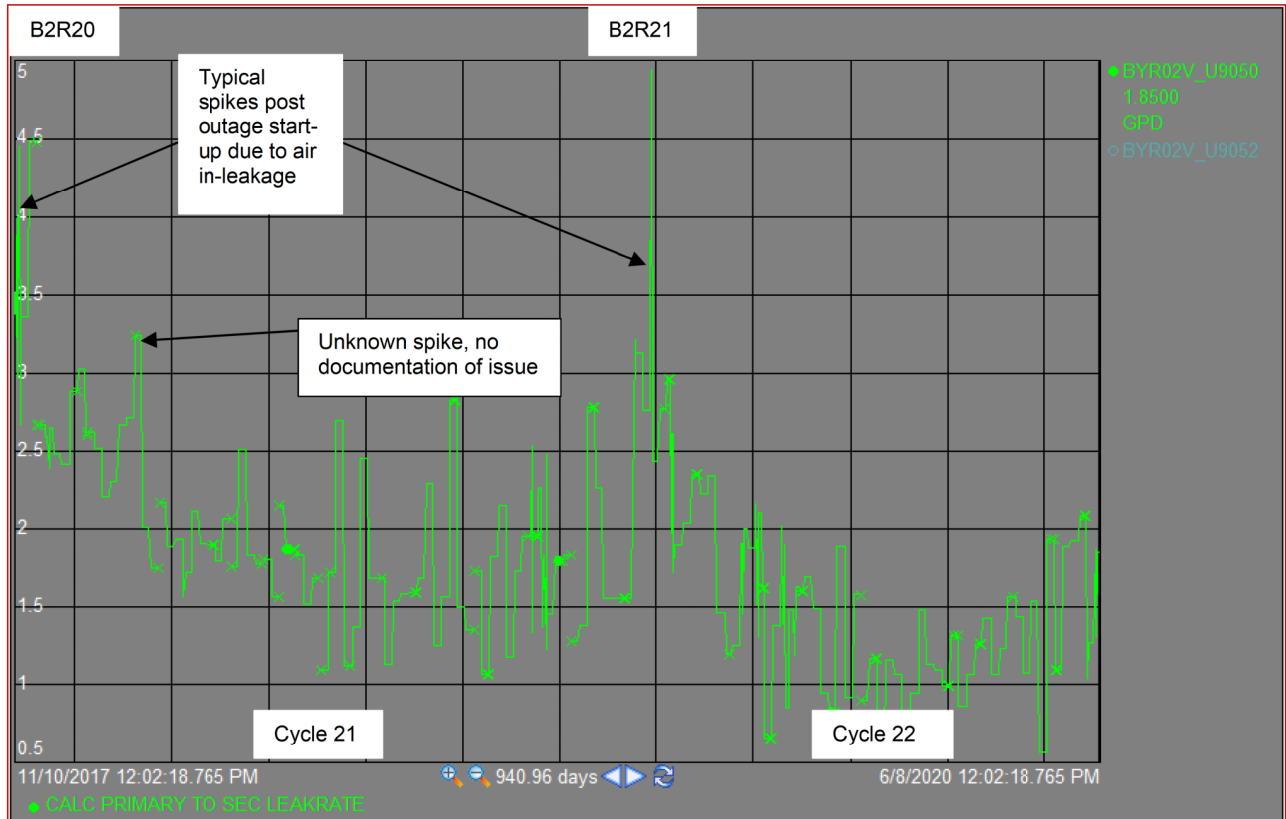
Figure 1: Primary to Secondary Leak Rate for Operating Cycles 21 and 22

No primary to secondary side leakage has been noted for operating Cycles 21 and 22. As seen in Figure 1, all trends are below 3 gallons per day (gpd), except for a spike occurring around February 23, 2018, possible due to computer point error since no issue was documented. Other typical spikes which occurred post refueling outages were due to air in-leakage issues and not related to primary to secondary leakage. The primary to secondary leak rate determination utilizes the Condenser Offgas method, which uses steam jet air ejector (SJAЕ) flow. During unit start-ups, these flows are normally higher due to systems being returned to service. The high SJAЕ flow causes a higher apparent primary to secondary leak rate during start-up and post outage which are not related to actual primary to secondary leakage.

Section 3.2.4 discusses the threshold for actions due to confirmed primary-to-secondary leakage and planned mitigating strategy that will be implemented during the extended operating cycle from B2R22 to B2R23.
