U.S. NUCLEAR REGULATORY COMMISSION
REGION I

Report No. 50-219/85-28

Oyster Creek Nuclear Generating Station

2.0 Followup of Unit Substation Transformers 1A2 and 1B2 Low Oil Level Event

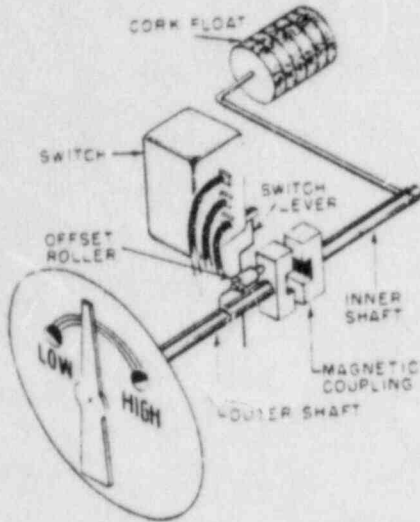
Fig. 1. Schematic view of magnetic liquid-level gage with alarm switch

Another instrument problem was the liquid level gauge. The accuracy of the level gauge required to sense small level changes in the transformer cooling headers is critical. The present level gauge may not have the required accuracy to indicate these small level changes in the cooling header to the extent that an operator could determine the onset of cooling degradation. In addition, the level indicator is not graduated to show the normal levels at various temperatures. It shows an acceptable range of level with minimum and maximum levels, the center point being the nominal level at 25°C (see Attachment 5). With the newly established higher levels in the transformers, the licensee plans to recalibrate the liquid level gauges to provide an accurate indication of the expected levels at various operating temperatures, or alternatively, provide a table or chart so that the operator can immediately determine if the levels are within acceptable limits.

Item 2 involves development of sampling and filling procedures and guidances. This item also includes the recalibration of the liquid level gauges to provide proper operator guidance on its use. The licensee committed to complete this item by the end of the April 1986 refueling outage.

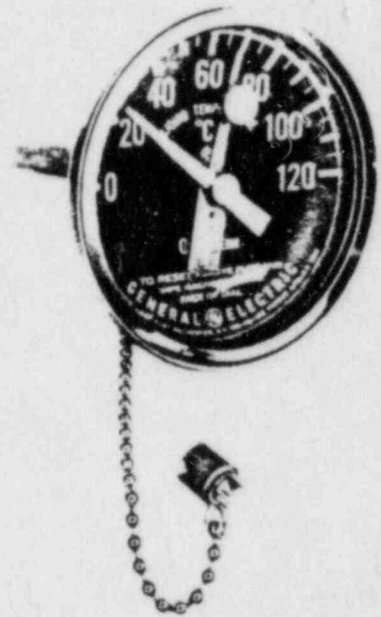
Fig. 2. Type AL liquid temperature indicator

Some problems with instrumentation were discovered during the licensee's investigation. The liquid temperature indicator on the 1A2 transformer did not give an accurate reading of the oil temperature. This also contributed to the event in that the instrument was not accurately indicating the status of the transformer. The temperature indicator is installed in a cooling fin tube header. To display an accurate liquid temperature reading, its sensor must be submerged in the transformer oil. This particular cooling fin tube header was one of those that did not receive any oil flow as a result of the low oil level. During licensee testing of the vital transformer, a portable pyrometer was used to measure the oil temperature. Once the oil flow in the cooling fin with the installed temperature device was established, the pyrometer and installed temperature sensor compared favorably. With the newly established higher levels in the transformers, this problem will not exist because the sensors of the liquid level indicators will be submerged in oil all the time.

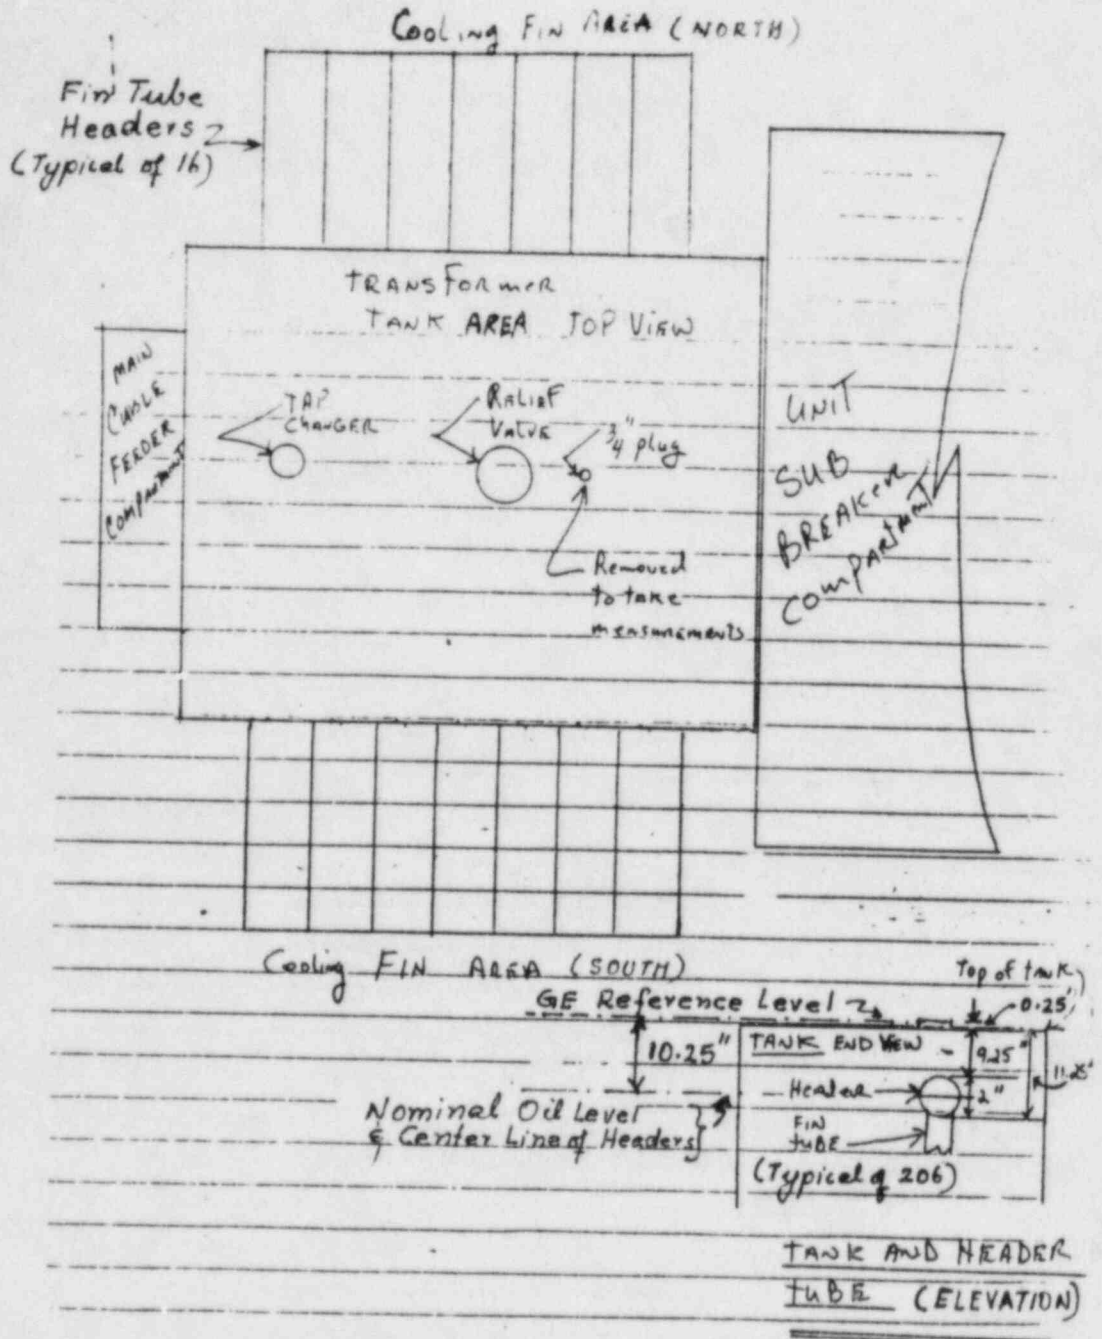
ATTACHMENT 6
SKETCH OF TRANSFORMER SHOWING THE NOMINAL OIL LEVEL

The transformers are rated for a 65°C rise over an ambient of 30°C. The nominal liquid level at 25°C is 10.5 inches below the reference point which is 0.25 inches above the top of the tank (See Attachment 6). The nominal nitrogen pressure is approximately 2-3 psig. The relief valve is set to relieve the nitrogen pressure if it exceeds 5 psig.

The apparent cause of the event was insufficient oil in the fin tubes. As a result of variable tube heights as the tubes extend into the fin tube headers, and the headers not being completely full of oil, flow of oil would not necessarily occur in all fin tubes. The licensee's investigations indicate that this condition has existed since the original plant installation. This is based on the following reasoning.

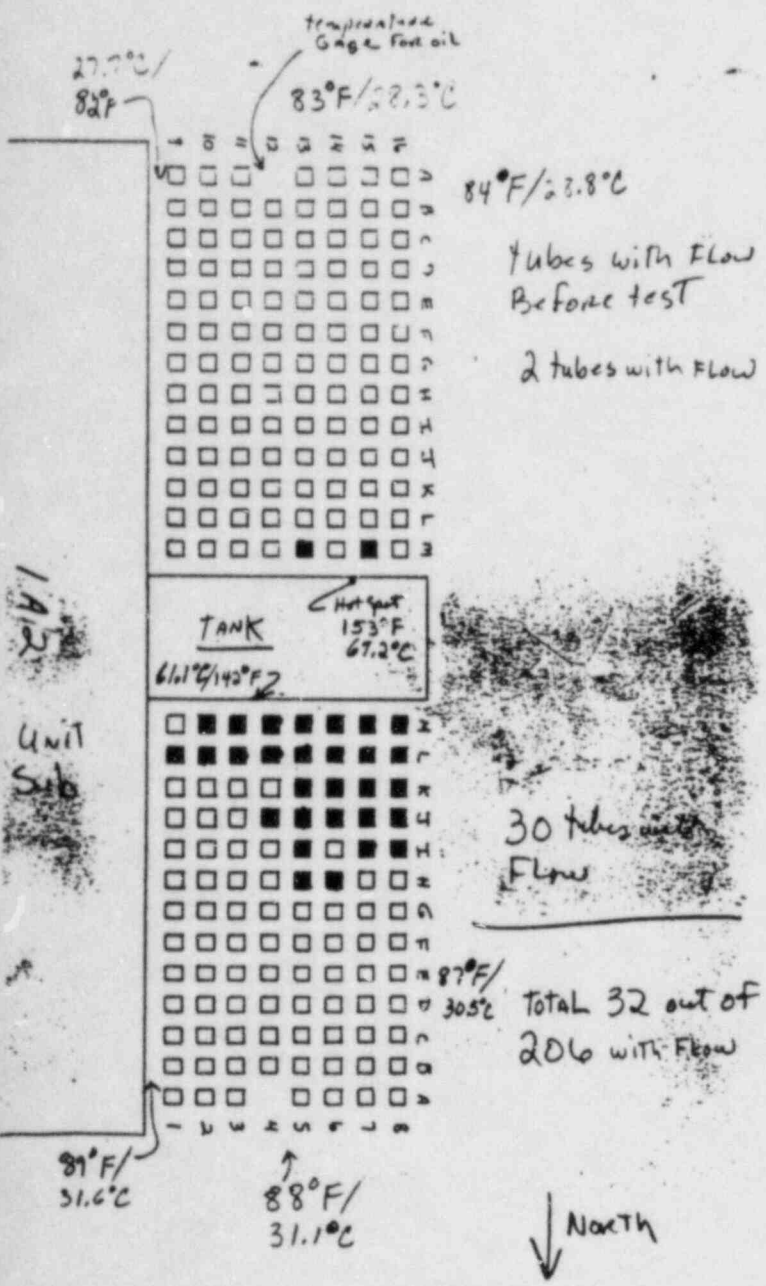
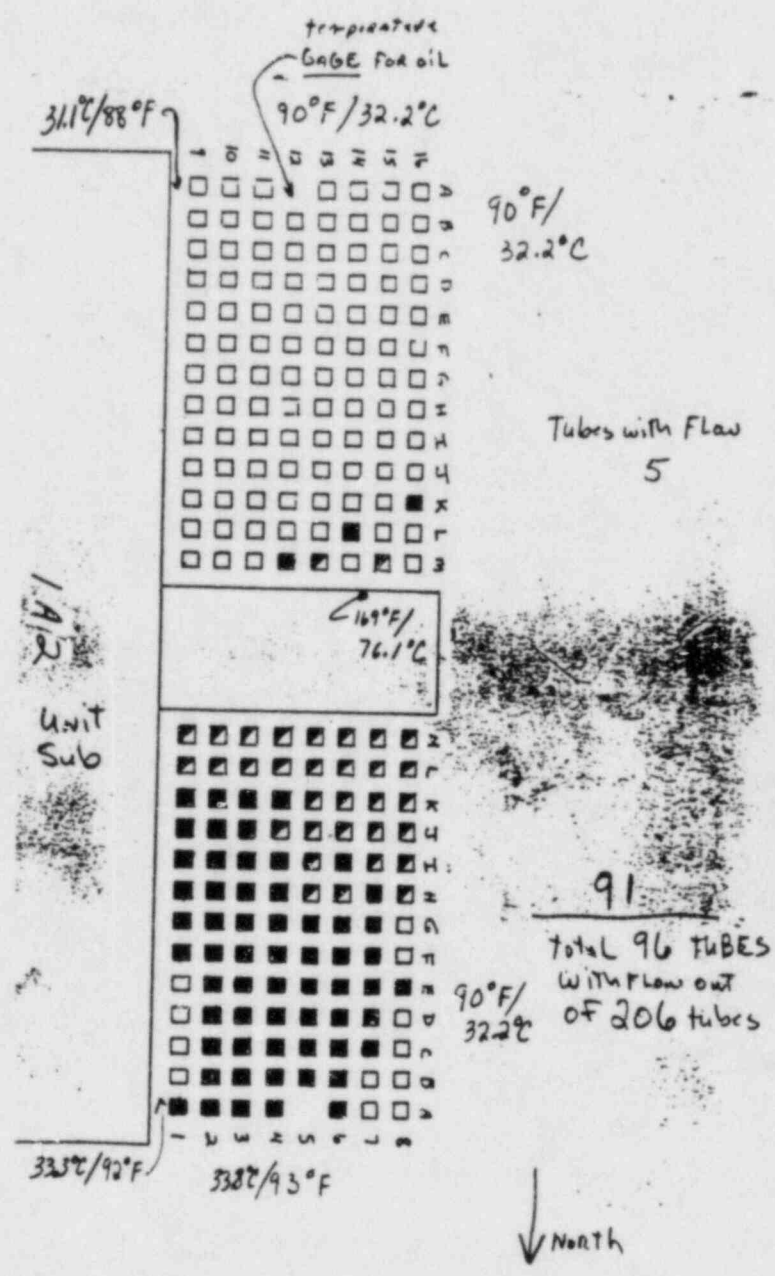
ATTACHMENT 7
SKETCH OF FIN TUBES SHOWING FLOW
BEFORE AND DURING LOAD TEST ON 1A2

The 1A2 transformer was chosen because thermographic photographs indicated that it had less oil flow in its fin tubes than 1B2. The load test on 1A2 was conducted on August 8, 1985. During the test, it was noticed that the liquid temperature gauge located on a top fin tube header did not move from the 32°C mark. The tank temperature was 76.1°C, as measured with a contact pyrometer. Prior to the test, 32 out of a total of 206 tubes had flow; and after the test, an additional 64 tubes had flow (see Attachment 7). This indicated that, at higher loading of the transformer with resultant heating and volume increase of the oil, more tubes received flow of oil.
