NRC Inspection Report: 50-267/88-26

Facility Name: Fort St. Vrain (FSV)

Inspection Conducted: October 17-21, 1988

Areas Inspected: Reactive, announced inspection of the failure of the emergency diesel generator output breakers to automatically close during an October 11, 1988, test and a routine inspection of the instrument calibration program.

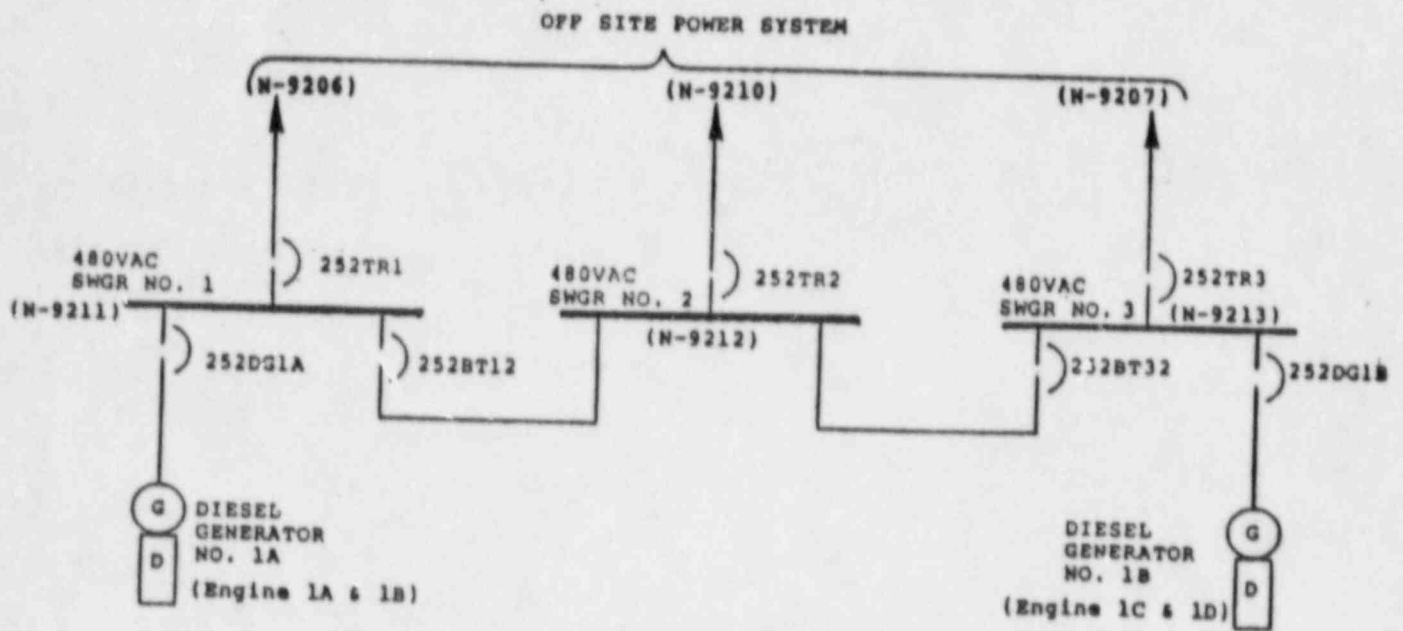
FIGURE 1

SIMPLIFIED ONE-LINE DIAGRAM
OF BREAKER LINE-UP
