U.S. NUCLEAR REGULATORY COMMISSION

Report No. 99-02

Facility: Three Mile Island Station, Unit 1

Dates: March 14, 1999 through April 24, 1999

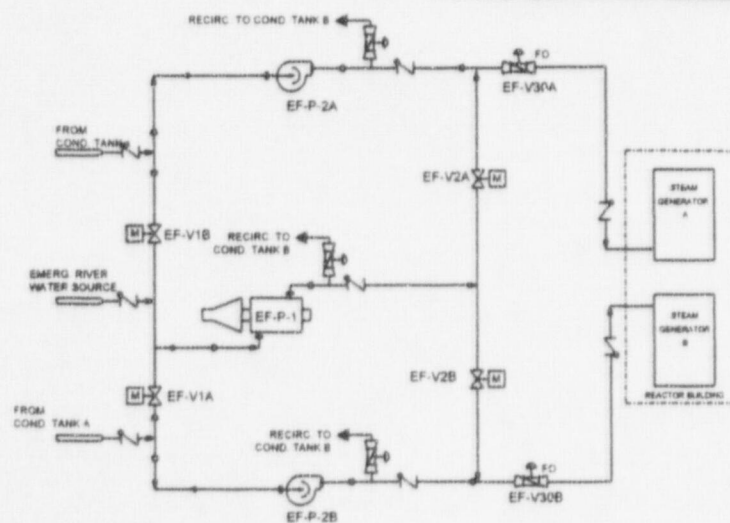
## System Description (original)

- The Original Design: Not safety grade, TDP auto started on loss of RCPs or MFPs, MDPs were manually started (and if necessary, EDG loaded).
- Post TMI-2 ASLB modifications: Significantly altered the physical system and introduced a revised set of design requirements and system design basis. Major changes were
  - MDP Auto-start & 1E power, control and indication upgrades
  - Cavitating Venturis to limit flow to failed OTSG and minimize overcooling
  - Redundant control valves
  - Pump recirculation valves blocked open
