U.S. NUCLEAR REGULATORY COMMISSION
REGION I

Report No. 50-322/87-09

Facility Name: Shoreham Nuclear Power Station

Meeting Summary: Management Meeting at Region I office on April 4, 1987 to discuss the Loss of Offsite Power Event of March 18, 1987. The licensee discussed the event including the cause and correction action to prevent future occurrences.

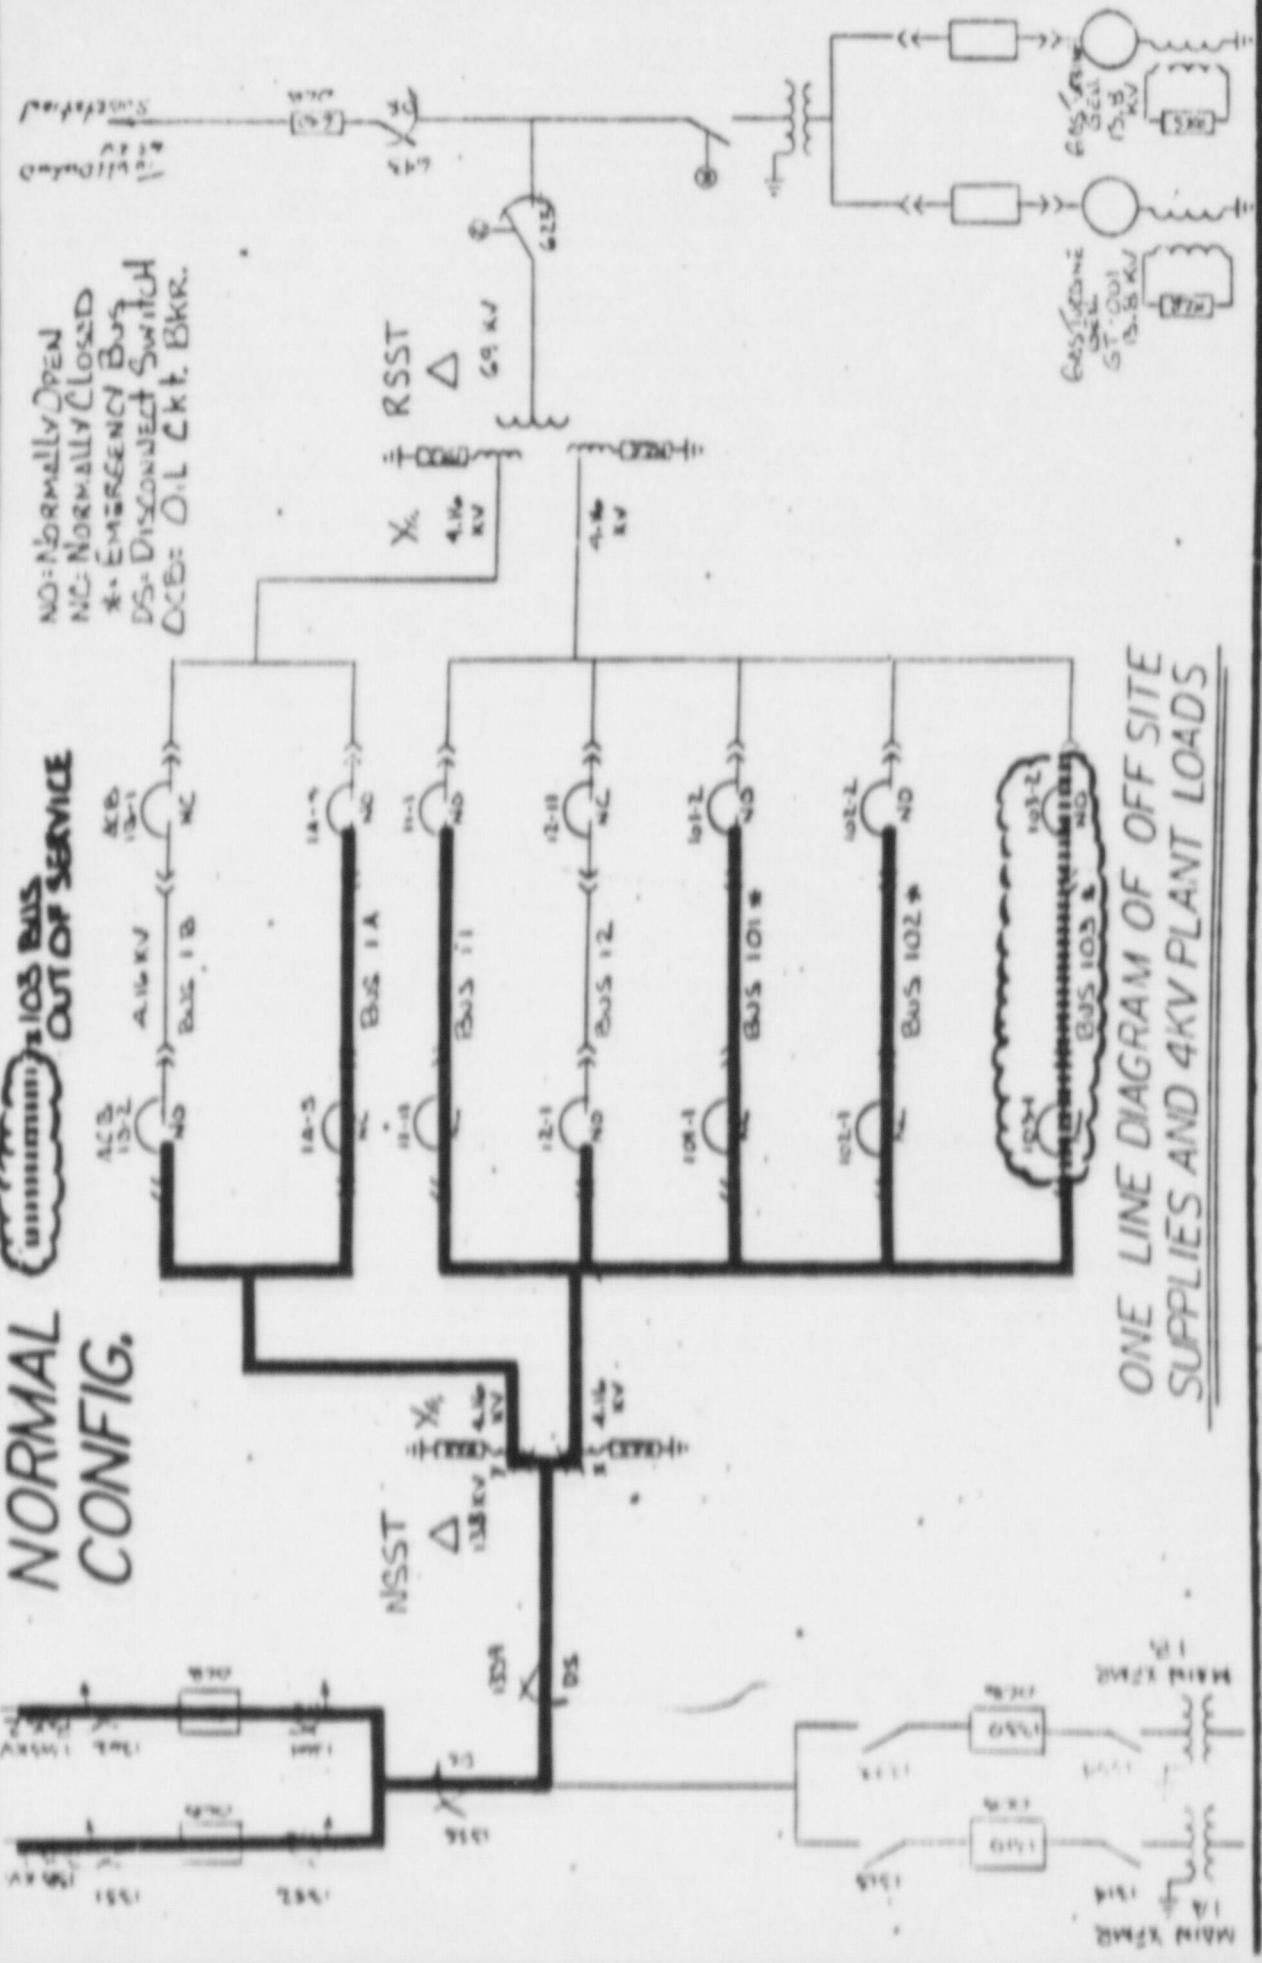
ONE LINE DIAGRAM OF OFF SITE SUPPLIES AND 4KV PLANT LOADS

BUS 105 OUT OF SERVICE

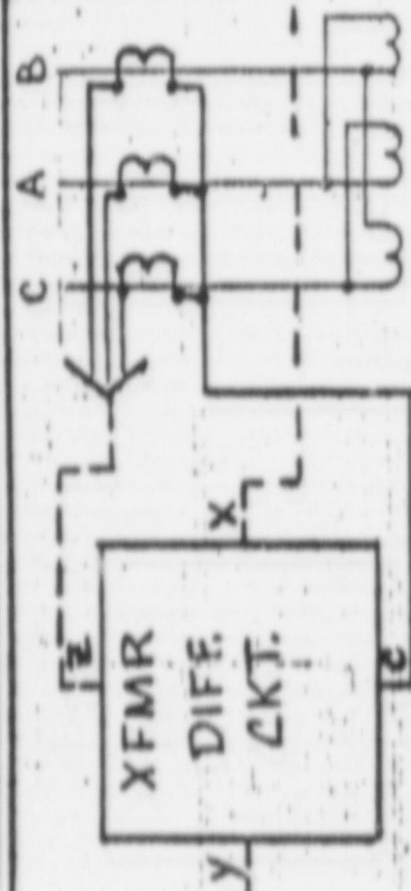
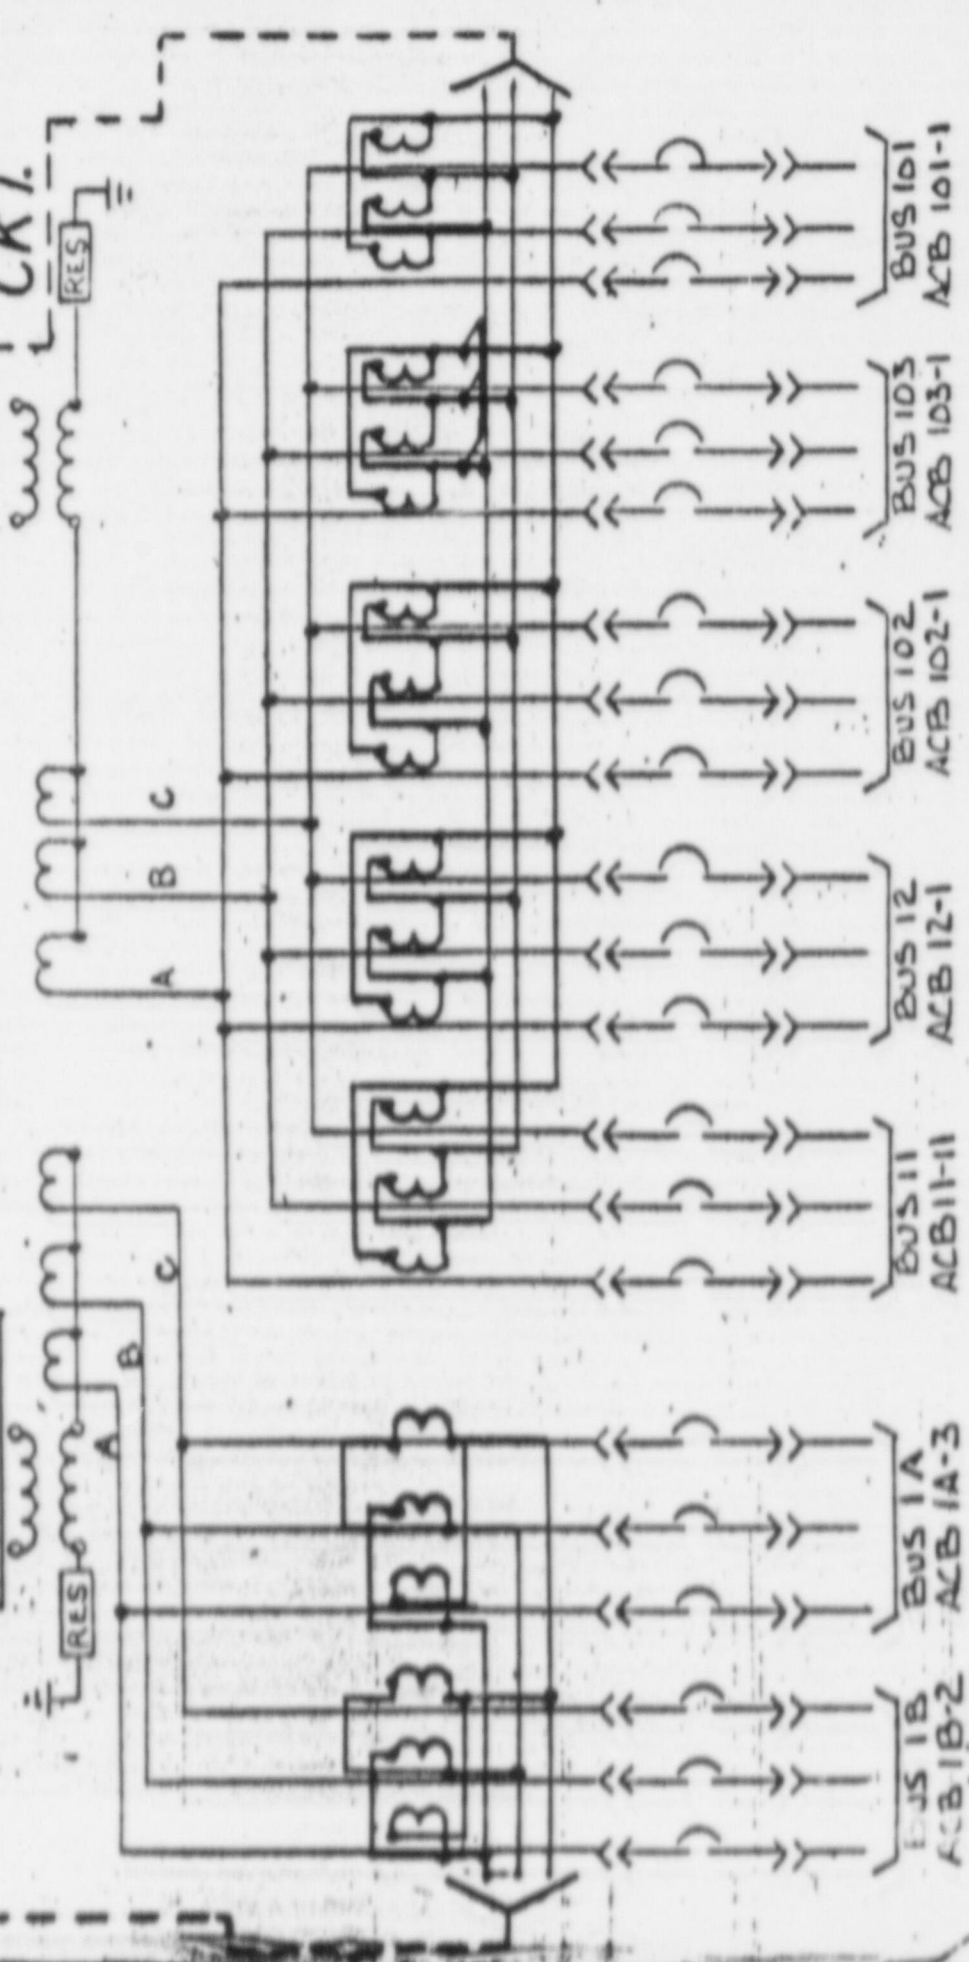
NSST
3PHASE
DIAG.

- 0 SHORTING OF BUS 103 CT CIRCUITRY (PUT UP SLIDE)
- 0 BOTH NSST AND RSST DIFF. PROT. RELAY CIRCUITS WERE AFFECTED BY SHORTING ALL THE CTs ON BUS 103
- 0 "A" CONDENSATE PUMP BUMPED
- 0 THE "SENSED" CT CURRENT, TRIPPED ØC NSST DIFFERENTIAL PROTECTION RELAY
- 0 NSST DIFF. RELAY ACTIVATED - LOCKING OUT THE NSST
- 0 LOCKOUT OF THE NSST INITIATED A FAST TRANSFER TO THE RSST
- 0 THE "SENSED" CT CURRENT, TRIPPED ØA, ØB, ØC RSST DIFF. PROTECTION RELAYS
- 0 RSST DIFF. RELAYS ACTIVATED - LOCKING OUT THE RSST
- 0 LOSS OF OFFSITE POWER

FOR
NSST CT JUMPERS
ON
NSST DIFF.
CKT.

- o REMOVED SHORTING PINS FROM DIFF. CIRCUIT CT'S (TIME 1000)
- o NSST DIFF. RELAYS CHECKED AND SETPOINTS VERIFIED
- o RSST DIFF. RELAYS CHECKED AND SETPOINTS VERIFIED
- o "A" CONDENSATE PUMP MEGGER TESTED AND SATISFACTORY
- o "A" CONDENSATE PUMP SUPPLY BREAKER PROT. RELAY & CIRCUIT CHECKED AND SATISFACTORY

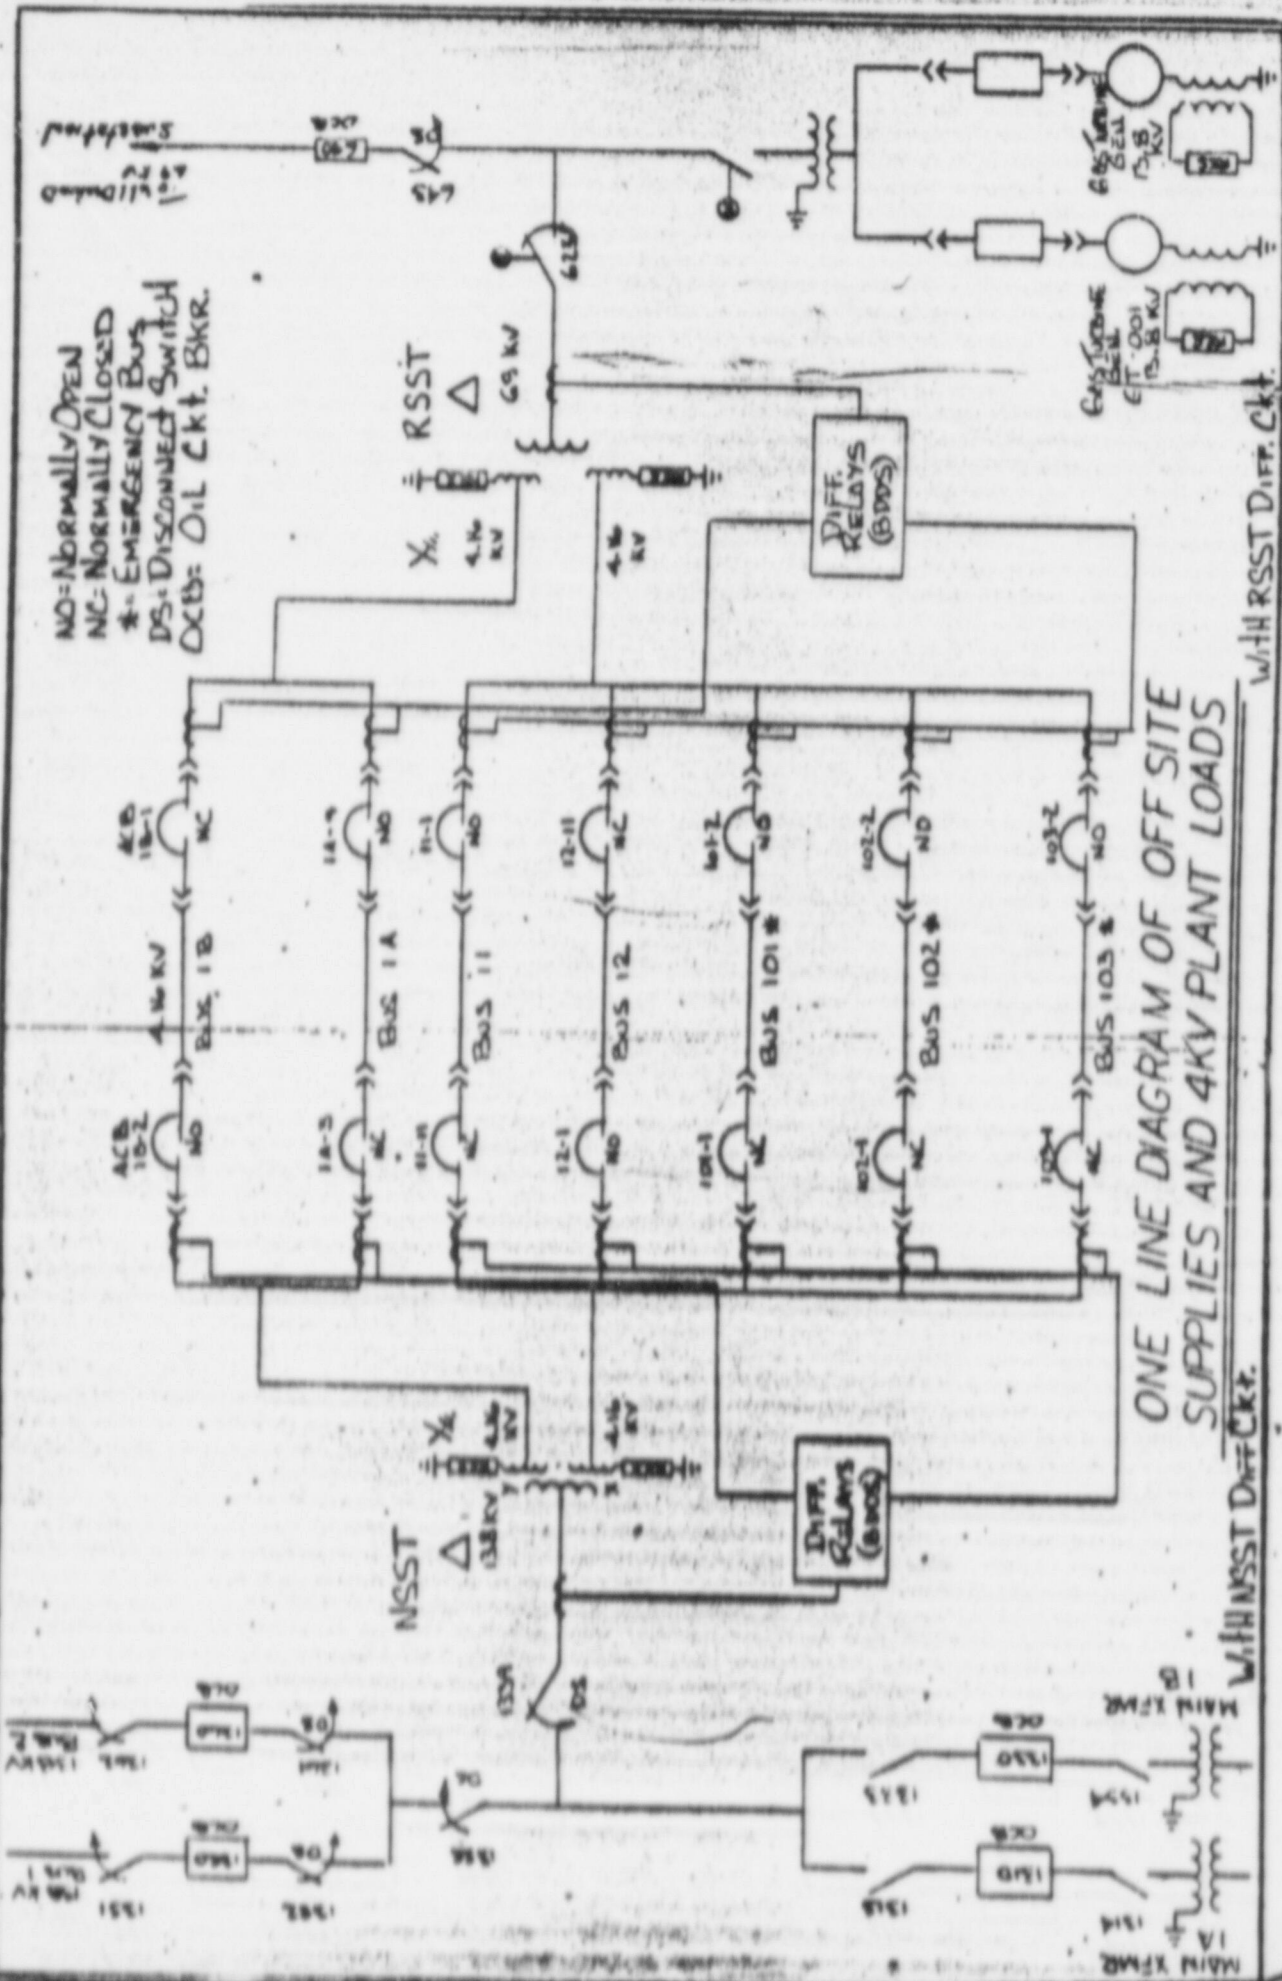
ONE LINE DIAGRAM OF OFF SITE
 SUPPLIES AND 4KV PLANT LOADS

WITH RSST DIFF. CKT.

WITH NSST DIFF. CKT.

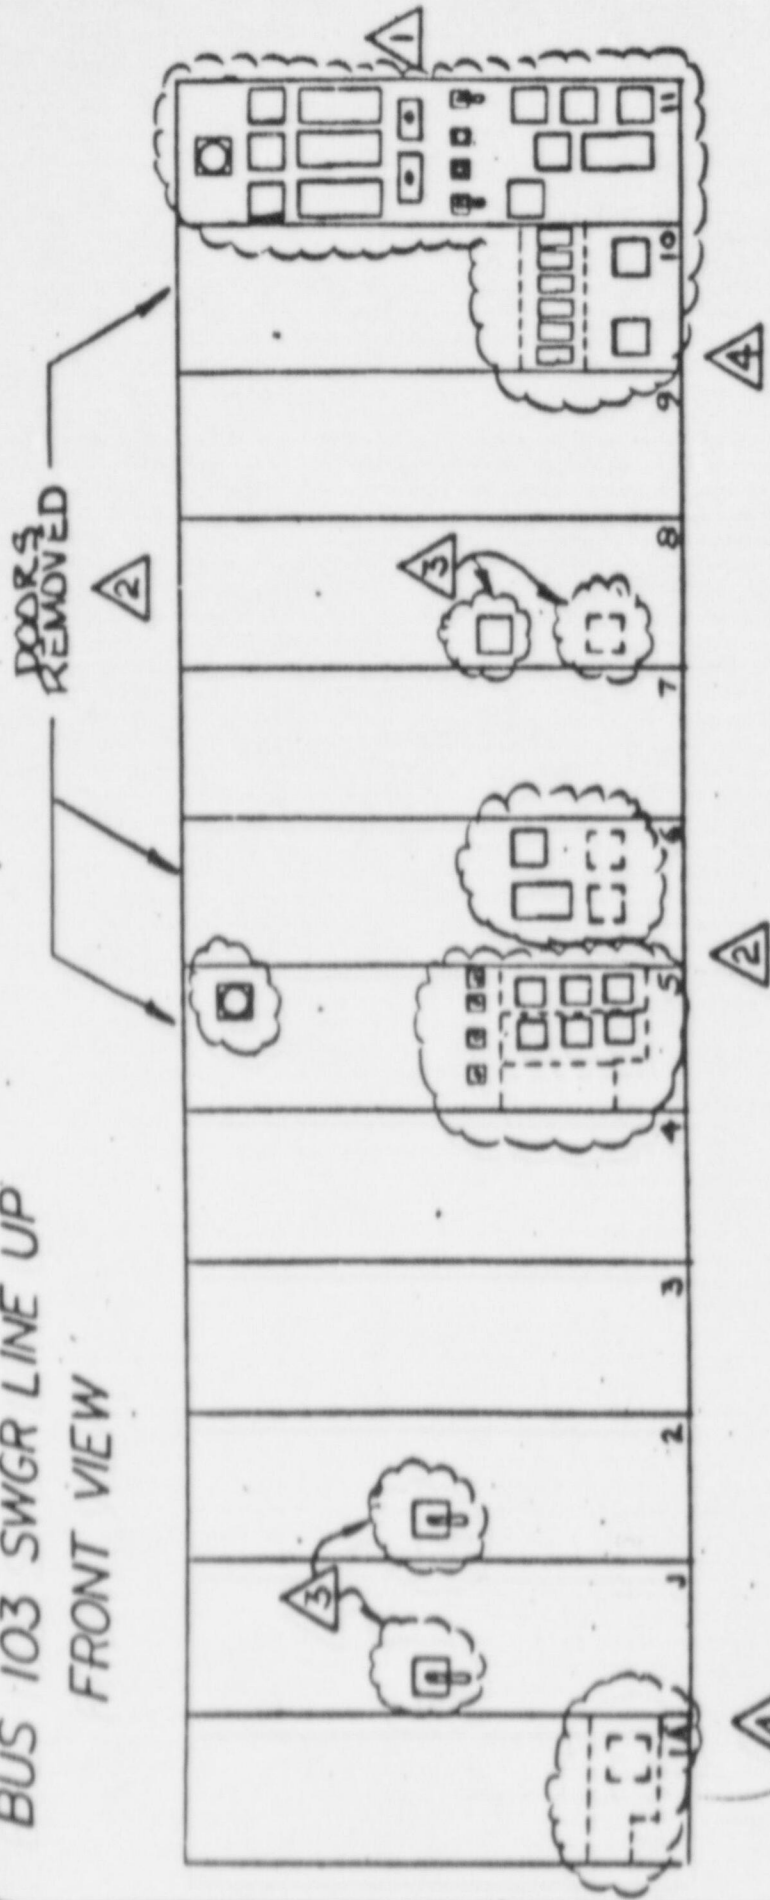
BUS 103 SWGR LINE UP
FRONT VIEW

- 1: NEW CUBICLE 103-11 ADDED TO BUS 103 LINE UP.
- 2: ALL THE DEVICES WERE REMOVED FROM THE DOORS IN CUB. 103-5, 103-6, 103-10 TO FACILITATE CUTTING, GRINDING, & WELDING.
- 3: RELAYING DEVICES REPLACED ON DOORS 103-1, 103-2, 103-8.
- 4: STIFFENERS AND FUTURE TIE-IN DEVICES ADDED TO DOORS 103-1A, 103-10
