Entergy Operations, Inc.
1448 S.R. 333
Russellville, AR 72801
Tel 501 858-5000

October 4, 1999

1CAN109905

Subject: Arkansas Nuclear One - Unit 1
Docket No. 50-313
License No. DPR-51
Special Report - Once Through Steam Generator Tubing Surveillance -
Category C-3 Results

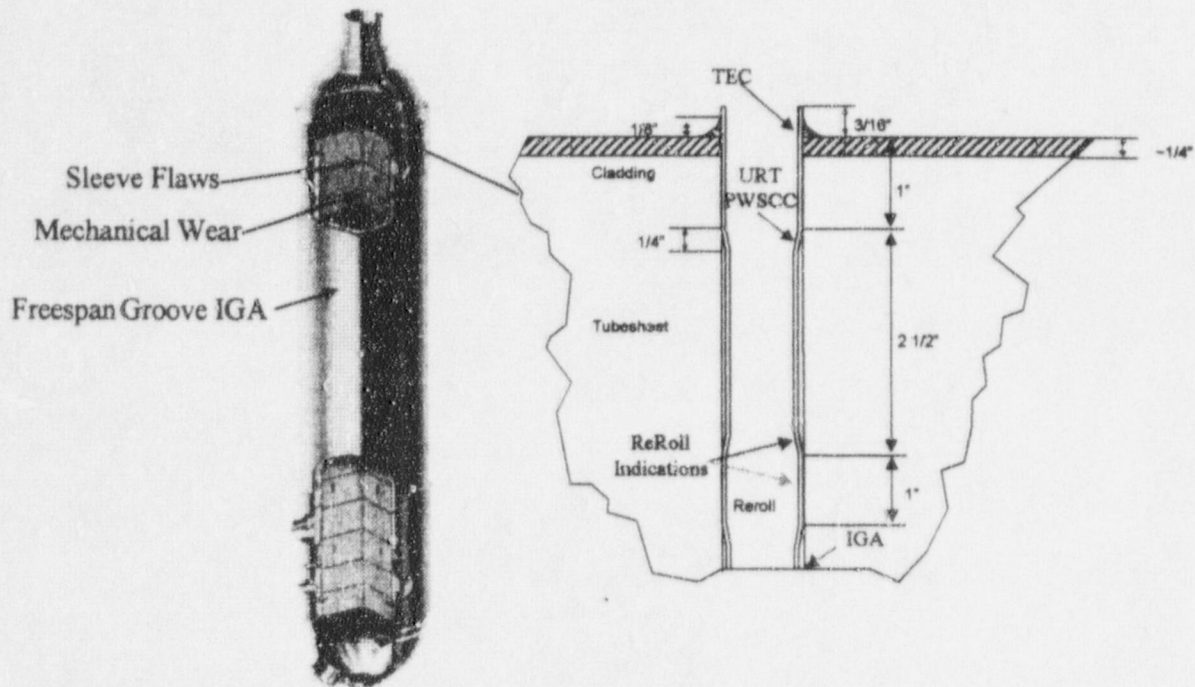
FIGURE 1
OTSG Degradation Detected During 1R15 Inspection

As noted in Table 2, the number of defective tubes due to indications in the upper roll transitions in the "A" OTSG and the rerolls in both OTSGs were greater than 1% of the corresponding number of tubes in that category. The tubesheet IGA and the TECs are considered under the ARCs and only counted as defective toward the general C-3 categorization if the tubes exceeded the ARC criteria. The individual damage mechanisms are discussed separately below. Figure 1 illustrates the different modes of degradation detected during the 1R15 inspection.
