MIT NUCLEAR REACTOR LABORATORY

Re: Massachusetts Institute of Technology, License No. R-37, Docket No. 50-20, Reportable Occurrence 50-20/2021-1: Operation with Less than the Required Staffing on Site; NRC OPS Center Log # EN 55212

1. Report No. 50-20/2021-1; Ops Center Log # EN 55212
- 2a. Report Date: 30 April 2021
- 2b. Date of Occurrence: 24 April 2021
3. Facility MIT Nuclear Reactor Laboratory
4. Identification of Occurrence:

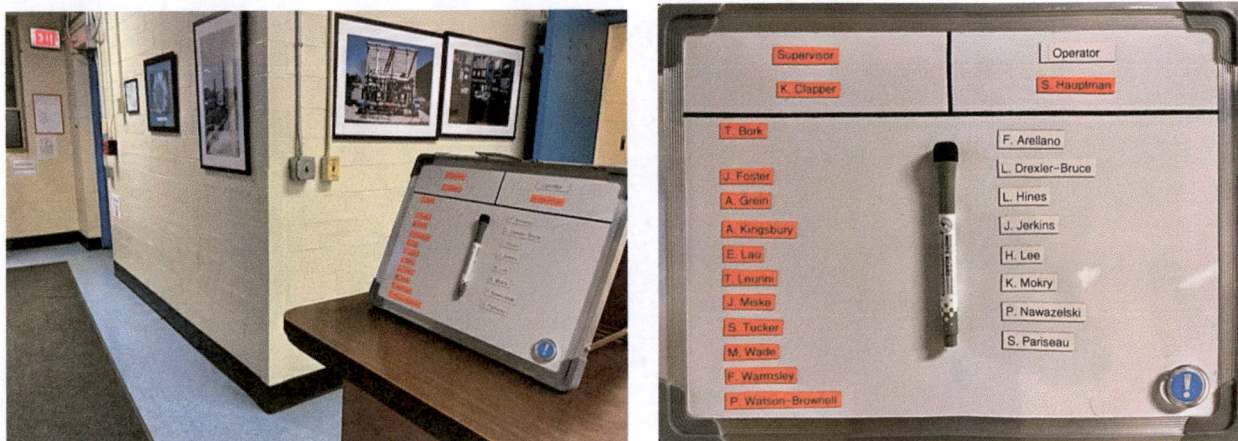
There was already a sign posted at the building exit to serve as shift turnover reminder, but its effectiveness decreases over time. A more effective reminder mechanism would allow ready recognition and confirmation of shift coverage and compliance for all outgoing licensed staff as they depart the facility.

Figure 1 – Two Views of the New Magnetic Whiteboard at Reception Desk

As a near-term corrective action, a shift coverage and compliance notice board is now installed visible to all outgoing license staff as they depart the facility. This notice board is a magnetic whiteboard (see Figure 1) at the reception desk where the names of the on-duty staff members are to be kept updated by the outgoing shift supervisor and outgoing console operator whenever the building is open.
