SUBJECT: SHEARON HARRIS NUCLEAR POWER PLANT – INTEGRATED INSPECTION
REPORT 05000400/2021003

**U.S. NUCLEAR REGULATORY COMMISSION
Inspection Report**

Report Number: 05000400/2021003

Facility: Shearon Harris Nuclear Power Plant

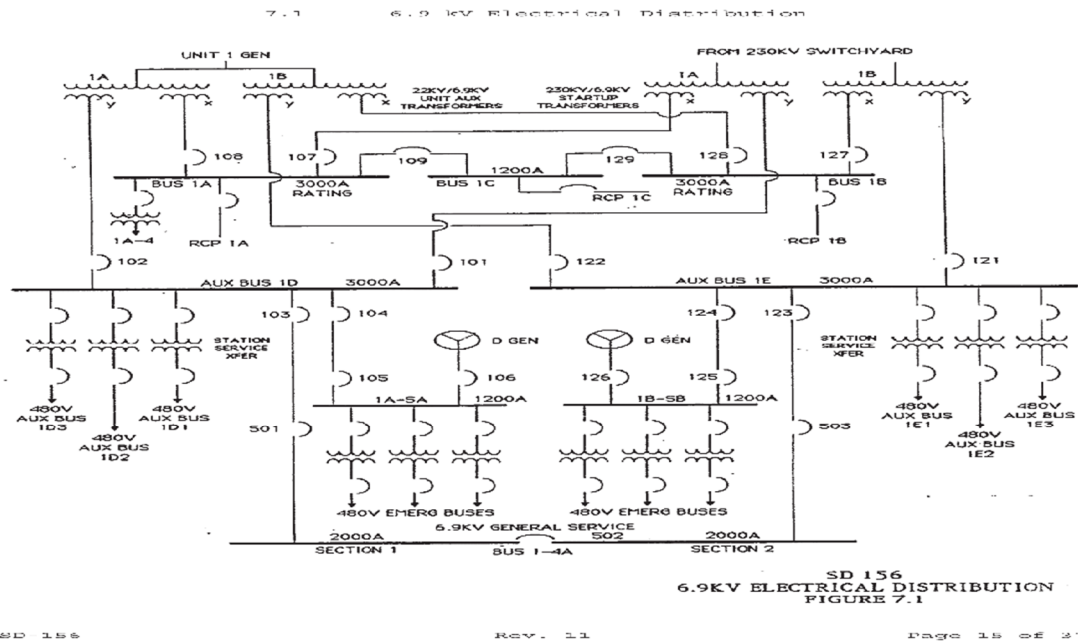
For the faults to occur, two factors were present that together resulted in electrical tracking. Degraded bus insulation combined with a medium to conduct the current (water) resulted in tracking on the bus. The degraded insulation was likely a result of cracking in the original bus insulation (Noryl). The site did not implement an adequate long-term strategy to address a known degradation mechanism with original Noryl insulation, particularly in inaccessible bus duct locations. In addition, the installed configuration of the wall penetration did not match the original design and was not being maintained to ensure weather tight characteristics.

Extent of condition inspections performed during the Spring 2021 outage showed arc tracking on the UAT-1B-Y windings as well and the 'A' SUT A Noryl insulation was cracked and evidence of water intrusion in the duct was identified although no evidence of arc tracing or other

degradation was identified on the SUT. Subsequent inspection of the 'B' SUT revealed no issues with the Noryl insulation or indications of arcing.
