Salem Generating Station Units 1 and 2
Renewed Facility Operating License Nos. DPR-70 and DPR-75
NRC Docket Nos. 50-272 and 50-311

Subject: Request for Relief from ASME Code Defect Removal for Service Water
Buried Piping

10 CFR 50.55a Request for Relief SC-I5R-221

10 CFR 50.55a Request No. SC-I5R-221
Request for Relief for Defect Removal for Service Water Buried Piping
Salem Units 1 and 2
Proposed Alternative in Accordance with 10 CFR 50.55a(z)(2)
Hardship or Unusual Difficulty without Compensating Increase in Level of Quality or Safety

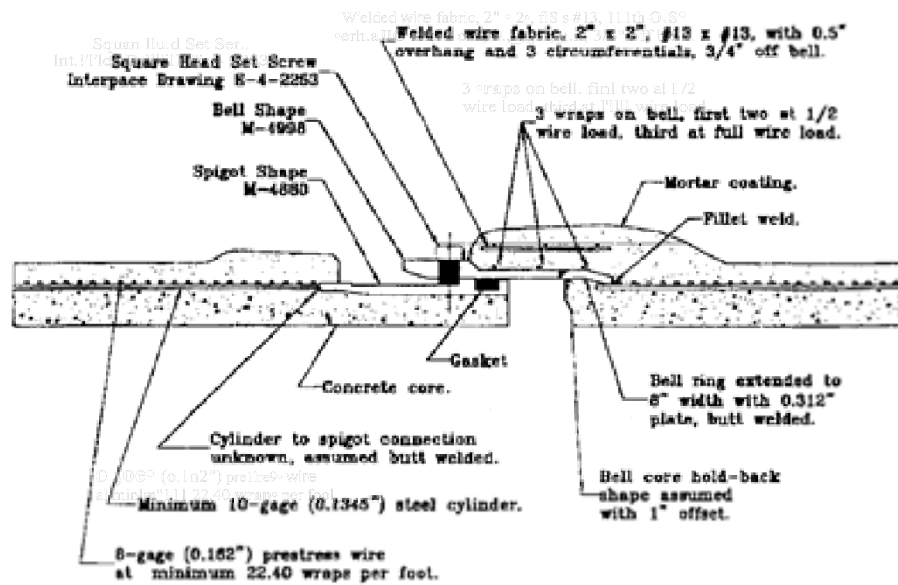
Figure 1 - Typical PCCP Joint Configuration

Salem Units 1 and 2 have identified bell band thinning due to corrosion in some bell and spigot joints.

A sketch of a typical PCCP bell and spigot joint is shown in Figure 1. The key elements of the pre-stressed concrete bell and spigot joint are as follows:

- A concrete core 1.5 inches thick is spun inside a steel cylinder 0.1345 inch thick (10 gage). The concrete core has an inside diameter of 24 inches and an outside diameter of 27 inches.

- The steel cylinder is wrapped with tensioned steel wire to pre-stress the concrete core and the steel cylinder. The wires are 0.162 inch in diameter (8 gage) and are installed with a tensile stress of 173,250 psi. The wire is wrapped 22.4 times per axial foot on the liner.

- After the cylinder/concrete core is pre-stressed, mortar is painted on the cylinder OD to protect the wires and cylinder. The mortar is nominally 13/16 inch thick.

- At one end of the pipe, a steel spigot (0.375 in. thick) is welded to the end of the cylinder. The spigot includes a groove for installation of an O-ring seal.

- At the other end of the pipe, a steel bell (0.312 in thick) is welded to the end of the cylinder. The steel bell includes 24 bell bolts (0.75 inch-10UNC-2A) around the circumference. The bell bolts provide longitudinal strength for the joint in the event of failure of the harness bolt assembly. The steel bell is pre-stressed with three wraps of wire. The first two wraps are placed at half load (i.e. a wire stress of 86,625 psi). The mortar over the joint is approximately 2.2 inches thick and includes a 13 gage (0.092-inch diameter) 2-inch x 2-inch wire mesh over the bell to prevent shrinkage cracking during fabrication. This mesh provides negligible structural strength to the joint.

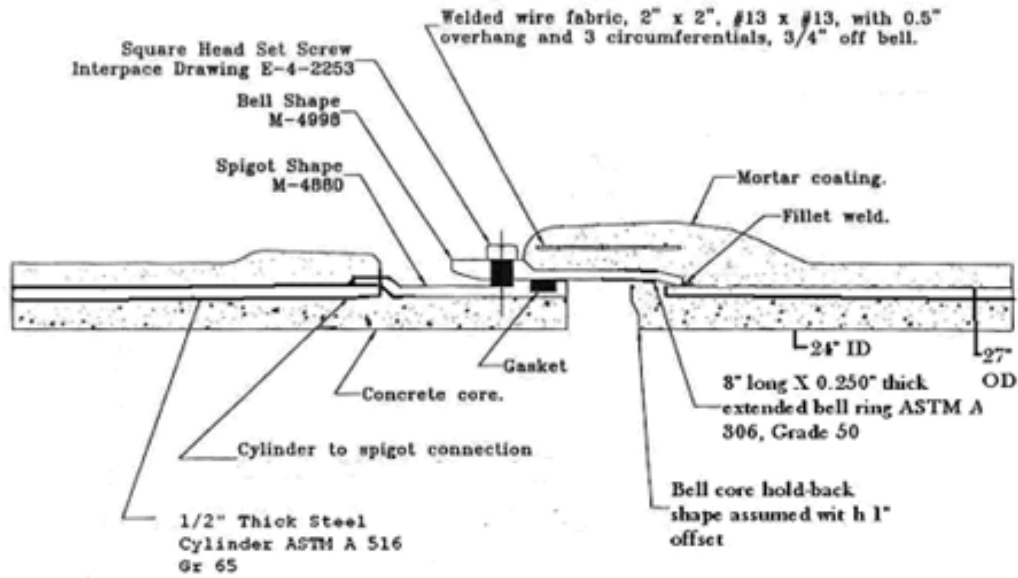
Figure 2 - Typical Special Joint Configuration

A sketch of a typical special joint is shown in Figure 2 (Note that the figure shows the configuration for both the bell and spigot when used with non pre-stressed pipe - "specials." This is provided for convenience; only one side of the joint would typically use a special). The key elements of the special bell and spigot joint are as follows:

Note: This figure shows a non pre-stressed "special" bell connected to a non pre-stressed "special" spigot. This configuration is not installed, but is shown for compactness (i.e., to present both the "special" bell and spigot configurations in one figure).

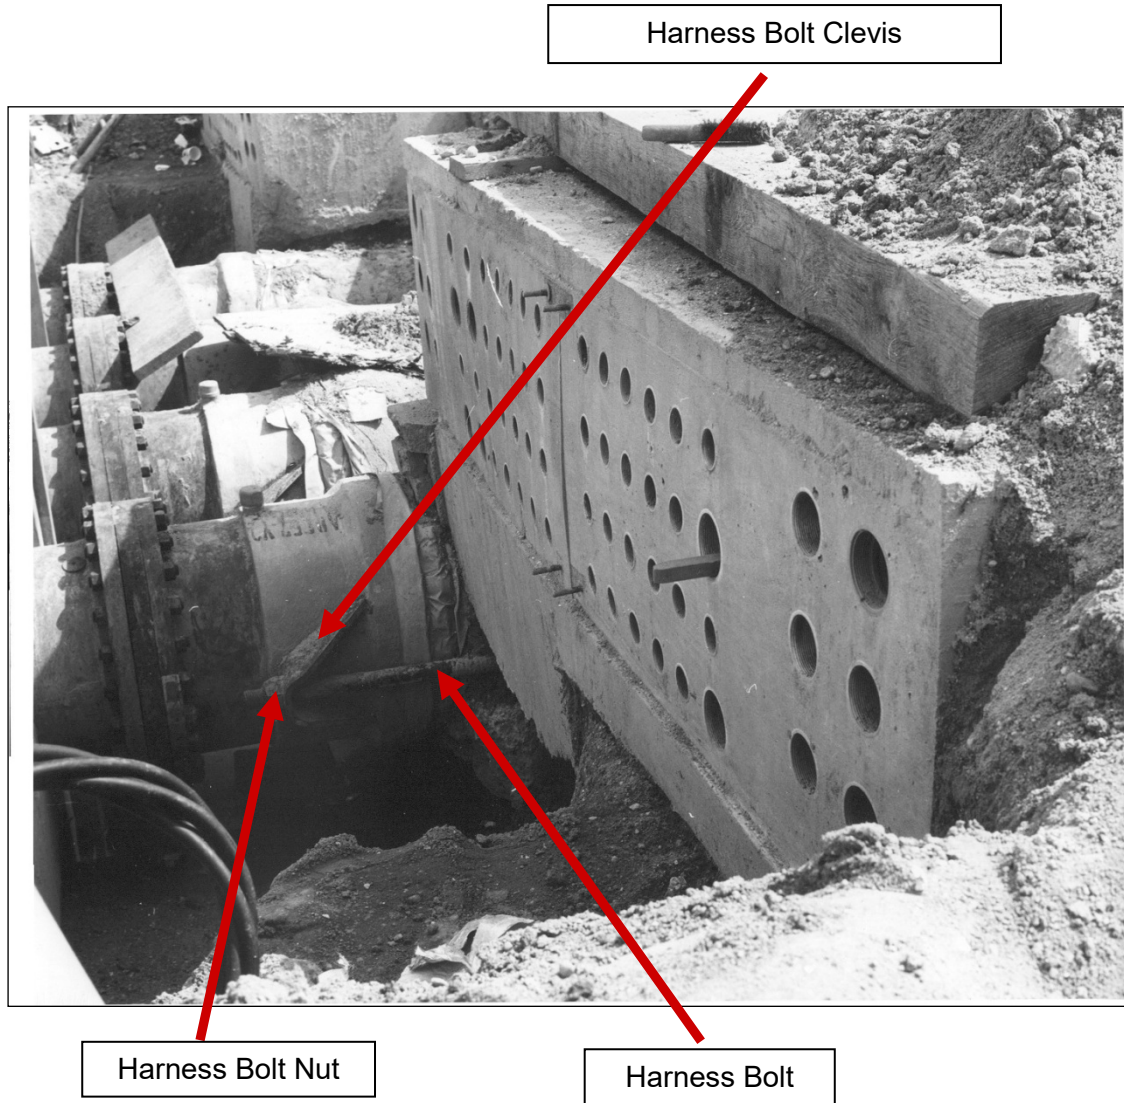
Figure 3 - Photograph of Harness Bolt Anchorage

Special joints, which are installed at elbows, end pieces, and other locations where the piping run starts, stops, or changes direction, as well as specified straight PCCP sections, include two external harness assemblies, one on each side of the pipe joint. The harness bolts are 2-inches in diameter, with a minimum tensile strength of 98 ksi. The harness bolts are attached to the pipe using heavy hex nut and clevis arrangements. They are of various lengths, normally exceeding 20 feet, incorporate all joints, and each includes a breakaway coupling ensuring breakage if the axial force exceeds 175,000 lbf. Typical harness bolt assembly arrangements are shown in Figures 3 & 4.

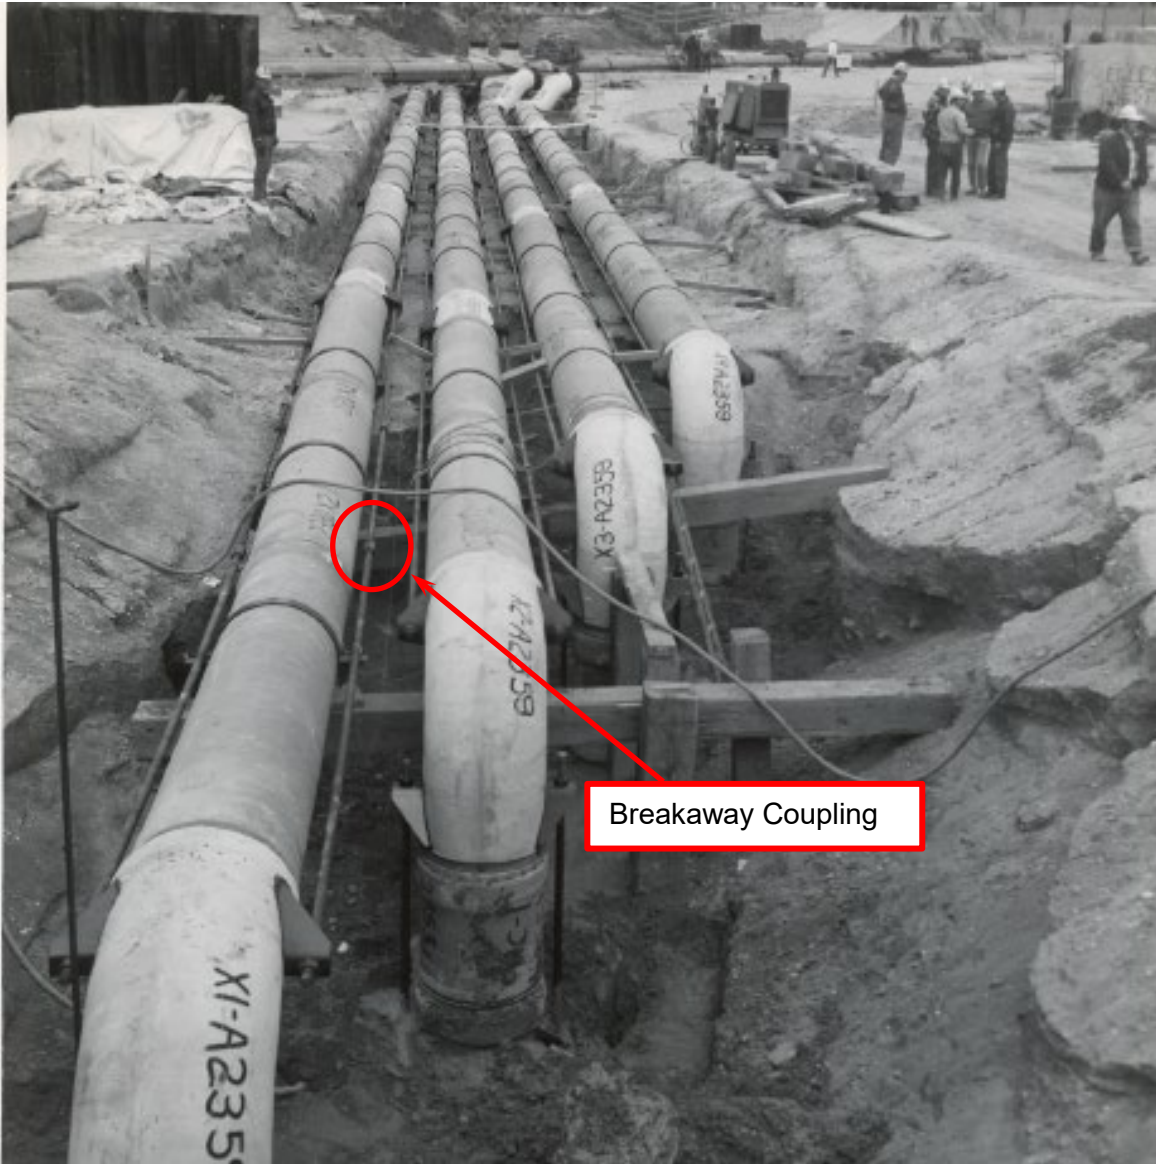
**Figure 4 1972 Construction Photo of Service Water Return Piping
Showing Harness Bolts with Breakaway Couplings**

As can be seen clearly from Figure 4, determination of whether a harness bolt is serviceable is not merely a matter of digging down at a pipe joint; extensive excavation would be required should such an examination be required.
