Subject: 10CFR21 Reporting of Defects and Non-Compliance -  
Engine Systems, Inc. Report No. 10CFR21-0136, Rev. 0

Voltage Regulator Chassis – Incorrect Bus Bar Installation  
P/Ns: 72-12300-100-ESI  
72-14200-100-ESI  
72-14000-100-6020

**10CFR21 REPORTING OF DEFECTS  
AND NON-COMPLIANCE**

SYSTEM: Emergency Diesel Generator

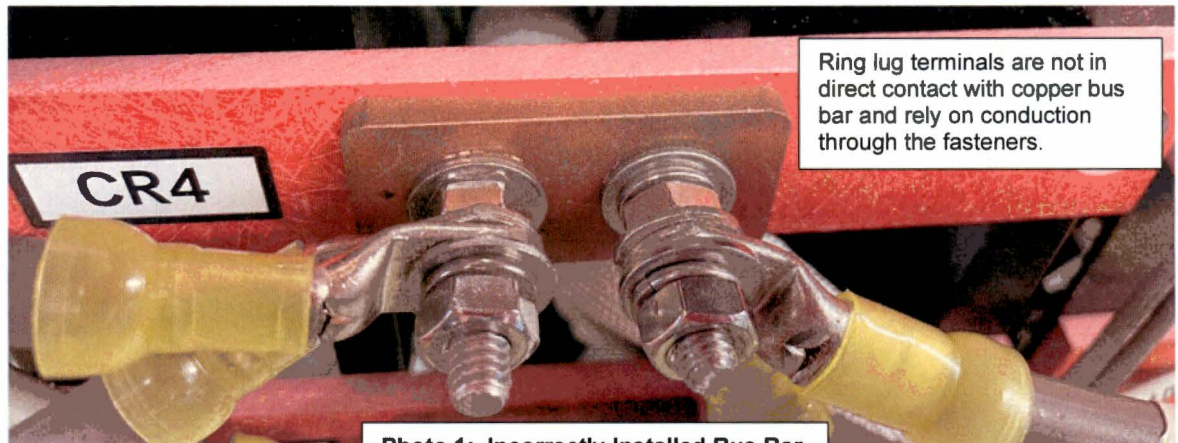
*Copper bus bars are used at rectifier diode pigtail connections CR1, CR2, CR3, CR4, and CR7 to provide a common connection point for associated wiring to minimize the number of conductors on a single fastener. It is intended for the conductors to clamp directly to the bus bar, thereby maintaining a low resistance conduction path between components. ESI has determined the bus bars were installed incorrectly whereby the conductors are not clamped in direct contact, resulting in current flow through the stainless steel fasteners. This configuration is undesired and will result in unnecessary heat generation which may lead to failure of the connection and therefore failure of the automatic voltage regulator (AVR) assembly. The AVR is relied upon to automatically regulate emergency diesel generator (EDG) terminal voltage. Failure of the AVR would impact ability of the EDG to perform its safety-related function and therefore may impact the nuclear plant's ability to manage safety-related loads during an emergency event.*

Photo 1: Incorrectly Installed Bus Bar

*Bus bar installation should be corrected immediately by restacking the components to ensure direct contact with all conductors. See section viii below for details.*

*The bus bar installation should be corrected prior to installation. If desired, the customer may perform on site or the voltage regulator chassis may be returned to ESI for rework.*

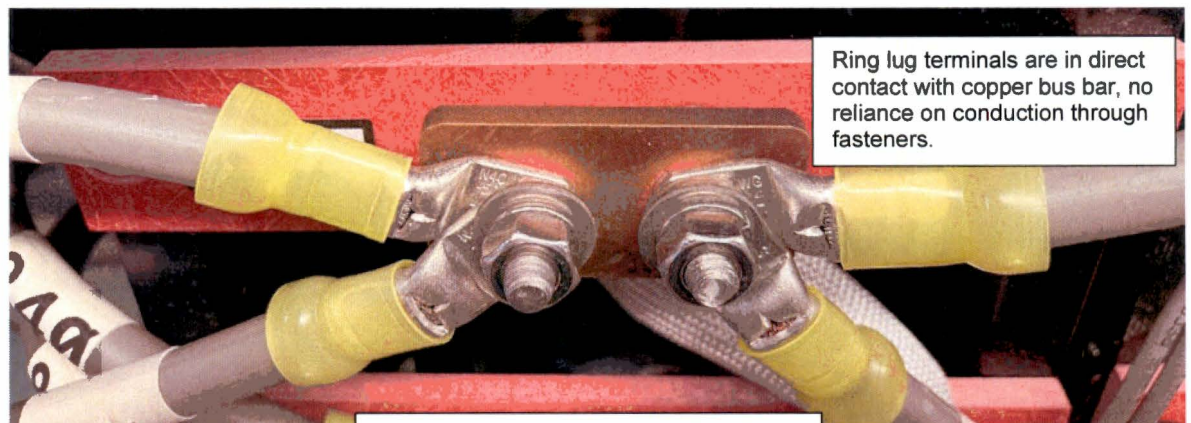
Photo 2: Correctly Installed Bus Bar

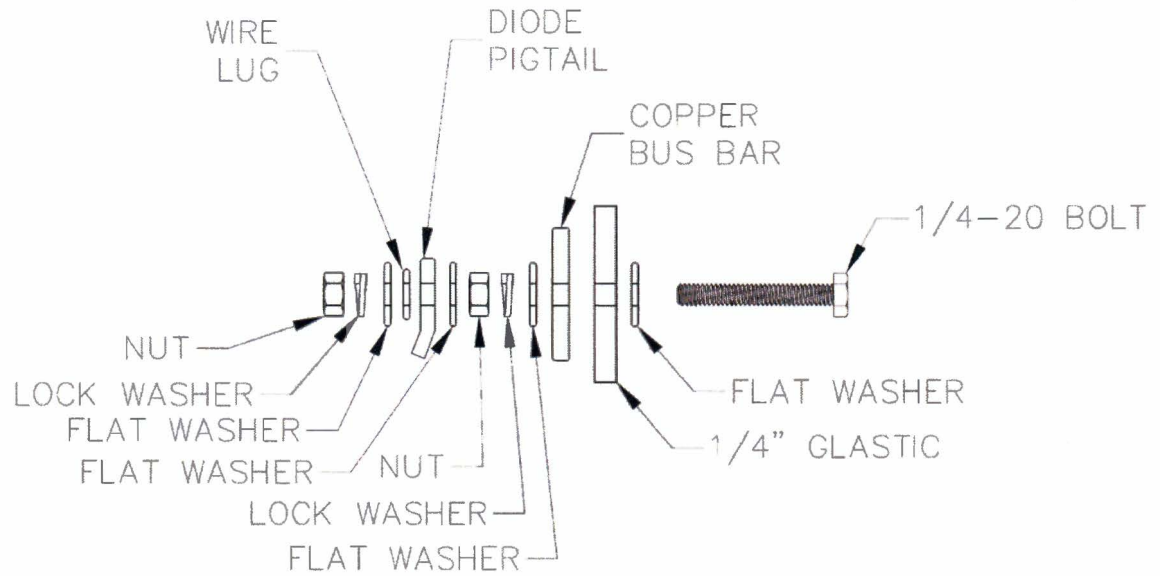
**Figure 1: Cross Section - Incorrect Bus Bar Install**  
(Note bus bar is not in direct contact with wire lug and diode pigtail)

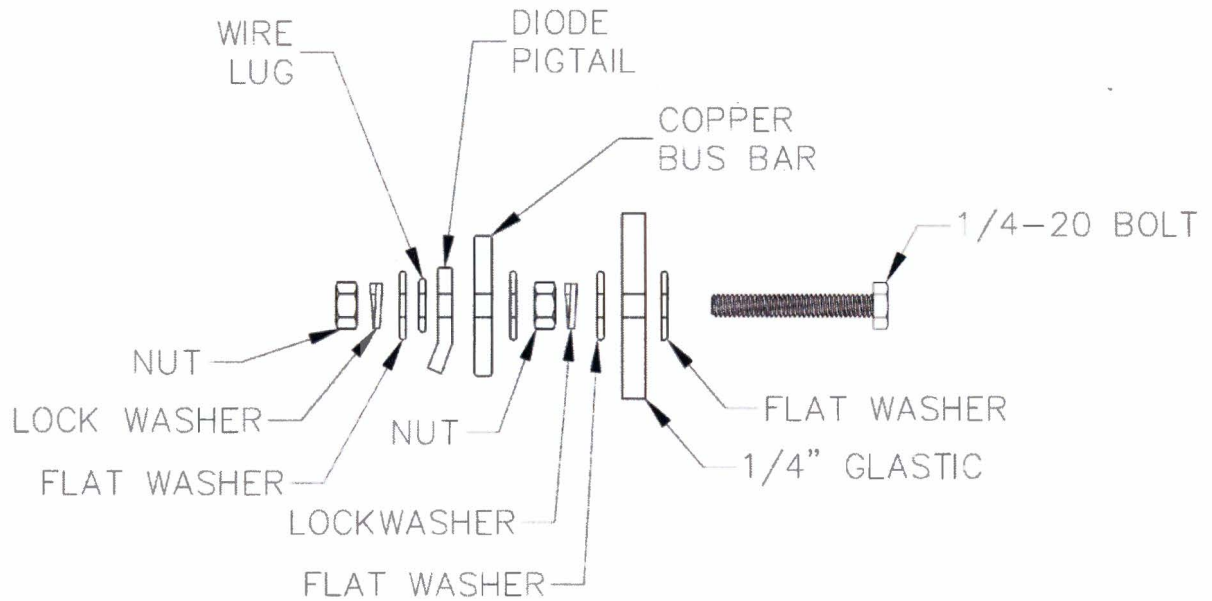
**Figure 2: Cross Section - Correct Bus Bar Install**  
(Note wire lug, diode pigtail, and bus bar stacked in direct contact)

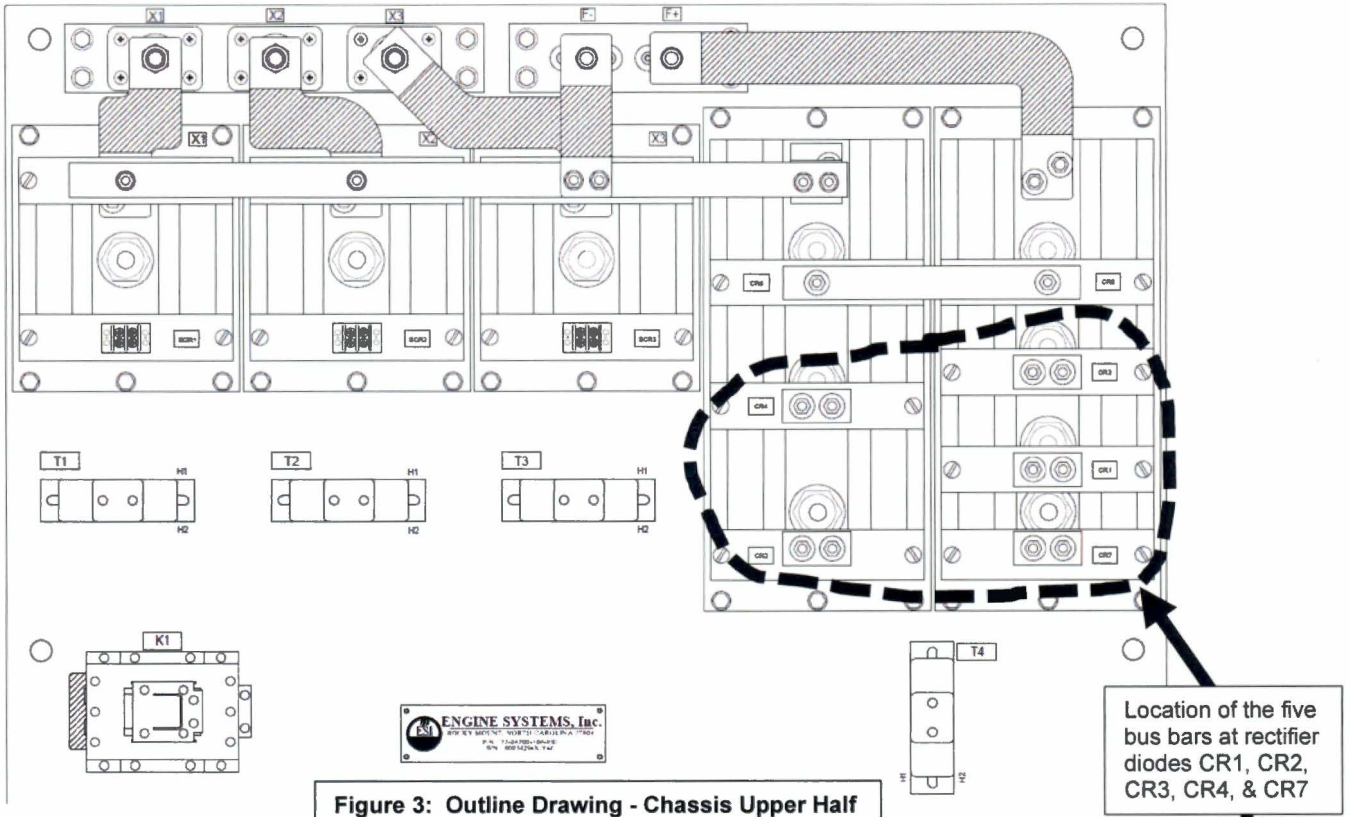
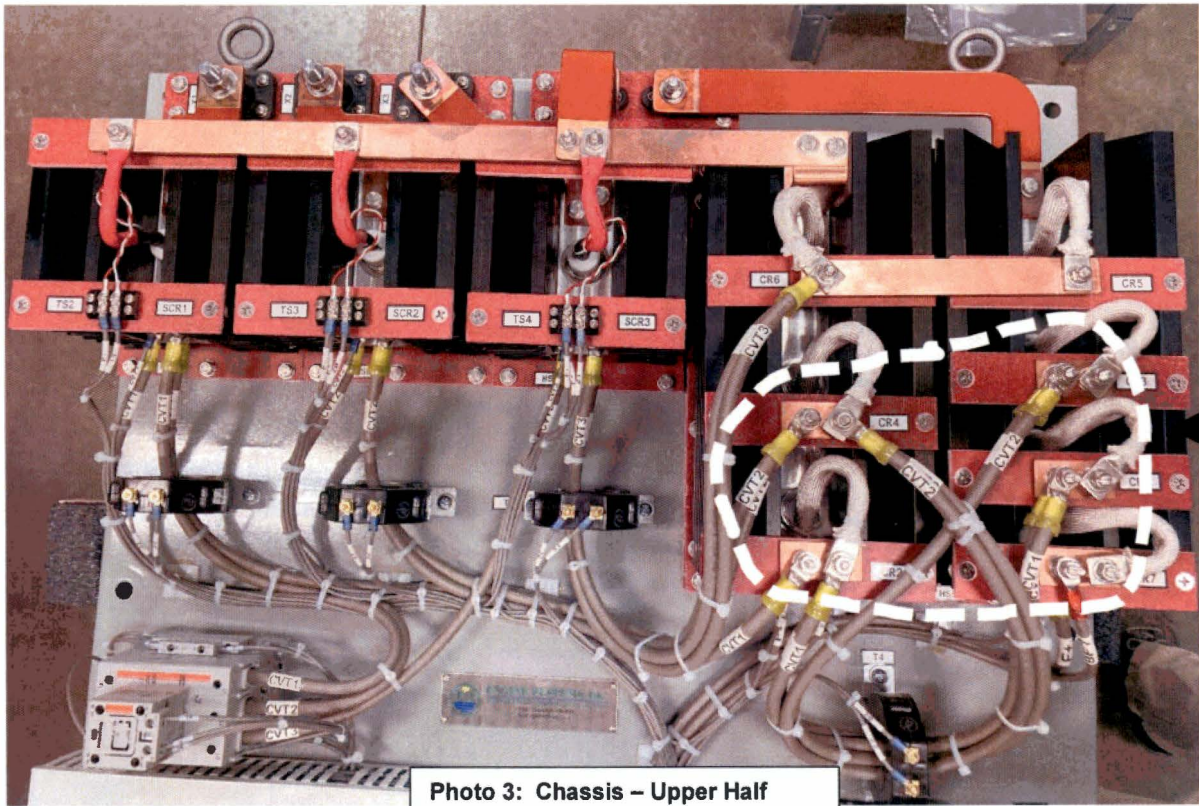
Photo 3: Chassis - Upper Half

Figure 3 and photo 3 below show location of the bus bars on the voltage regulator chassis.
