South Texas Project  
Units 1 and 2  
Docket Nos. STN 50-498 and STN 50-499  
Supplement to Proposed Alternate Frequency to Containment Unbonded Post-Tensioning  
System Inservice Inspection (Relief Request RR-ENG-4-06) (EPID: L-2023-LLR-0004)

Revised Relief Request RR-ENG-4-06, Alternative Frequency to Containment  
Unbonded Post-Tensioning System Inservice Inspection

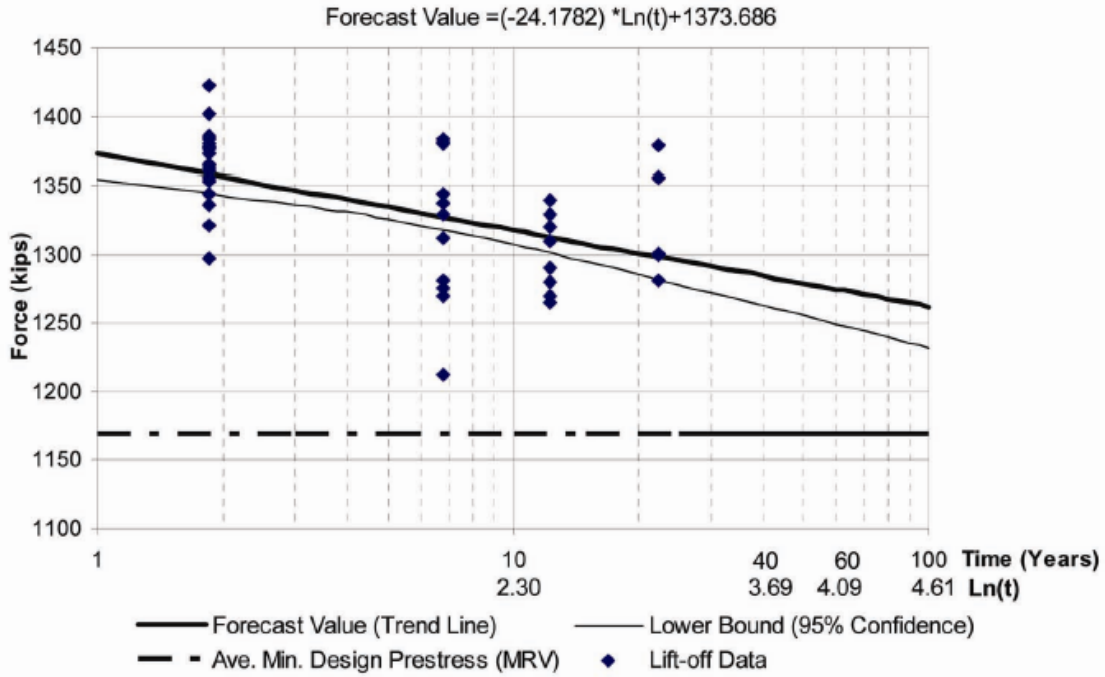
Figure 6.5.1 is Fig. 4.5-2 in LRA, Revision C. It used data through year 20. Figure 6.5.2 is an updated version that includes 30<sup>th</sup> year surveillance data. The figures are not directly comparable because the top figure uses a semi-log plot. In Figure 6.5.1, the forecast value at year 60 is 1275 kips. In Figure 6.5.2, the forecast at year 60 has increased slightly to 1283 k, which remains above the minimum required value (1169 k). The trend is essentially stable.

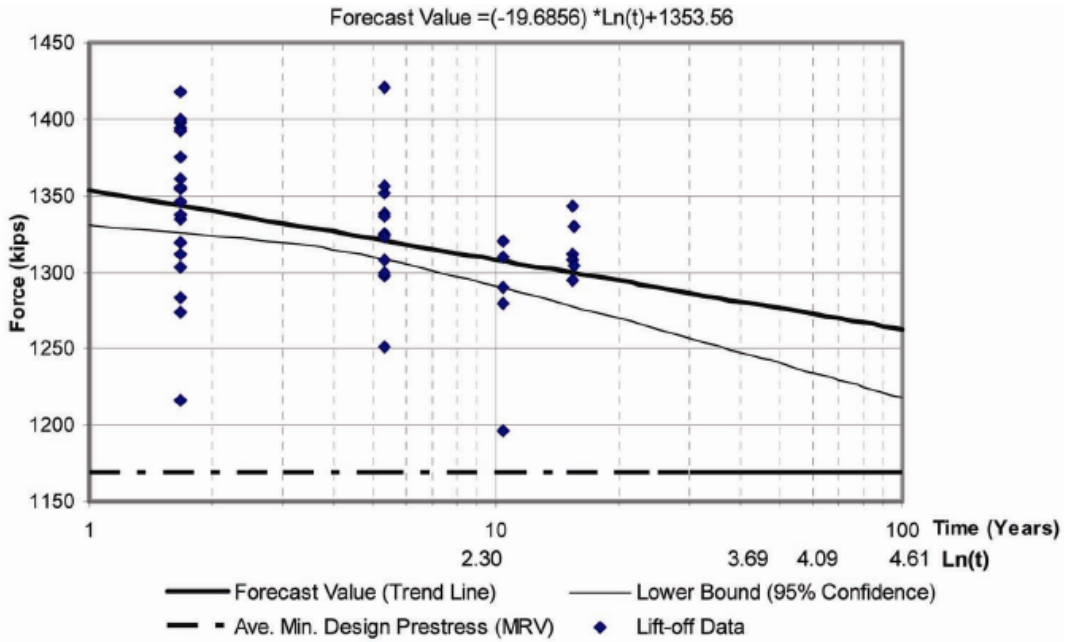
Figure 6.5.3 is Fig. 4.5-4 in LRA, Revision C. It used data through year 15. Figure 6.5.4 is an updated version that includes 25<sup>th</sup> year surveillance data. The figures are not directly comparable because the top figure uses a semi-log plot. In Figure 6.5.3, the forecast value at year 60 is 1273 kips. In Figure 6.5.4, the forecast at year 60 has increased slightly to 1283 k (MRV = 1169 k). The trend is essentially stable.

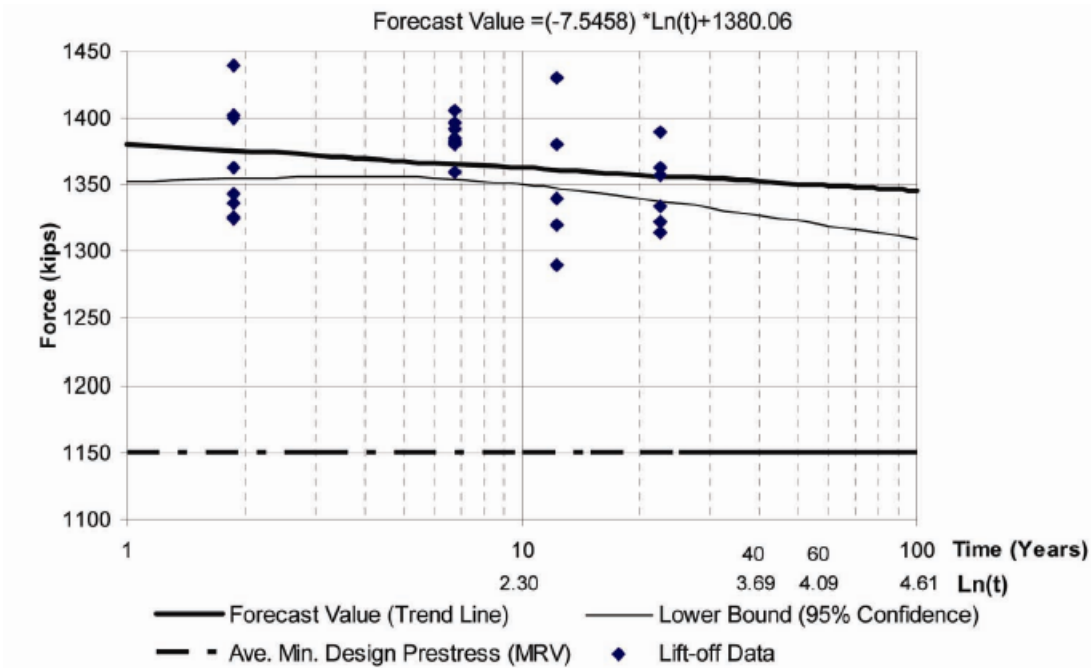
Figure 6.5.5 is Fig. 4.5-2 in LRA, Revision C. It used data through year 20. Figure 6.5.6 is an updated version that includes 30<sup>th</sup> year surveillance data. The figures are not directly comparable because the top figure uses a semi-log plot. In Figure 6.5.5, the forecast value at year 60 is 1349 kips. In Figure 6.5.6, the forecast at year 60 has declined roughly 1% to 1334 k, but still far above the minimum required value (1150 k). The trend is essentially stable.

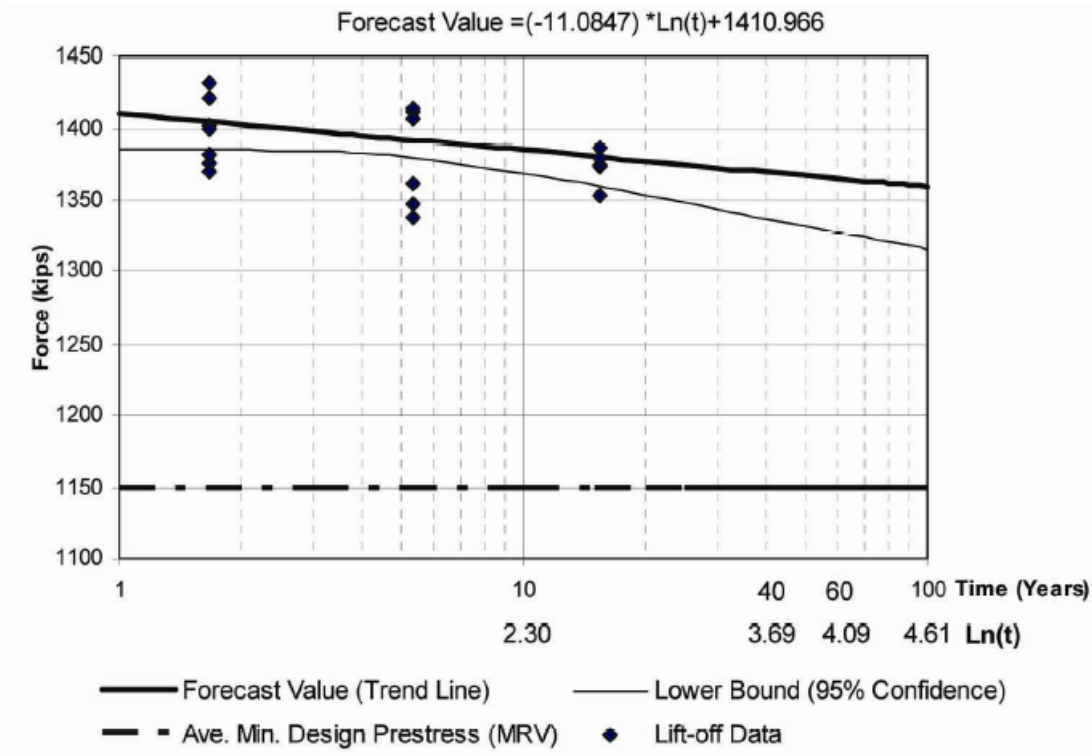
Figure 6.5.7 is Fig. 4.5-4 in LRA, Revision C. It used data through year 15. Figure 6.5.8 is an updated version that includes 25<sup>th</sup> year surveillance data. The figures are not directly comparable because the top figure uses a semi-log plot. In Figure 6.5.7, the forecast value at year 60 is 1366 kips. In Figure 6.5.8, the forecast at year 60 has declined very slightly to 1362 k, but it is still far above the minimum required value (1150 k). The trend is essentially stable.
