**Subject: Updated - Part 21 60-Day Interim Report Notification: Failure of the CRD  
Collet Retainer Tube/Outer Tube Weld (SC-23-01)**

Part 21 60-Day Interim Report Notification: Failure of the CRD Collet Retainer  
Tube/Outer Tube Weld (SC-23-01)

**SC 23-01 R0**  
**007N7348 R0**

**Subject: Failure of the CRD Collet Retainer Tube/Outer Tube Weld – Interim Notification**

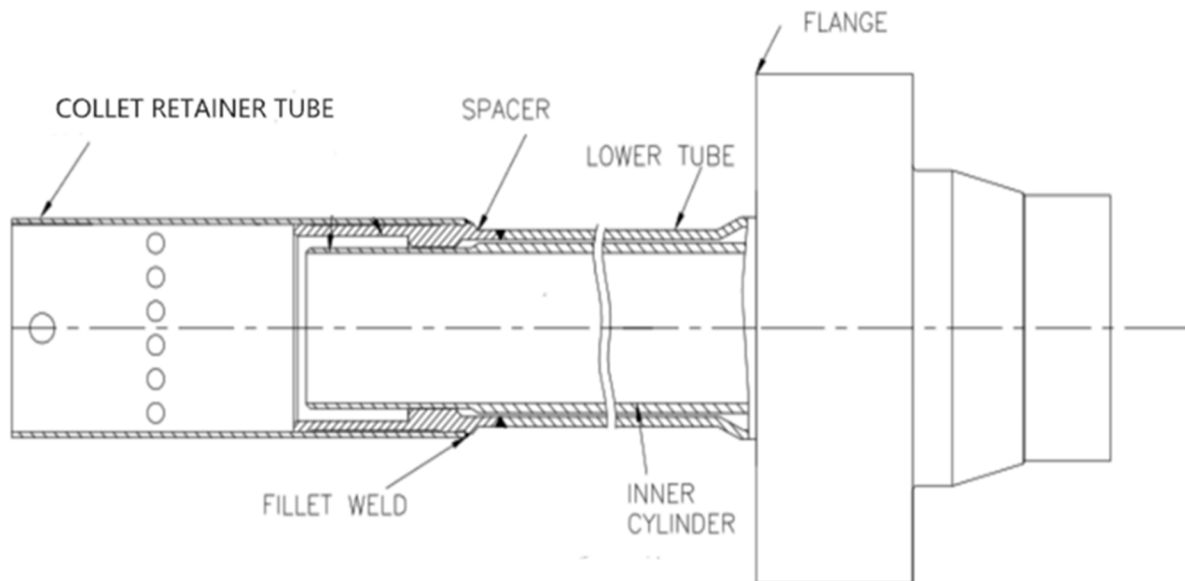
Figure 1 - CTF Assembly

During removal of a Control Rod Drive Mechanism (CRDM) from a domestic plant in February 2023, the plant operator discovered that a 360° failure of the collet retainer tube fillet weld had occurred, and the retainer tube had displaced approximately 1.125" from its original position. This retainer tube is part of the CRDM 919D258G003 Cylinder, Tube and Flange (CTF) assembly (see Figure 1). This is the first reported occurrence of significant displacement of the retainer tube on any in-service CTF assembly. The function of this assembly is to react to the applied hydraulic loads allowing the collet fingers to be retracted from the index tube and allow the CRDM to be moved for control rod positioning or scram.

The subject CTF assembly had been in-service since 1992. From 1992 until August 2021, the associated CRDM operated without significant performance issues. Then, during routine control rod exercising in August 2021, the control rod would not withdraw from position 46 to 48. Subsequent troubleshooting by the operator determined the control rod would not insert normally and could not be withdrawn. However, the plant operator was able to fully insert the control rod using elevated drive water differential pressure (DP), and left it inserted until a recent refuel outage.

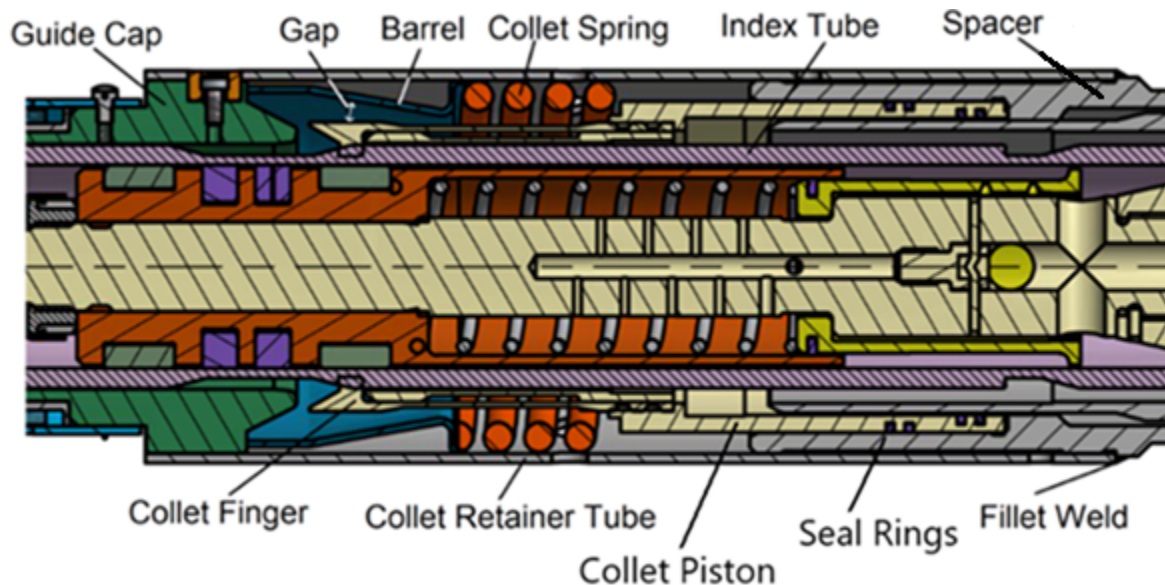
**Figure 2**  
**Upper Section of CRDM Assembly**

During control rod withdrawal, drive water pressure is applied to the bottom of the collet piston causing it to actuate and press the collet fingers against the guide cap (see Figure 2). With the guide cap fastened to the collet retainer tube the upward force is applied to the tube. With failure of the retainer tube fillet weld, movement of the collet retainer tube is no longer constrained. Therefore, it is expected that movement of the retainer tube may occur during attempts to withdraw the control rod. With significant movement or separation of the collet retainer tube, the

collet spring expands narrowing the gap between the collet fingers and the barrel and spring. With insufficient gap size, the fingers are restrained which adversely impacts actuation of the collet piston needed for control rod withdrawal.

During normal control rod insertion (not scram), pressure is applied to the under-piston area of the CRDM drive piston connected to the bottom of the index tube. This pressure exerts an upward force which results in control rod insertion. Normally during insertion, the collet piston stays in the latched (down and seated) position and the collet fingers ratchet in and out of the index tube notches as the tube moves up. However, with significant retainer tube movement and narrowing of the gap between the collet fingers and the barrel and spring, the fingers can no longer freely move out of the notches. This creates a friction force opposing rod insertion which then exerts an opposite upward force on the collet fingers and piston. With the collet spring no longer compressed, this upward force can cause upward movement of the fingers with respect to the barrel and spring, which increases the gap. When the gap size increases, this allows the fingers to sufficiently clear the index tube notches, which permits rod insertion. For the recent event, the movement of the retainer tube was such that the positioning of the barrel, spring and collet fingers allowed the fingers to clear the notches, allowing insertion of the control rod, although at elevated drive water DP (325 psid).

As discussed above, with significant movement of the collet retainer tube, the ability to insert and withdraw the control rod will be impacted. That is, during an attempt to notch the control rod, either insert or withdraw, if the control rod fails to leave the initial position, or it moves in slightly then fails to normally settle back to the initial position, collet retainer tube separation should be considered as a possible cause for subsequent troubleshooting. The troubleshooting plan should recognize that if collet retainer tube separation has occurred, when a withdraw signal is applied with the use of elevated drive water DP, the potential exists to drive the outer piston seal rings above the top of the spacer and key the collet piston and fingers in the unlatched position. With the collet piston fingers unlatched from the index tube notches, the control rod will drift out to the fully withdrawn position.

1. Limit use of elevated drive water differential pressure when excessive collet piston seal leakage is preventing the collet mechanism from actuating during attempts to notch out from position 00. Specifically, elevated DP may be used to allow for unlatching after it has been confirmed that the control rod is inserting as expected, and the withdrawal stall flow has been confirmed to be high (significantly above trend) due to suspected collet piston seal leakage. It's recognized that other issues may prevent normal control rod insertion. Use of elevated drive water DP to assist with rod insertion is not limited by the above recommendation.

2. If a control rod fails to insert or withdraw with normal drive water DP (250 to 265 psid), recognize that these are potentially symptoms of a separated collet retainer tube on the CTF assembly.

3. Review SIL 139 and its supplements (References 1-7) and ensure recommendations provided in these SILs are adequately addressed in plant procedures.
