Report No. 10CFR21-0137
Rev. 0: 01/04/24
Rev. 1: 01/17/24

10CFR21 REPORTING OF DEFECTS AND NON-COMPLIANCE

COMPONENT: EMD Cylinder Liner with Bore Deficiency
P/N 9318833 (component of power assembly P/N 40124897)
S/N 20M0938

SYSTEM: Emergency Diesel Generator

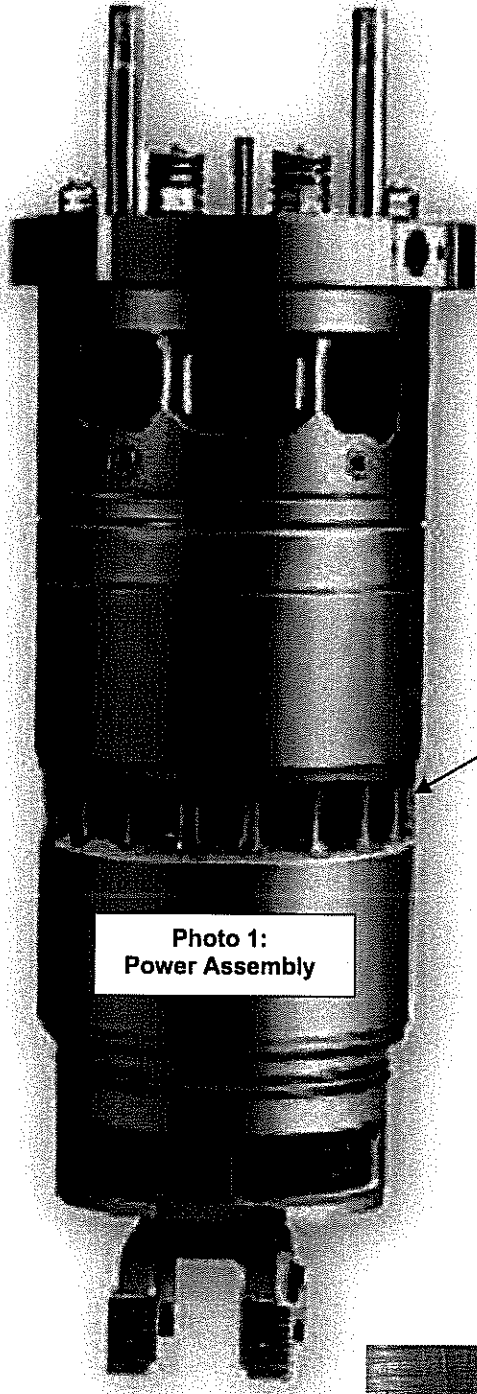
**Photo 1:
Power Assembly**

An edge or lip in the bore of an EMD cylinder liner prevented successful installation of the corresponding power assembly on an emergency diesel generator set. The lip is located axially at the bottom of the inlet ports and is present around the circumference of the bore. See photos of the power assembly, liner, and air inlet ports on page 3. The EMD model 645E4 is a 2-stroke engine with air inlet ports in the wall of the cylinder liner. As the piston travels below the inlet ports, air box pressure scavenges and replenishes air to the power assembly.

Installation of the power assembly requires lowering the piston through the liner in order to secure the connecting rod to the crankshaft. During this process the piston could not be lowered below the inlet ports due to the piston rings catching on the lip. The power assembly was not installed and therefore there was no safety hazard; however, if the defect had gone undetected there was the potential to damage engine components and possibly reduce load carrying capacity of the engine.

To prevent reoccurrence, ESI has revised the dedication package to include verification that bore machining is continuous along the entire length and no edges or lips are present. The revision was implemented on December 6, 2023.

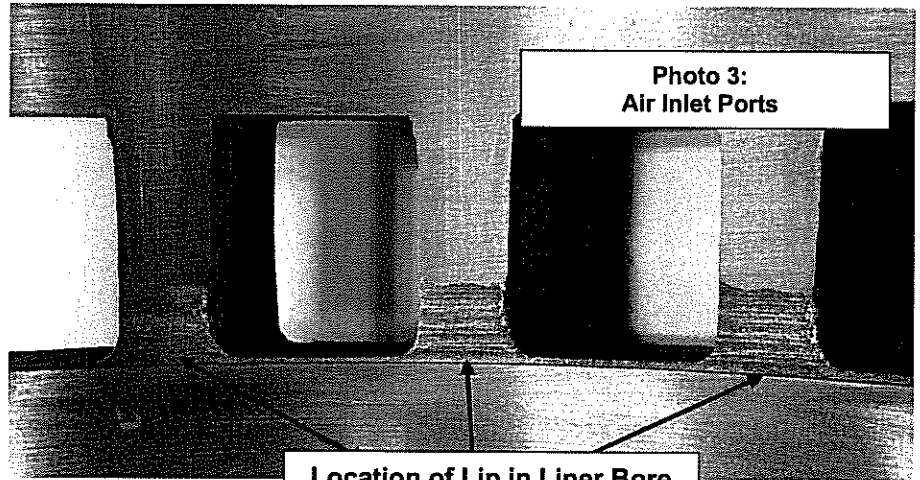
**Photo 3:
Air Inlet Ports**

Location of Lip in Liner Bore
at Bottom of Inlet Ports
