San Onofre Replacement Steam Generator Tube Wear February 7, 2013

Peter T. Dietrich, Senior Vice President and Chief Nuclear Officer

San Onofre Nuclear Generating Station

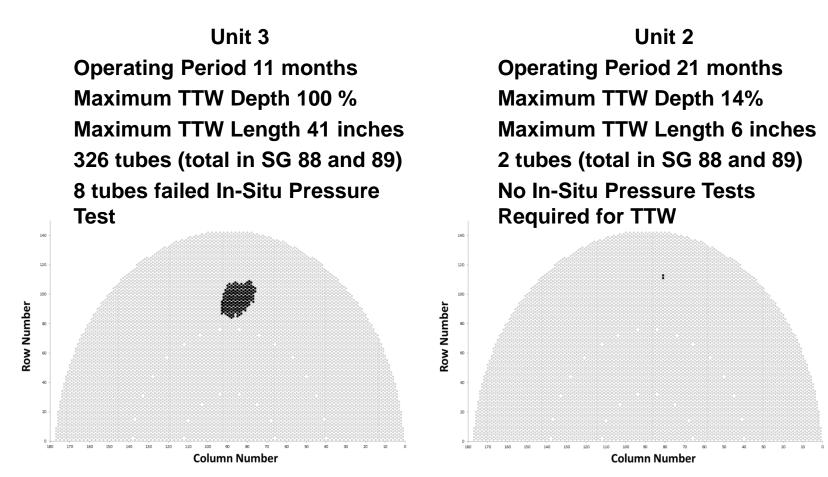
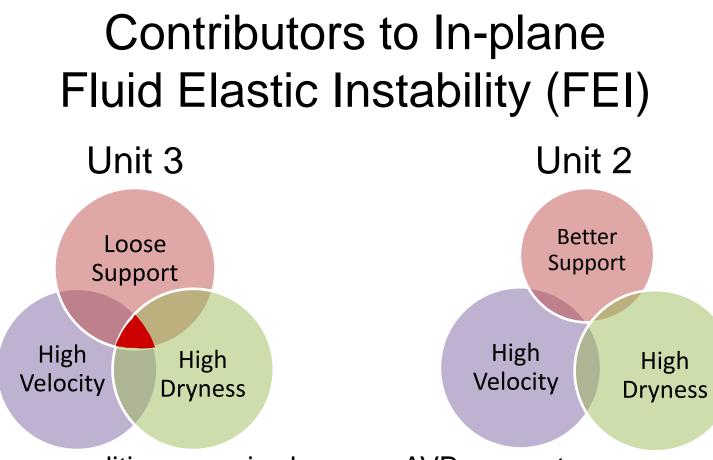
SG89 Tube-To-Tube Wear

All three conditions required for FEI existed concurrently for many tubes AVB supports are more effective in Unit 2, reducing potential for in-plane FEI

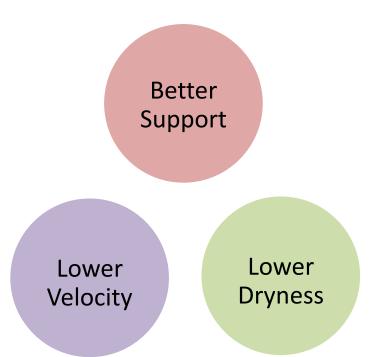
In-plane FEI can be Precluded

Eliminating the concurrent combination of high velocities, high dryness and inadequate support can preclude FEI

- Assure adequate support
- Reduce velocity
- Increase damping by decreasing dryness (insure adequate moisture levels in bundle)
- Demonstrate acceptable in-plane FEI stability ratios based on conservative assumptions
- Compare and justify the operating conditions based on those of satisfactory service in existing steam generators
